## COMPOSITE TUBES AT LOWER FURNACE OF KRAFT PULPING PROCESS CHEMICAL RECOVERY BOILER– MATERIAL AND CRACKING PROCESS ANALYSIS

**Alexandre Yamasaki Nakayama**

**Leandro de Almeida Laube**

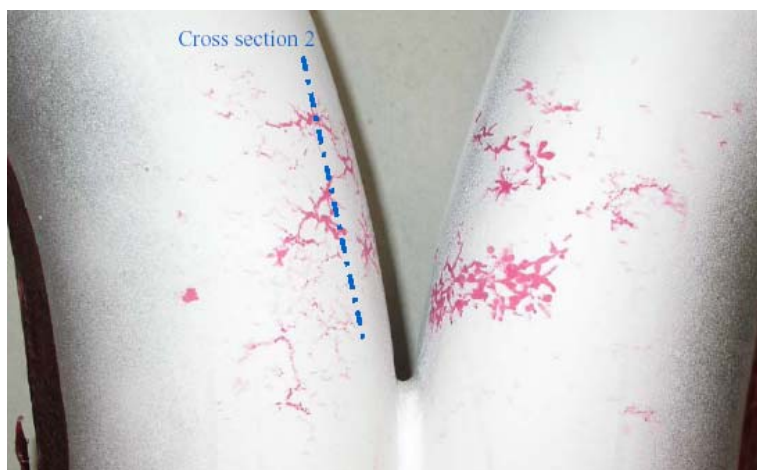
Barna and Rivers (1999) relate that if cracks exist in the form of a crazed pattern, they will typically not penetrate beyond the stainless cladding and into the carbon steel pressure bearing tube and if cracks develop in a circumferential pattern, there is a likelihood that cracking has or will penetrate into the carbon steel layer. Metallographic examination of cracked tubes retired from the case study boiler revealed that the characteristics cracking patterns were followed. Figures 2 shows the lower portion of a smelt spout opening taken off operation in 2004 showing a crazed pattern cracking and Fig. 3 shows the cross section indicated with crack ending at the composite tube interface.

Figure 2. Crazed pattern cracking

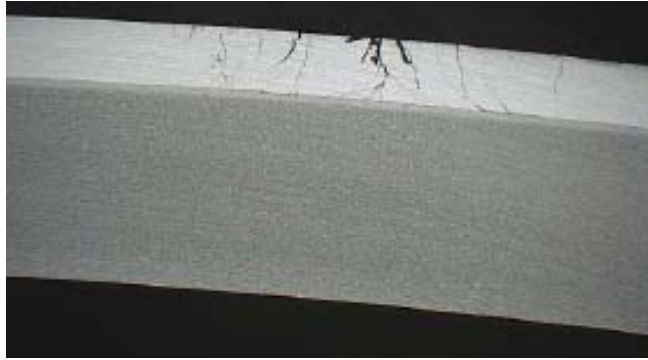
Figure 3. Cross section 2

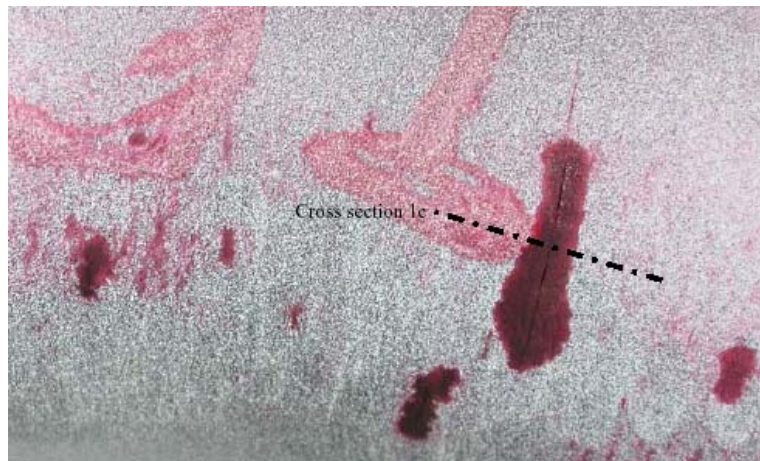
Figure 4 shows a circumferential pattern crack indication after liquid penetrant test of a smelt spout opening tube taken off operation in 2003 and Fig. 5 shows the cross section indicated with crack penetrating the carbon steel layer.

Figure 4. Circumferential pattern cracking

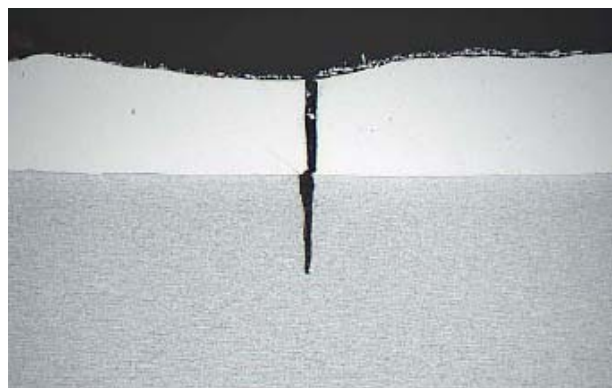
Figure 5. Cross section 1c

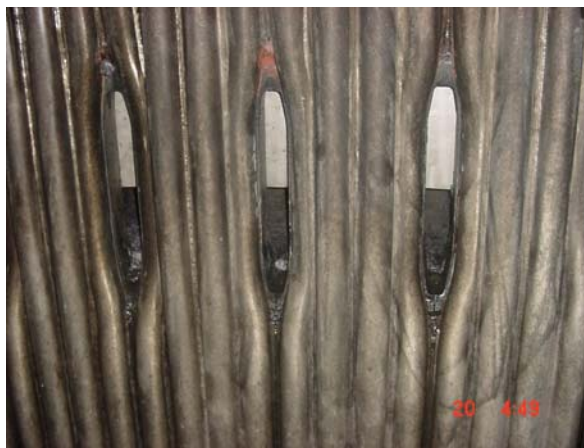
Figure 6. Primary air ports

Two factors determine the likely severity of a leak: the amount of water coming in contact with the smelt and proximity to the smelt bed (Howell, Silberglit and Norland, 2002). Since the floor tubes are closer to the smelt bed, they are considered more critical regarding tube leak. However, at the case study boiler, inspections of the floor tubes did not reveal major signal of studs wear or tube affecting along the operation time. Due to the proximity to the smelt bed, the main sources of risks are the primary air ports (Fig.6) and smelt spout openings (Fig. 7).

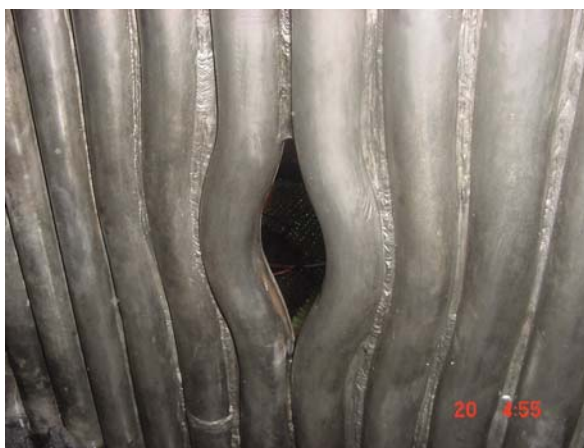
Figure 7. Smelt spout opening

Keiser et al. (2001) report that the smelt spout openings tubes and the tubes adjacent revealed cracking fairly soon after composite tubes were first used in wall panels. The environment around smelt spouts is expected to be especially severe because of the intermittent splashing that occurs as the smelt drains through the spout. At the tubes panels forming the side walls near the floor, there is also a fluctuating temperature due to level variation of the smelt bed.

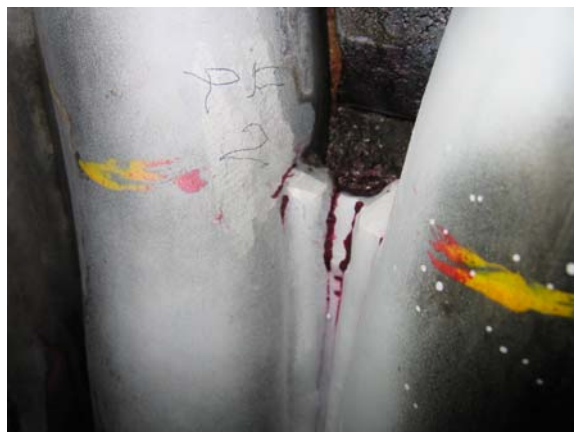
As reported at Keiser et al. (2001) and Wensley and Voit (2002) works, primary air ports tubes of the case study boiler also presented both circumferential and crazed pattern cracking at the lower portion of the air port and in all four boiler walls. The cause of cracking is probably thermal fluctuations at the bottom of air ports where the temperature gradients, as indicated at Keiser et al. (2001) study, were greater. Many cracks nucleated at the lower port crotch plates due to stresses at weld toe caused by thermal loads (Fig. 8).

Figure 8. Crack at the lower crotch plate of primary air ports
