FAILURE ANALYSIS OF A FUEL PUMP INJECTION

Abstract. *This work have the objective to determinate causes of the failure in component of the diesel fuel pump injection cracked in the wear application. That component is used in trucks. The fuel pump injection is submitted by hydraulic pulsation, where the fuel injection pressure is the 1800Bar. That injection pressure is cyclic with variable stress. That fuel injection pump cracked after 20000Km by wear. The examined component is made of the forging steel SAE 4144, hardened, tempered and plasma nitriding. The experimental procedure consisted in the characterization of the fracture aspects of that component. The visual examination by stereoscopy. Fractography method using scanning electron microscopy FEI-Quanta200 and metallographic examination were made by optical microscope Olympus Q color3. The component crack is visible without a equipments in the to the side of part. In the examination by stereoscopy, after crack aperture, it was possible to observe the presence of beach marks. This aspect of the breaking is typical of a alternaded loading of low nominal stress (constant loading amplitude). It was observed two principal points of

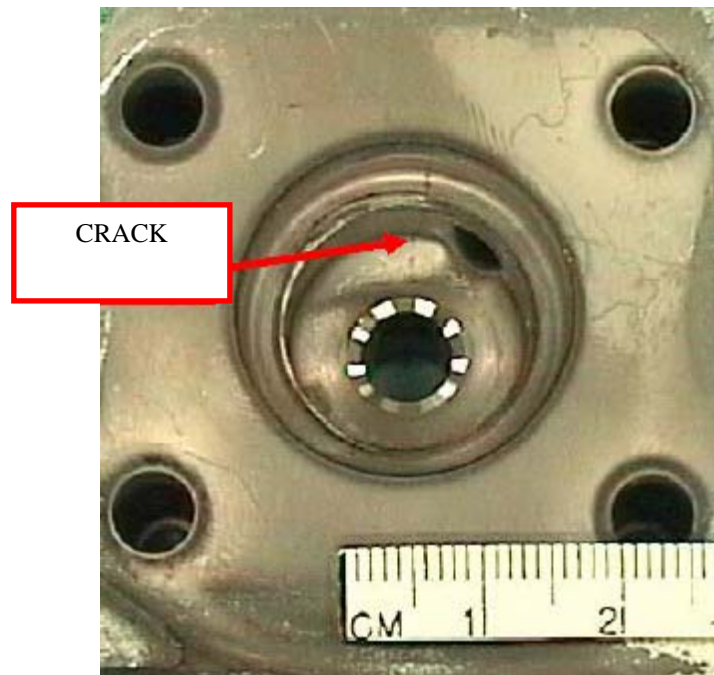
The objective of this study is to determine the cause of the failure in the body of the injection pump. The examined pump is used in heavy vehicles and the failure happened after the vehicle to reach 20000km turned (used), provoking stop of the vehicle.

Figure 1. Injection pump body – crack position

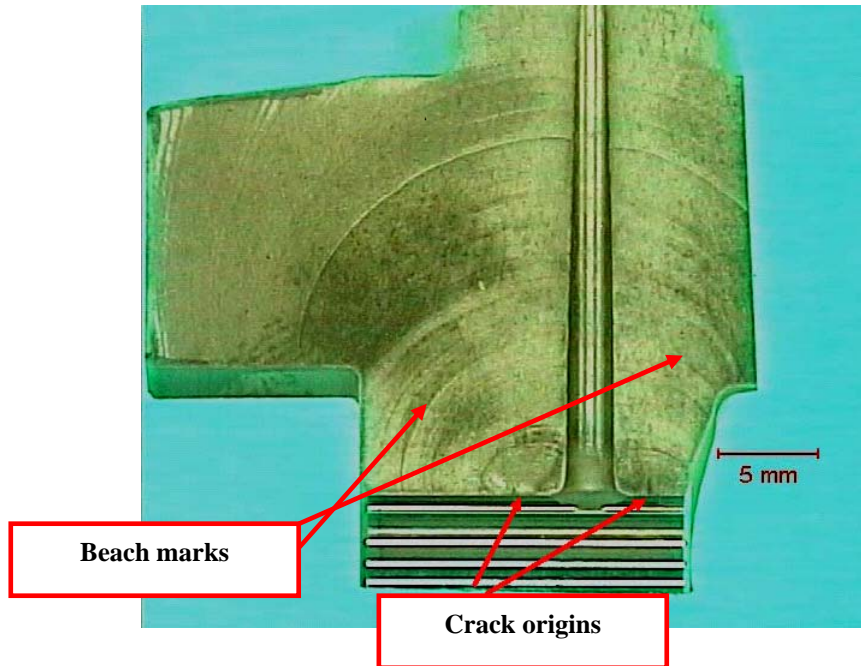
The fracture surface pump was examined by stereoscopy revealed the presence of the beach marks. The beach marks are indicative of fatigue loading and show the result of changes in loading or frequency, ASM Handbook (2001) and low nominal stress. Godfroid et al (2002)

In this case there are main two fatigue crack origins. Figure 2

These origins are in the valve hole surface. The analysis by scanning electron microscope showed multiple fatigue nucleation from micro cracks in the valve hole surface and the final fracture area was very small indicate high concentration of tensions and the fracture happened under low nominal tensions suggesting low tenacity because heat treated material.

Figure 2. Fracture aspect. Beach marks are observed (concentric marks that never cross and they happen for the significant alteration in the loading cycle) and they indicate the origin of the cracks (arrows) where there is nucleation of the cracks for fatigue in two places indicating high concentration of tensions.

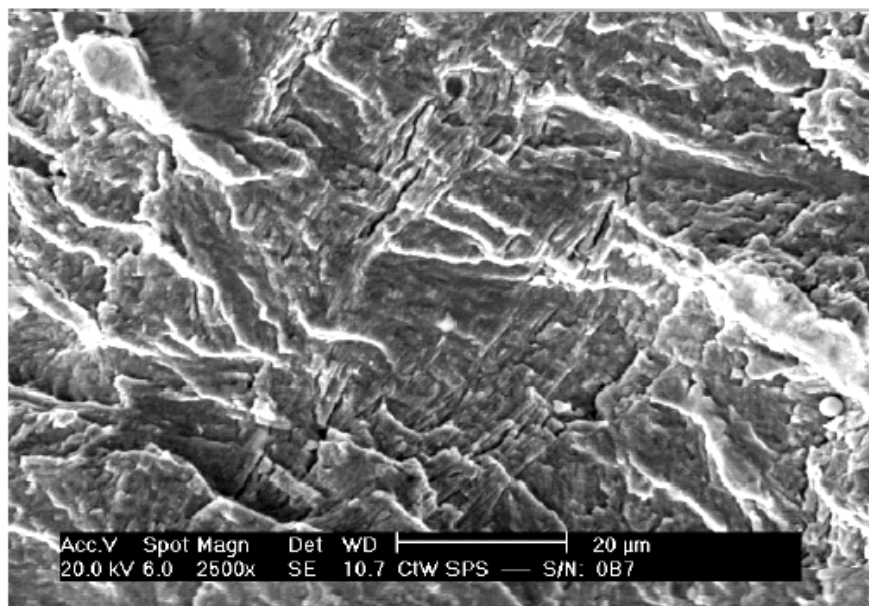
In the fracture surface they where found grooves, fig 3, that they appear in the single tension cycle and not depends of the cycles tension variation (nor every cycle produces grooves) and beach marks for example, they indicate the crack origin.

Figure 3. Grooves proving the mechanism of fatigue. They exist independently of the loading cycle to be variable or uniform (to contradict of the beach marks) and they correspond to the front position of the crack in a certain instant.

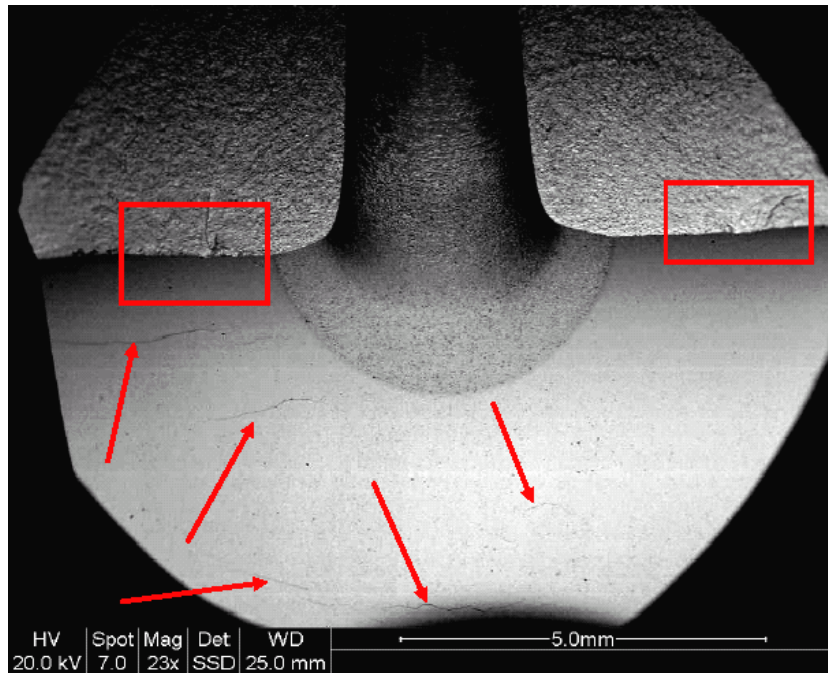
The crack origin surface in the valve hole was made by grinding for the mating of the closing valve.

Figure 4. Micro cracks in the valve hole surface. (arrows)

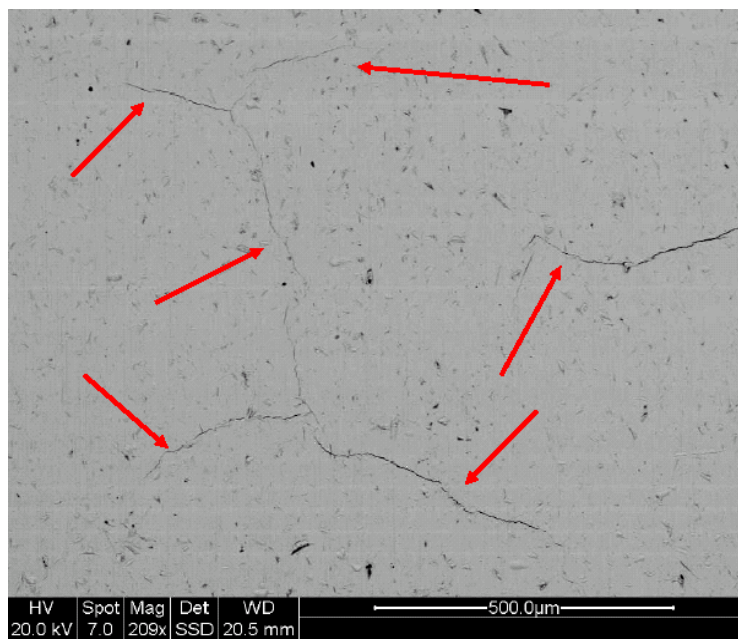
Figure 5. Micro cracks in web form in the valve hole surface. (arrows)

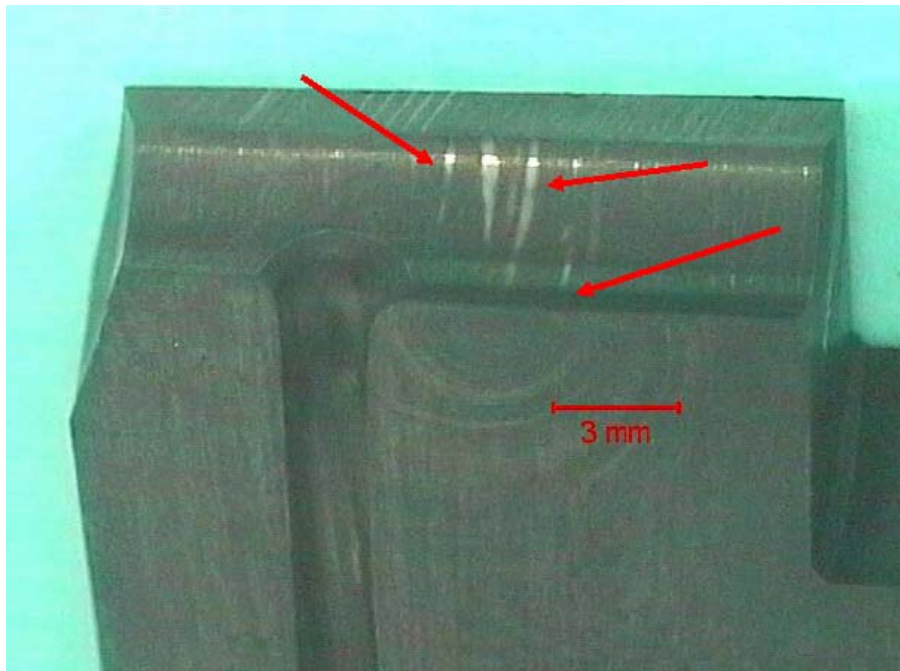
The macrography analysis was made by macroetching – Nital 0, 3% for re-temper visualization. Figure 6

One face of the fracture was macro etched by Nital 0,3% during 30 seconds for revealed in this surface the presence of the burning and re-temper by grinding. Figure 5

Figure 6. Valve hole surface after macro etching - clear areas regarding re-temper by grinding. (arrows)

The failures this component was caused by fatigue cracks that beginning in the micro cracks provoked by grinding in the valve hole surface. In this case it was recommended the verification of the cooling grinding parameters as well as should be periodically inspected as for burning and re-temper of the manufacturing process.

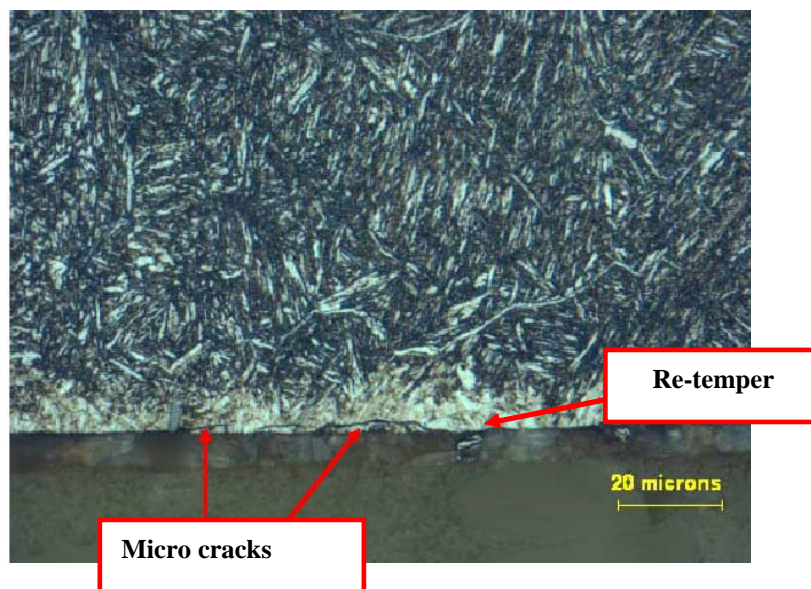
That region was cut and surface preparation by microscopy examination. In the metallographic examination was found presence of the burning and re-temper by grinding with 15µm depth. Figure 7

Figure 7. Areas with micro cracks and re-temper (15 μ m). (arrows)
