## FAILURE ANALYSIS OF A REVERSAL CHAMBER PIPELINE IN A FIRE-TUBE BOILER

**Abstract.** This study investigates the possible causes of the reversal chamber pipeline cracking of a fire-tube boiler. The secondary pipe of the reversal chamber showed extensive cracking at the joint with the mirror that seals the water chamber used in the boiler cooling system. The tube-mirror joint is welded on one side of the mirror in the outer surface of the water chamber, where a fluid leakage was detected. Samples were removed from the failed pipe and subjected to visual and metallographic analyses. It has been concluded that cracks nucleated in voids introduced during the tube-mirror welding process. A crack propagation was induced by the thermal cycles imposed during the operation of the equipment, and the mechanism of sub-critical crack growth was recognized as thermal fatigue.

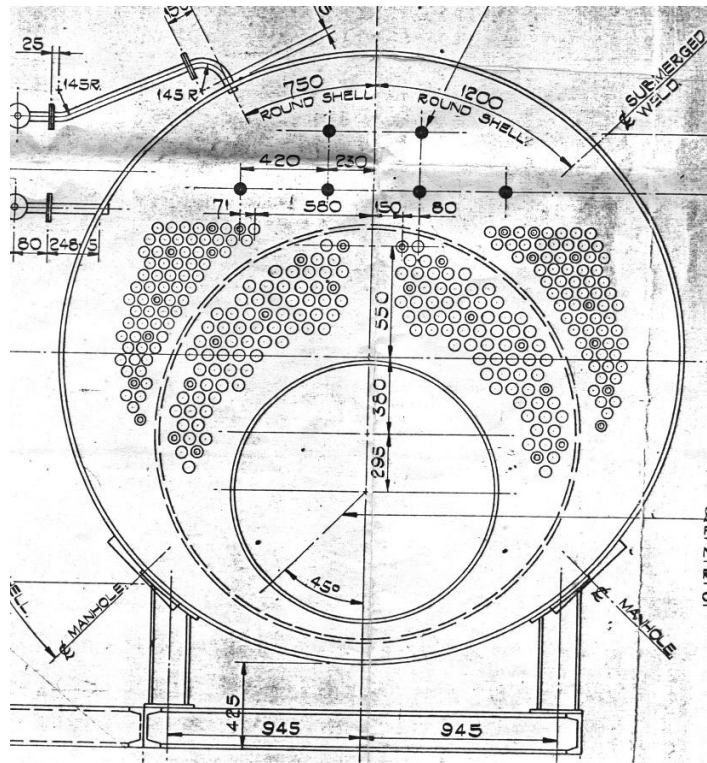
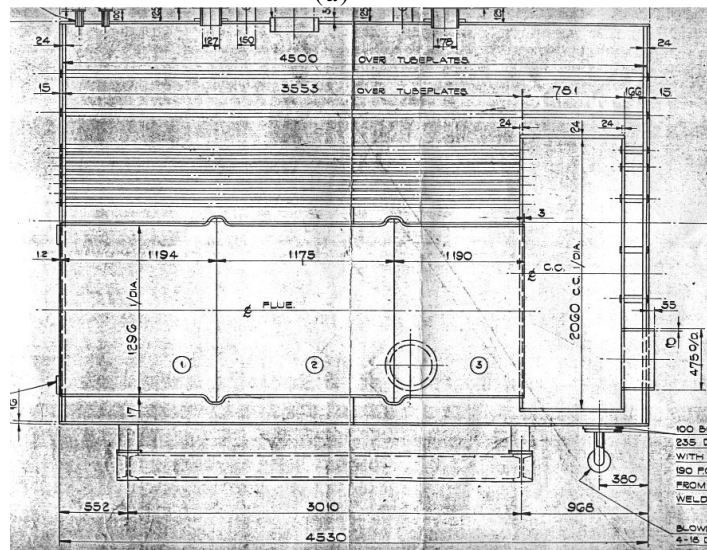
Figure 3 shows a sketch of the boiler, indicating the problem area that was removed for failure analysis and subjected to detailed inspection. Figure 4 shows the cracks developed at the mirror/pipe junction, as revealed during testing with penetrating liquid (PL).

Figure 3. (a) View of the boiler containing the furnace and secondary pipe circulating hot gas by combustion and (b) View of the combustion chambers and water.

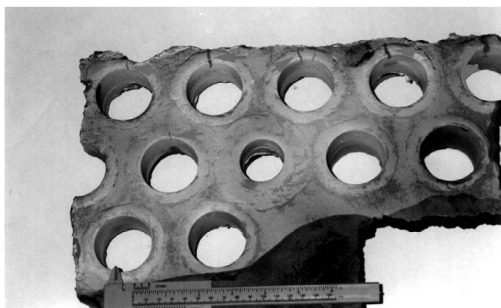
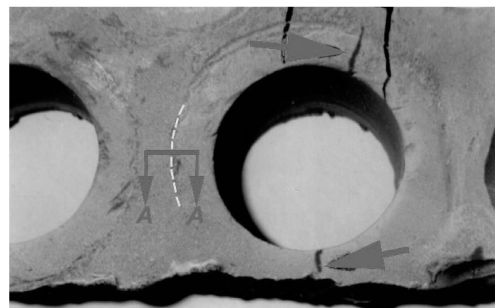
Figure 4. (a) Mirror seal of the water chamber welded showing extensive cracking that propagates in the pipe thickness and (b) detail of (a).

In fact, Figure 4 confirms that, without exception, all cracks detected by the penetrant liquid began at some point along the thickness of the mirror, more exactly in the voids of welding, and invariably propagated towards the outer surface of the mirror along the thickness of the tube, i.e., regions heat-affected during the welding of the joint.

The inspection of similar components operating under the same conditions and manufactured by the same techniques appraised in this case is mandatory in view of the high probability of occurrence of similar events in service, such as those reported here.

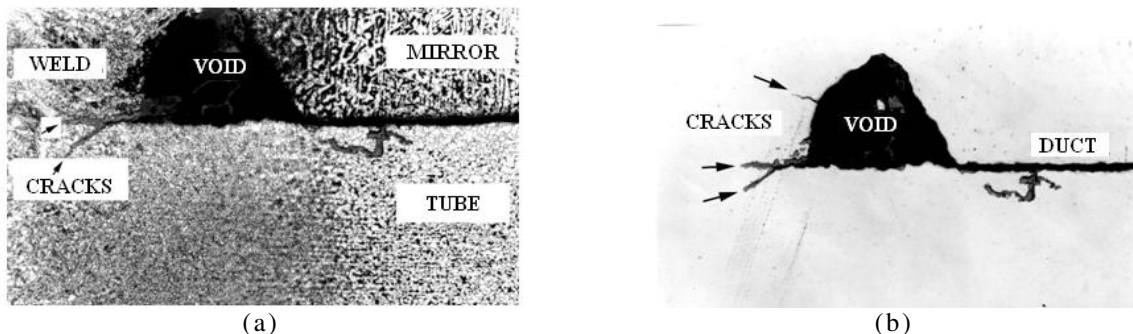
Figure 6 shows some views, with and without chemical attack, of the mirror and combustion pipes joint, following the pattern shown in Figure 5, which reflects the presence of a defect (void) typical of the welding process, called lack of weld penetration. This defect is a potential enhancer and stress concentrator, causing cracks (Figure 6) emanating from the defect in the weld metal region and directed toward the outer surface of the mirror, where the leak liquid was detected.

Figure 6 also shows a separation channel between the mirror seal and the water chamber. This channel permits the direct passage of water from inside the refrigerated space to the welding defect. In the presence of this defect, the liquid can leak freely out of that chamber of the boiler water, thus creating the leaks in question.

Figure 6. Metallographic sections showing the presence of empty-type defects and cracks emanating from the same sample: (a) with etching (Nital 2%) and (b) without chemical attack.

The cracks shown in Figure 6 are orthogonal to those revealed by the penetrant liquid and illustrated in Figure 4, indicating that several cracks originated from the defects introduced by the welding process. Such cracks emanated to the second radial (Fig. 4) and longitudinal (Fig. 6) directions. However they always followed a path and directions dictated by both the metal weld and more particularly the microstructure of the tube thermally affected during the welding process.

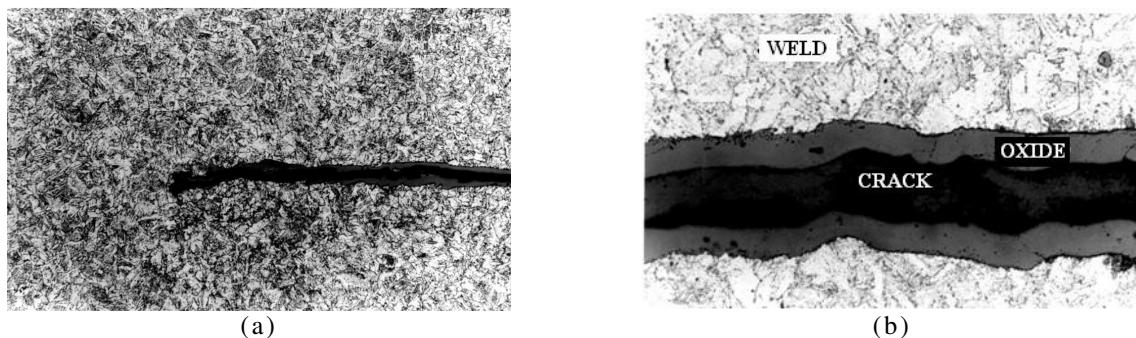
Fig 7 shows the surfaces of cracks originating in the defect-type void, where we observe the oxidation of their inner walls as a result of contact with the water coming from the camera's cooling system.

We can assume that the voids provided some cracks through the welding process, which are powerful enhancers of stress concentrators and, very probably, have spread due to thermal cycles typically developed in the equipment in question. The thermal cycles, including events to disconnect/re-link the plant, as well as any transient power system generate tensile stresses due to thermal expansion/contraction of materials. Such stresses force the opening of cracks, thus inducing their spread subcritical mechanisms under cyclic thermal loading, or thermal fatigue.

Figure 7. Internal oxidation of cracks originating in the welding defect of mirror/tube pair. (A) Type and (b) detail of crack.
