FAILURE ANALYSIS OF PUMP SHAFT USED IN OIL EXTRACTION PLATFORMS

Abstract. *This study investigates the possible causes of the failure of a horizontal centrifugal pump shaft used in coastal oil extraction platforms. The rotating shaft in question broke in service under normal operational conditions of the equipment during brackish water pumping for enhancing oil well extraction. Brackish water was reported as not containing a significant amount of hydrogen sulfide (H₂S), as typically resulting from seaweed decomposition. The shaft material was UNS S31803 duplex austenoferritic stainless steel supplied in the forged condition. A 24 mm long carbon steel nut was threaded to the shaft in the fractured region. Chemical analysis, hardness measurements and metallographic and fractographic inspections were carried out. It has been concluded that the pump shaft ruptured by sub-critical fatigue crack growth. Two cracks nucleated simultaneously at the root of two neighbor fillets, with extensive spread of the main crack leading to the complete fracture of the component. The poor quality of the root fillet finishing led to a massive presence of stress raisers, such as sharp edges and corners,

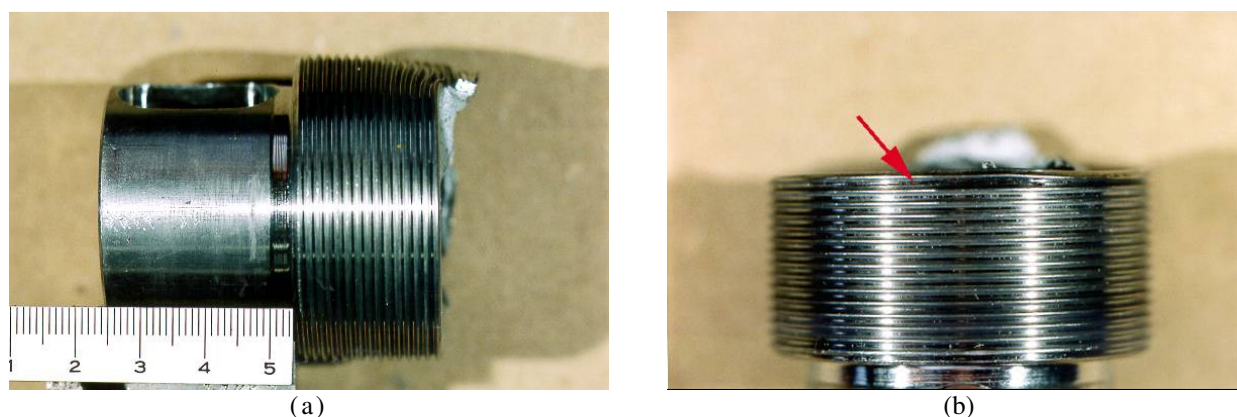
Fig. 3 shows two views of the fractured shaft profile. It is possible to observe that two cracks propagate in parallel, one over the other, leading to complete fracture of the component.

Figure 3. (a) Profile of the fractured shaft. (b) The red arrow indicates the main crack parallel to the cross-section of the component

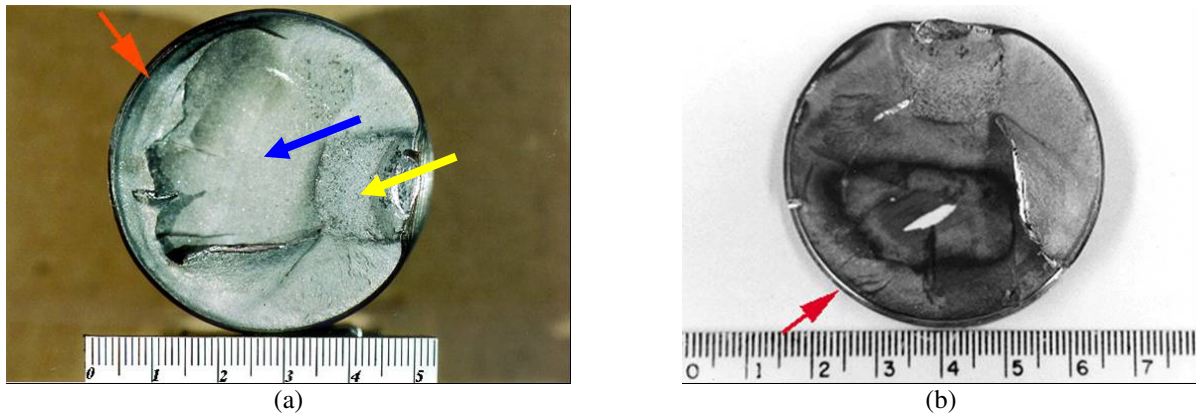
In Fig. 4, the red arrows indicate the nucleation sites of the secondary (Fig. 4(a)) and main (Fig. 4(b)) fatigue cracks shown in Fig. 3.

Figure 4. Sites of initiation of fatigue cracks indicated by red arrows: (a) secondary cracks and (b) main crack

The presence of beach marks on the fracture surface of the shaft, indicated by a blue arrow in Fig. 4(a), demonstrates that the axle broke under the fatigue mechanism. In the same figure, the yellow arrow points to the remaining section of the shaft, which fractured catastrophically when the applied stress exceeded the strength of the material. The small remainder of this section shows the relatively low voltages at which the component was subjected in service. This type of fracture is similar to that shown in studies of Muhammad and Deen (Muhammad, 2010).

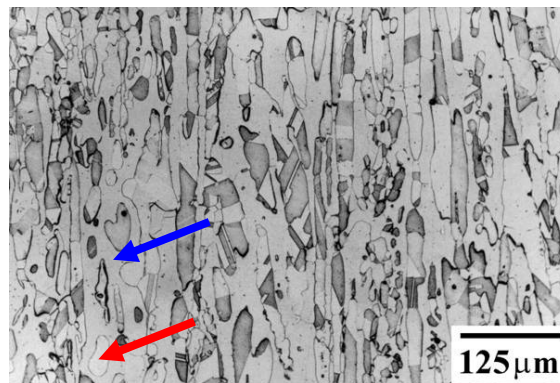
Fig. 5 shows the microstructure of steel that makes up the fractured shaft, confirming the development of a duplex structure. The micrograph shows the ferrite (indicated by a blue arrow) and austenite (a red arrow), typical of this steel in the solubilized state. There is also a high texturing of the steel structure in the longitudinal direction of the axis, indicating a high degree of deformation experienced by the material during hot work.

Figure 5. Microstructure of the studied steel

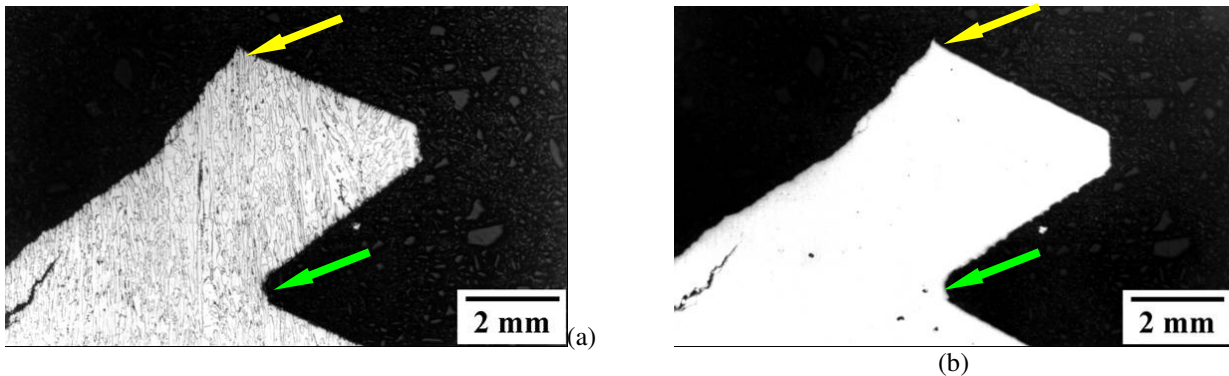
Fig. 6 shows two views of the same metallographic sample respectively with and without chemical attack, identifying the exact point of rupture of the shaft located at the bottom of the fillet and indicated by yellow arrows. The green arrows point to the bottom fillet closest to that fractured components in service.

Figure 6. Two views of the fractured fillet profile indicated by yellow arrows: (a) with etching and (b) without chemical attack

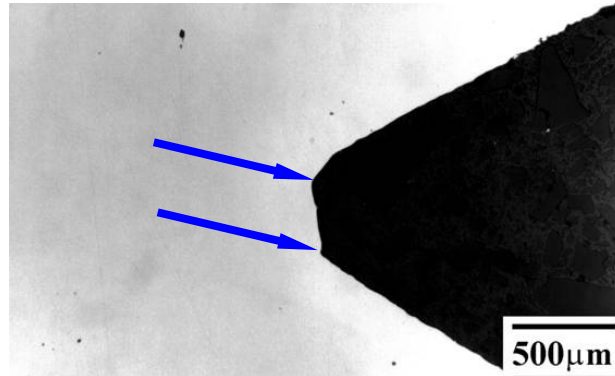
An expansion of this thread is shown in Fig. 7, where the blue arrows point to two preferred points of stress concentration in the form of sharp edges or corners, placed on the shaft during the machining process of the fillet. Returning to Fig. 6, one can conclude that the fatigue crack which completely fractured the left edge shaft started in the lower profile of the fillet.

Figure 7. Detail of the bottom of the fillet neighbor which broke in service (without etching)

Based on these results, a stricter control of the machining process of the fillets should be adopted. A change in the process of introduction of fillet into the shaft, for example, opting for rolling the fillets instead of their machining, could lead to a better performance of the service provided that a suitable quality control is also implemented for the new procedure.

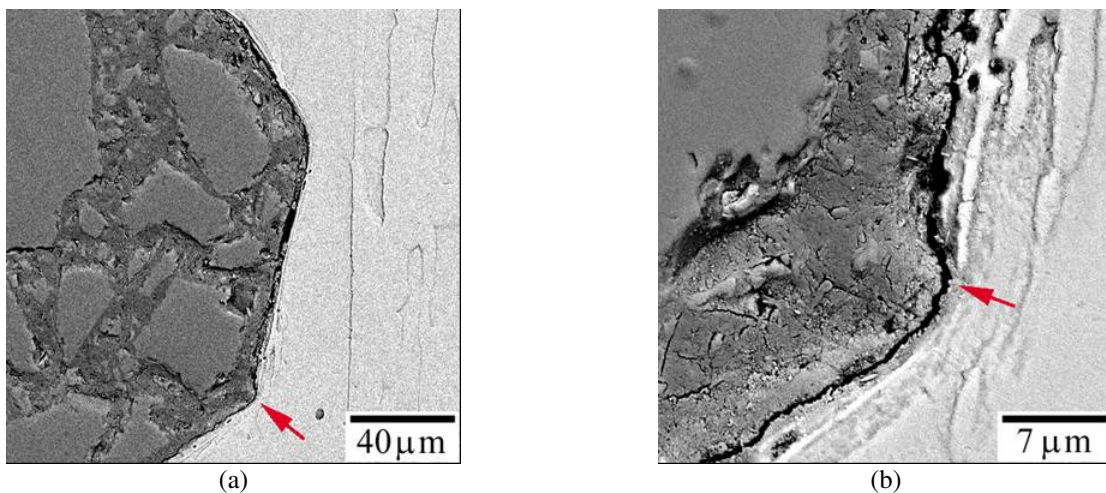
Fig. 8 shows a sequence of magnifications of an edge (indicated by red arrows) similar to that in which the fatigue crack nucleates in the shaft fracture.

Figure 8. Sequence of SEM pictures detailing the site of fatigue crack nucleation (red arrows) on the shaft fractured in service (sample with chemical attack). Images obtained with back-scattered electron

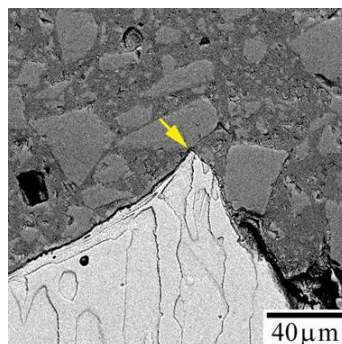
Fig. 9 depicts the site of fatigue fracture indicated by the yellow arrow.

Figure 9. Site of fracture indicated by the yellow arrow (sample with chemical attack). Image obtained with back-scattered electron

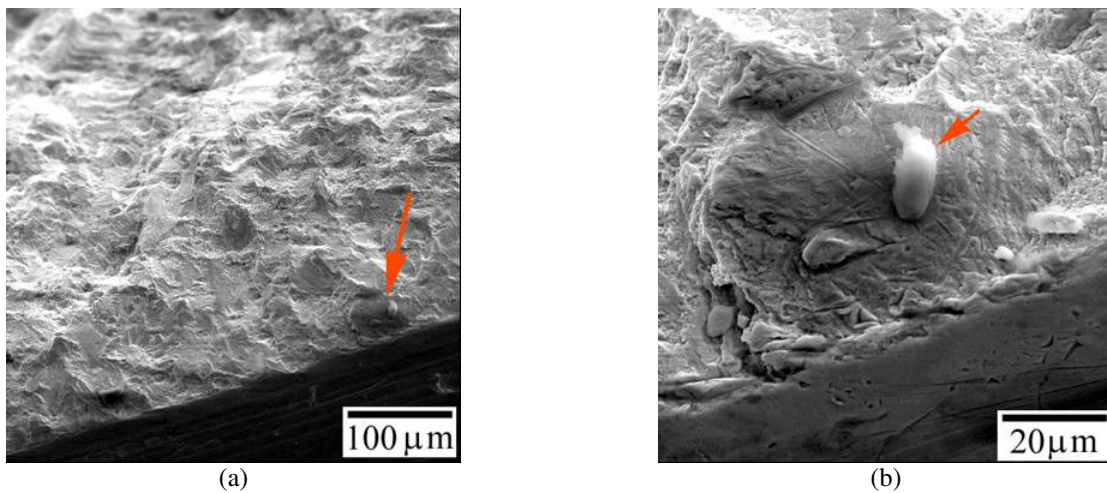
Using SEM, it was possible to identify and characterize in detail the nucleation sites of the broken minor and major cracks, previously shown in Fig. 4. As shown in Fig. 10, the secondary fatigue crack was nucleated near the root of the fillet, more precisely in an inclusion present in that location. The micro-chemical analysis allowed identifying a second phase, probably a particle of iron carbide and chromium.

Figure 10. Details of the site of initiation of secondary fatigue crack nucleated at an inclusion (red arrows) the root of the fillet

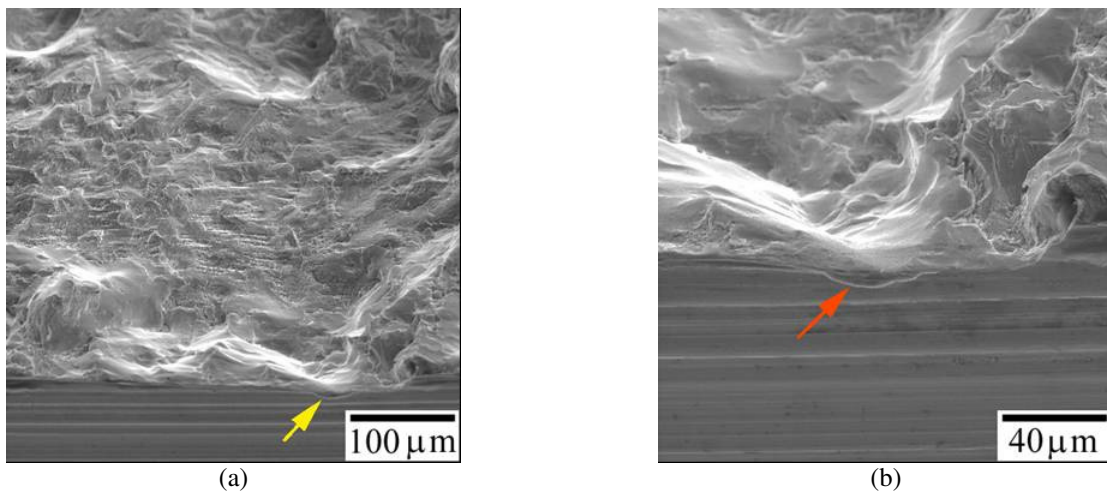
Fig. 11 shows that the main fatigue crack nucleation occurred exactly at the bottom of the fillet, which appears highly irregular, with the presence of indiscriminate risks and defects of the notch. Fig. 12 illustrates the patterns of rifling through both minor and major fatigue cracks developed.

Figure 11. Details of the site of initiation of the main crack from fatigue nucleated on the bottom edge of the bead machined in the shaft (yellow and red arrows, respectively)

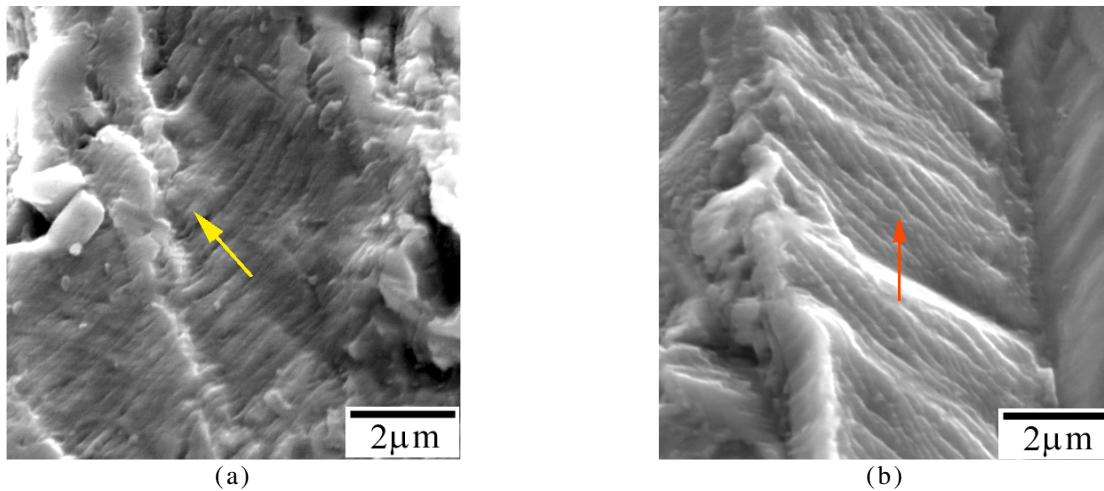
Figure 12. Patterns of fatigue rifting developed on the fracture surface during the progress of cracks: (a) secondary and (b) main. Arrows indicate direction and location of the crack growth

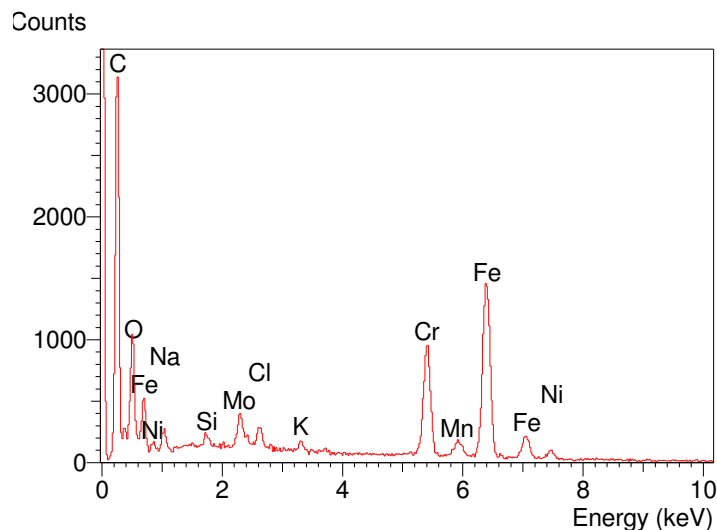
Through a microprobe operating with energy dispersive X-ray, which equips the scanning electron microscope, the particle of the second phase that originated the secondary fatigue crack, shown in Fig. 10, was chemically analyzed. Fig. 13 depicts the absorption spectrum of the particle, which allows identifying peaks of the absorption of elements Fe, Cr and C. Other elements present in the composition of the steel matrix, which involves the particles analyzed, also show their characteristic peaks.

Figure 13. Absorption spectrum of the particle that caused the secondary fatigue crack
