## Characterization of localized corrosion processes on copper pipes using the technique of X-ray microtomography.

**Keywords:** *copper corrosion, ant nest corrosion, X-Ray microtomography*

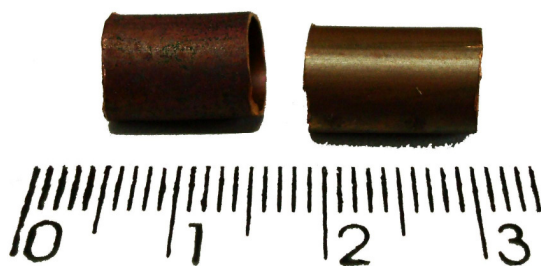
The samples were hollow cylinders composed of pure copper. Each one had 1cm of diameter, with a 0.4cm wall thickness. Both of the samples were part of a refrigeration system in which there had a leaking failure. After the acknowledgement of the leaking, the samples were cut to the length of 3cm, as exposed in the Fig. 1.

Figure 1. Test copper tubes used in this experiment

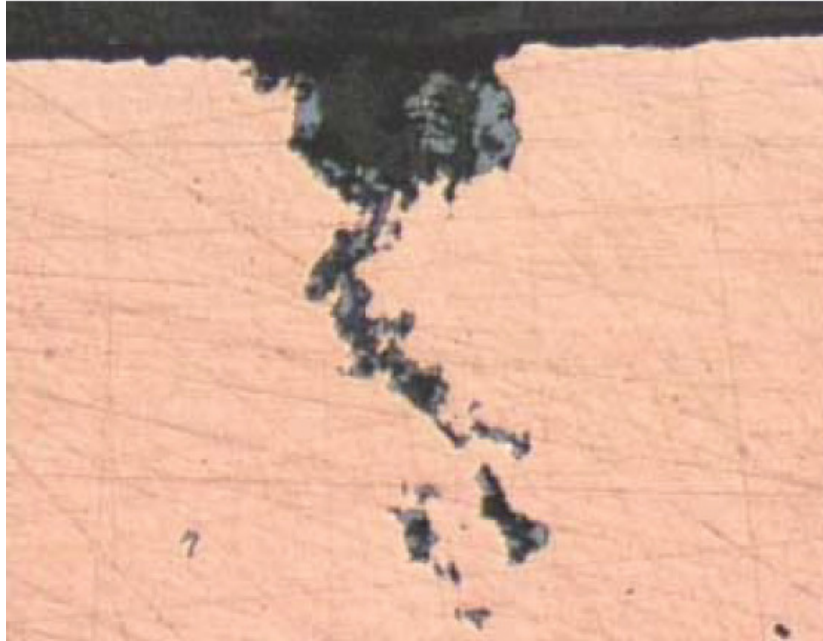
Figure 2. Image of a copper tube which leaked by ant-nest corrosion extracted from Elliott and Corbett (2000)

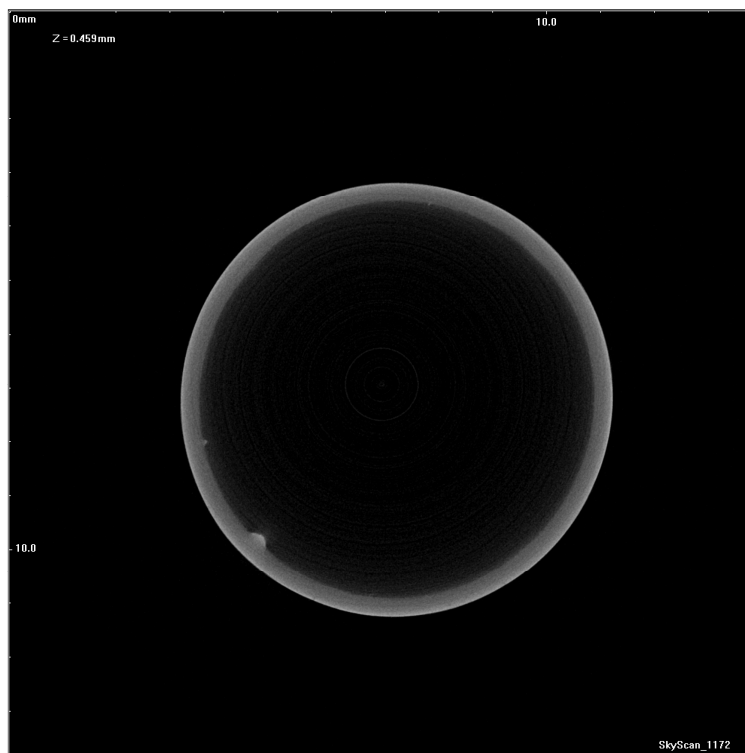
The images were acquired with a resolution of  $7\mu\text{m}$ , 100kV voltage and current of  $100\mu\text{A}$ . The rotation was of  $360^\circ$  and the step of  $0.4^\circ$ . The equipment could achieve a  $1\mu\text{m}$  resolution, but the authors considered the  $7\mu\text{m}$  resolution sufficient to represent the ant-nest corrosion phenomena, considering the 100x amplification Elliott and Corbett (2000) adopted in their work. There may be corrosions process smaller than this scale, however this will not be investigated in this research. The X-ray technique results in images which show sections of the original sample. For each sample it was acquired 1.226 images, comprising 8.52mm of the physical sample. One section extracted from the position 0.459mm can be observed in the Fig. 4. The grey “circle” is the copper tube named sample A.

Figure 4. Copper microtomographic image acquired from sample A

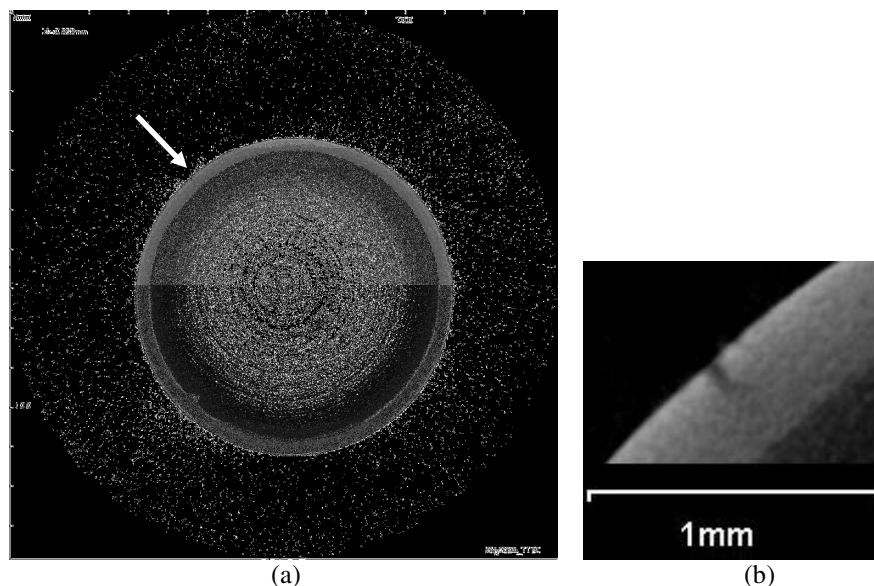
Following the images sequence, at the position 0.696mm, it can be seen a localized corrosion, which is indicated by an arrow at Fig. 5 (a). This corrosion extended itself until the image located at position 0.904mm, comprising a 31 images sequence. The corrosion detail can be observed in Fig. 5 (b).

Figure 5. Copper microtomographic image acquired from sample A at position 0.696mm

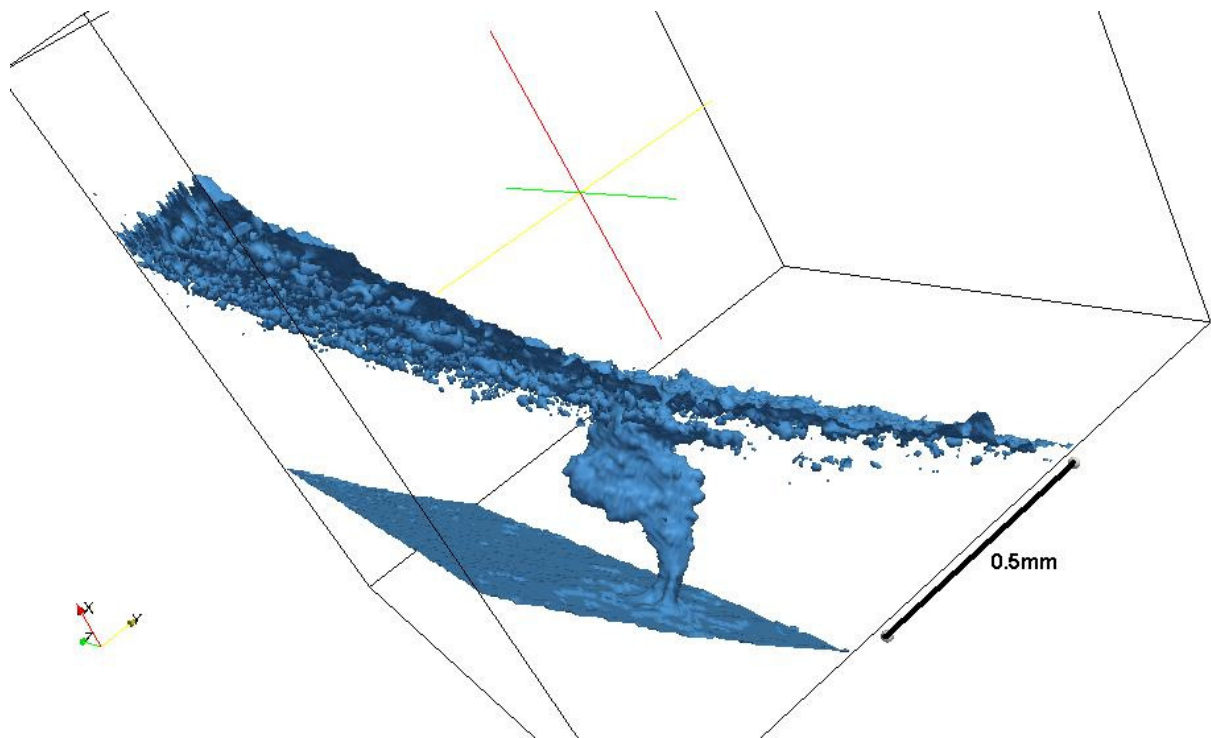
After locating the corrosion process, the images were stacked, a region of interest (ROI) was selected and the latter was binarized. This procedure was executed with the MicroImage software. The ROI was chosen so it would be greater than the corrosion. It was adopted a grey-level threshold binarization. The images were exported to the Paraview software and the entire corrosion can be observed at Fig. 6. The upper part of the image is the inner side of the sample, while the lower part of the image is the outer part of the sample, where the corrosion began. Notice that the corrosion process was very curved, and would have been difficult to observe it just using regular techniques. The isolated points are noisy data and must not be considerate.

Figure 6. 3D image of a sample A comprising approximately 0.3mm

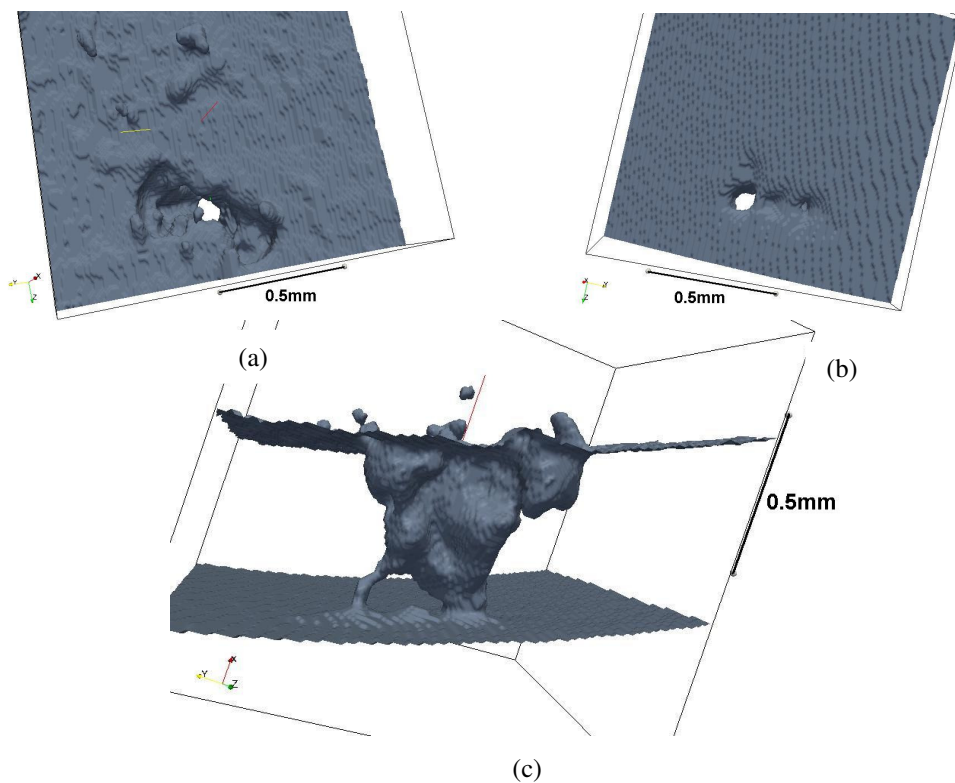
At the sample B, at the height 1.51mm it was detected another corrosion event. This one was bigger than the previous, and extended itself for 80 images, comprising 0.5mm. This corrosion can be observed in detail in the Figs 7 (a), (b) and (c). The figures expose different angles of the same phenomenon. The Fig 7 (a) exposes the internal wall of the sample, the 7 (b) shows the outer wall and the 7 (c) presents the side view angle of the corrosion, with the upper part of the image representing the inner side of the sample. This corrosion started at two different points which merged into one. This one formed a larger process which percolated.

Figure 7 corrosion at position 1,51mm (a) internal wall of the sample, (b) outer wall, (c) side view angle
