VIBRATION ANALYSIS OF THE SYNCHRONOUS MOTOR OF A PROPANE COMPRESSOR

Abstract: *This paper aims at describing the Analysis of a synchronous electric motor which presented high vibration levels (shaft displacement and bearing housing vibration) during the commissioning process, as well as propose the best practices for the solution of vibration problems in similar situations. This motor belongs to the propane centrifugal compressor installed at a Gas Compression Station. The methodology used in this study conducted an investigation of the problems presented in the motor through the execution of many types of tests and the analysis of the results. The main evaluations were performed, such as the vibration analysis and the rotor dynamic analysis. The electric motor was shipped back to the manufacturer's shop, where the manufacturer made certain modifications to the motor structure so as to improve the structure stiffness, such as the improvement of the support and the increase of the thickness of the structural plates. In addition to that, the dynamic balancing of the rotating set was checked. Finally, the excitation at a critical speed close to the rated speed was found after Rotor D

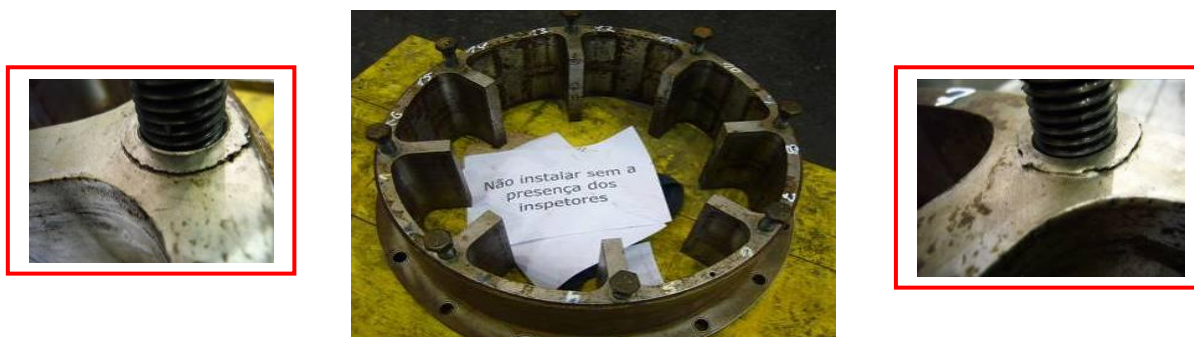
Figure 5. Coupling damages

During assembly of the coupling for tests, damages to the bolt threads of the sleeve and ring cover were detected, as shown in Fig. 5, which caused the increase of vibration levels.

Since the coupling manufacturer recommended against using these damaged components in their current conditions or repairing them, new ones were supplied to replace the damaged items. The replacement was supervised by the manufacturer’s representative to ensure no new damages to the coupling.

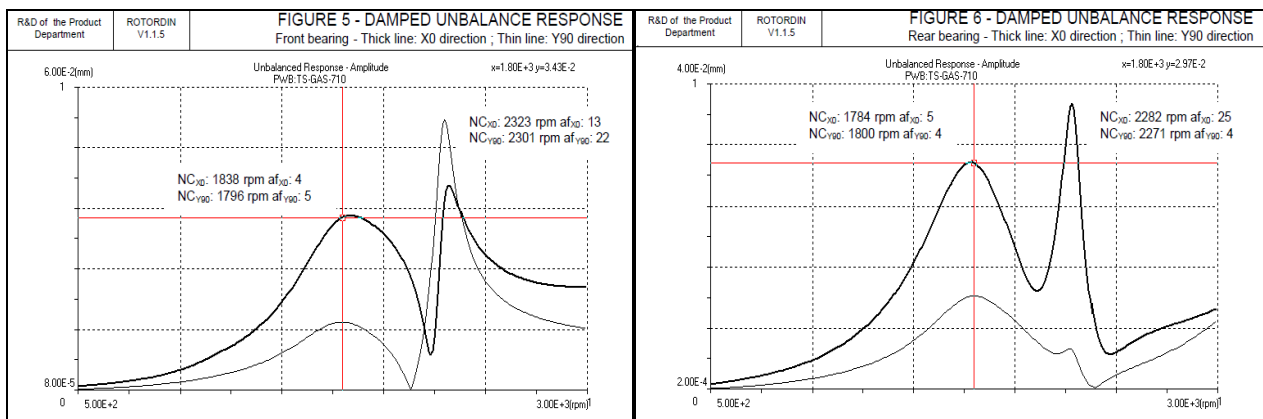
Figure 7. Rotor Dynamics Analysis – front and rear bearings with increased clearances

The calculations and Rotor Dynamics Analysis of the motor were performed again due to increased clearance of the bearings caused by burnishing of the shaft in the bearing seats. During this analysis, excitation of the first critical speed (1784 rpm) close to rated speed (1800 rpm) was detected, as shown in Fig. 7, representing a clearance of only 1%, while the API Standard 546 3rd edition requires a minimum separation margin of 15%.

The solutions proposed by the manufacturer in order to increase the separation margin between the first critical speed and the rated speed are described below:

- Replacement of the cylindrical bearing shells for new ones with a special dimension (reduced internal diameter) which would reduce clearances between the shaft and the bearings and consequently increase the stiffness of the system.
- Modification of the bearing design and replacement of the bearings for new ones with four lobes. The use of four lobe bearings implies changes in the parameters of the lubrication system, such as:
 - ✓ Oil flows due to the higher temperature levels of this kind of bearing, resulting in the need to resize and replace the calibrated orifices.
 - ✓ Oil pressures due to the different design of these bearings.
- Replacement with a new shaft to restore the dimensions of the original project.

It was decided that the replacement of the bearings for new cylindrical ones with reduced dimensions (clearances) would be carried out. The new Rotor Dynamics Analysis presented very close results for both types of bearings (cylindrical ones with reduced dimensions and four lobes). Additionally, changes would be avoided in the lubrication system required to adopt the four lobe bearing. After bearing replacement, a new Unbalance Response Test would be performed.

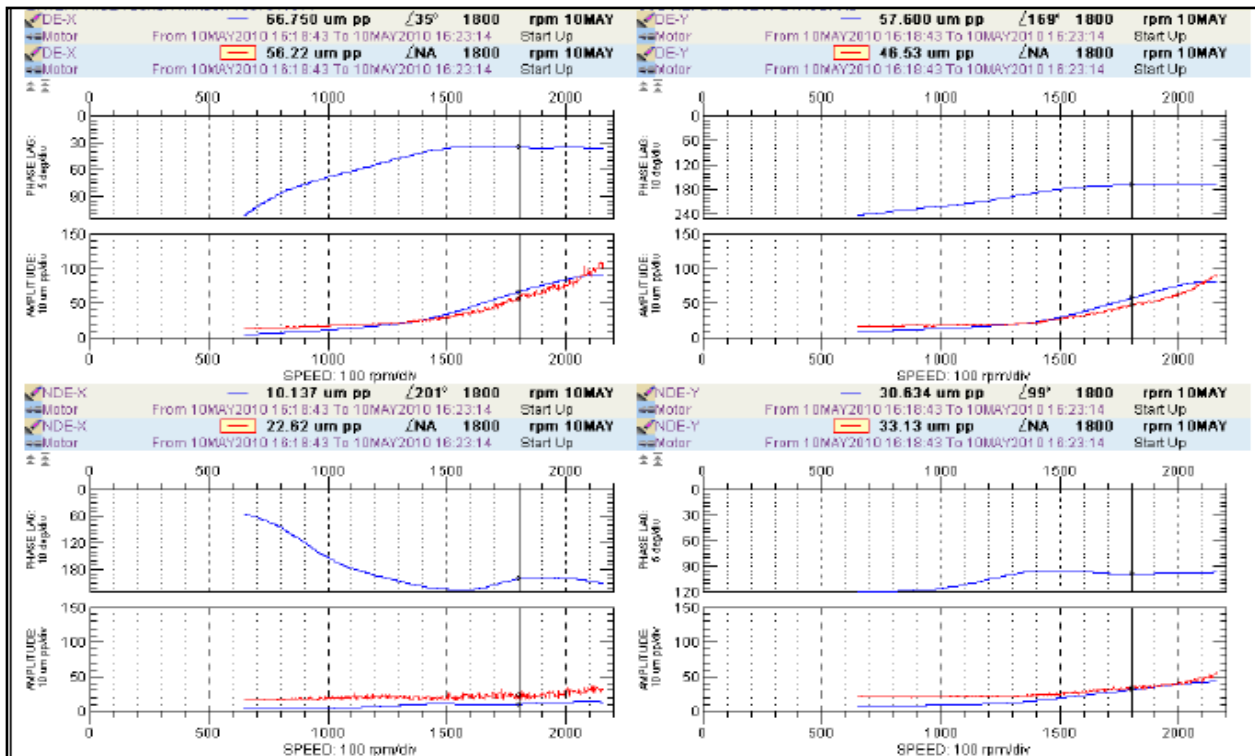
Figure 8. Bode Plots of the internal Unbalance Response Test performed by the manufacturer

The manufacturer performed an internal Unbalance Response Test to confirm the Rotor Dynamics Model. However, this test was not considered valid because the unbalance weights were added at points different from those indicated in the Rotor Dynamics Analysis. The balanced condition of the motor prior to testing was not duly proven either. In addition to that, API Standard 546 3rd edition establishes maximum limits for the amplitudes of shaft displacements for the Unbalance Response Test (maximum 98 mm). These limits have been exceeded during the test, as shown in Fig. 8.

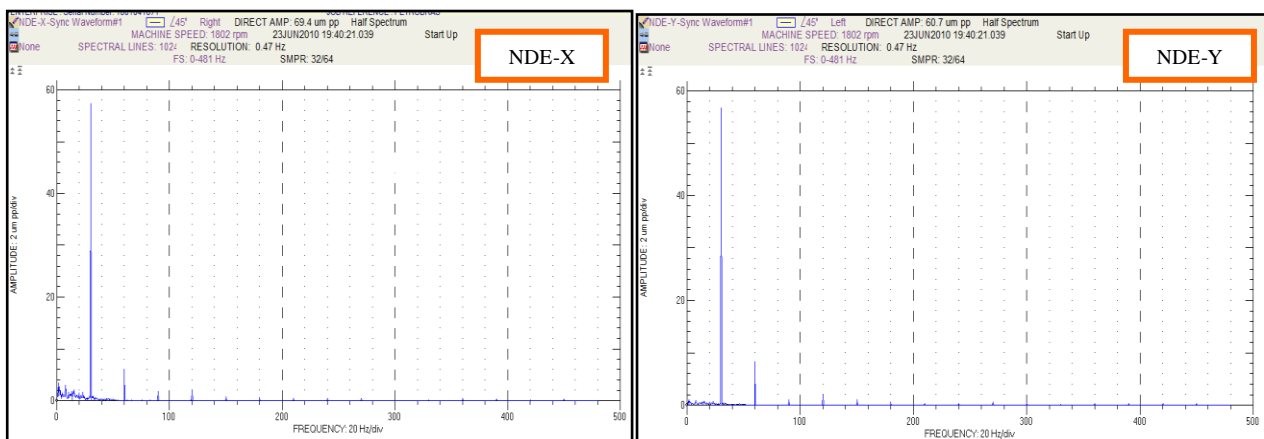
Figure 11. Spectrums of the shaft vibration from the Mechanical Running Test (no drive end - NDE)

After analyzing the vibration spectrum of the motor shown in Fig.11, it was found that the amplitudes in the running frequency were very pronounced, suggesting an unbalance condition of the rotating set, according to Bently (2002). Based on these data, the manufacturer was requested to perform further verifications of the balance condition of the motor.

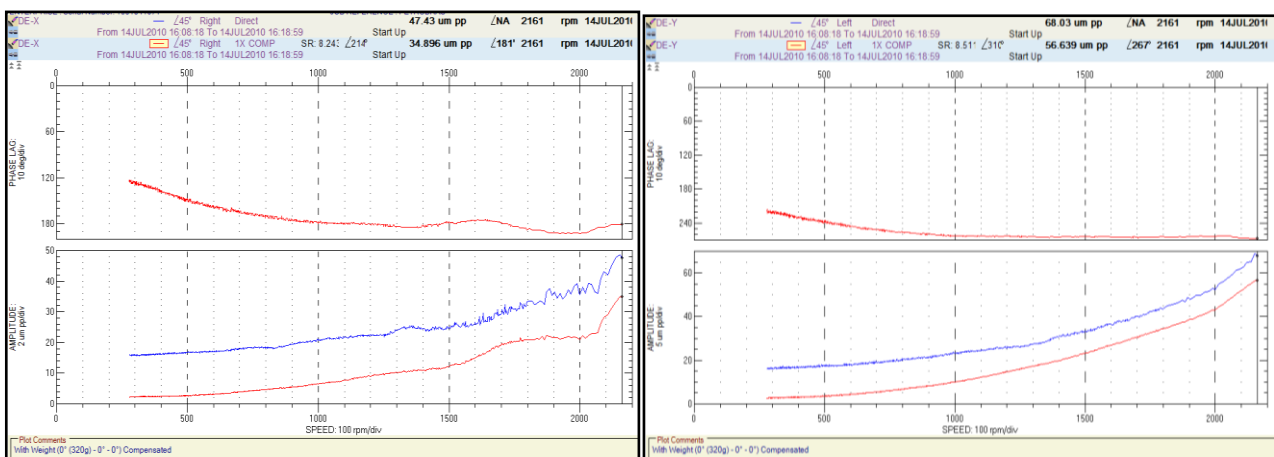
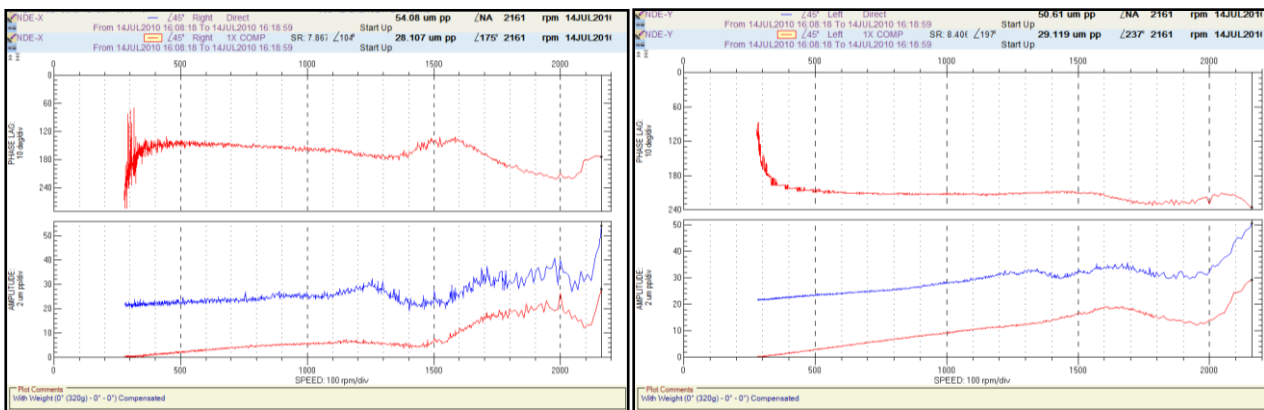
During the test, characteristic peaks that suggest critical frequency excitation were not observed at any speed within the operating speed range (up to 2162 rpm or 120%), in other words, within the limits of the separation margin. The shaft vibration remained within the limits of API Standard 546 3rd edition for the Unbalance Response Test (maximum 98 μm). The shaft displacement amplitudes at the operating speed were higher than those described in the manufacturer's Rotor Dynamics Analysis. However, they were below the maximum permitted by API Standard 546 3rd edition. Table 15 shows shaft vibration (overall values and 1x Runout compensated) and bearing housing vibrations obtained in step 6. Figures 16 and 17 show Bode Plots of the last test step (STEP 6).

Figure 16. Bode Plots (Runout compensated) of Unbalance Response Test after bearing shell replacement-DE

Figure 17. Bode Plots (Runout compensated) of Unbalance Response Test after bearing shell replacement -NDE
