NONDESTRUCTIVE INSPECTION OF FATIGUED RIVETED LAP JOINTS OF HYBRID FIBER-METAL LAMINATE GLARE™

Almeida, E.G.R., euripedes_almeida@yahoo.com.br

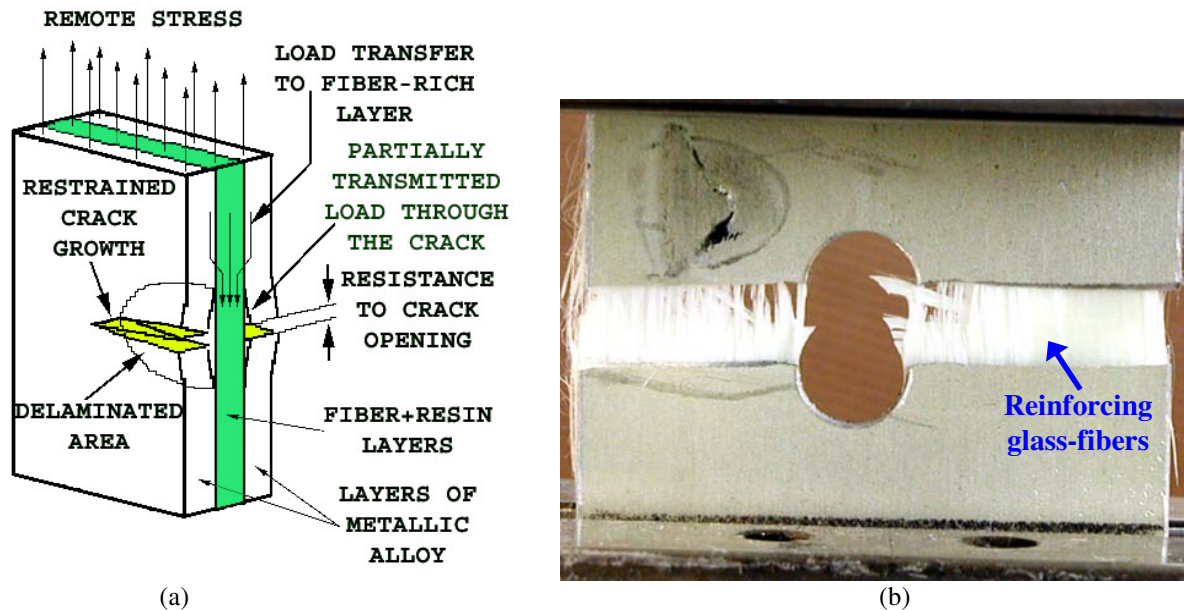
Figure 1. (a) Crack bridging concept, extensively explored in hybrid FML. (b) Crack bridging in a fatigue experiment with Glare at EESC-USP.

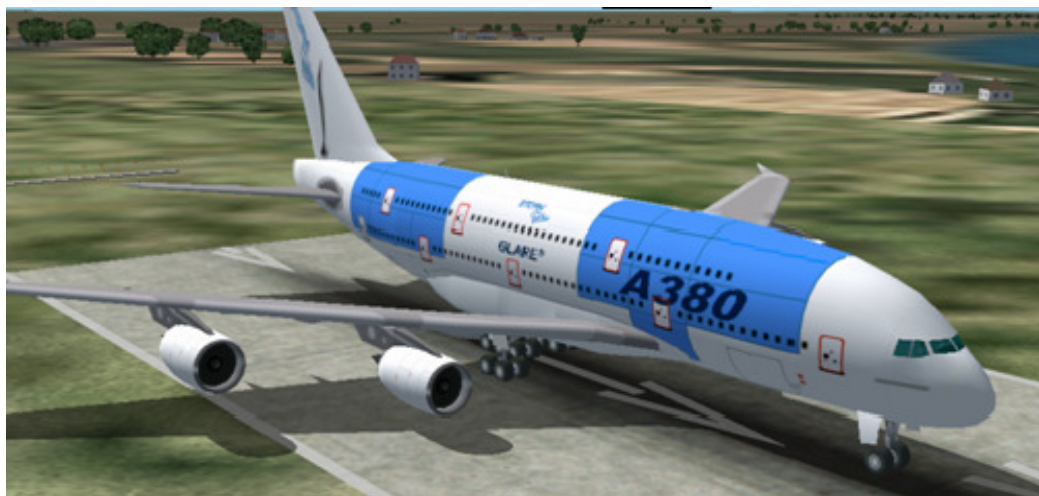
Figure 2. Airbus A380 aircraft: the upper Glare-made fuselage is in blue.

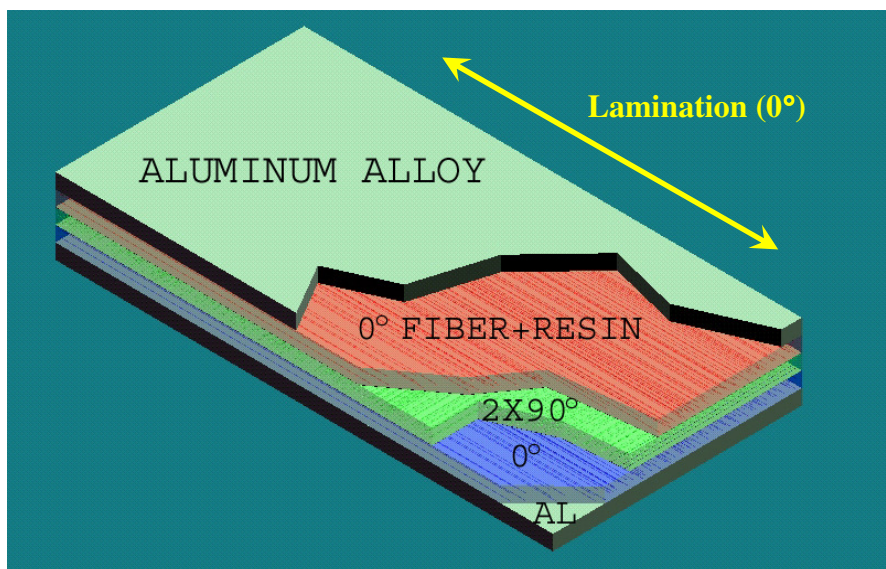
Figure 3. Glare-5 2/1 laminate exhibiting a centrally symmetrical array $2/(0/90)_s$.

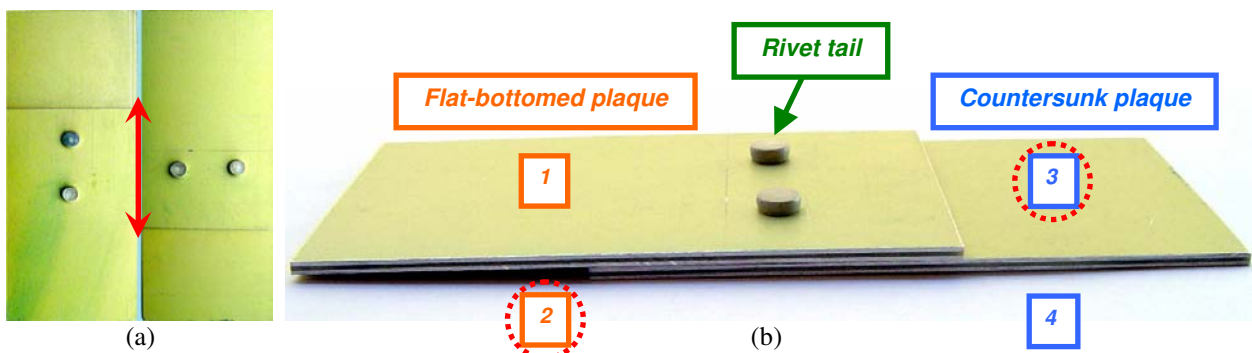
Figure 4. (a) Two specimen geometries tested in this study (the axial loading direction imposed during fatigue testing is indicated by a red arrow) (b) Test specimen with horizontal rivets and nomenclature utilized for the joint's elements.

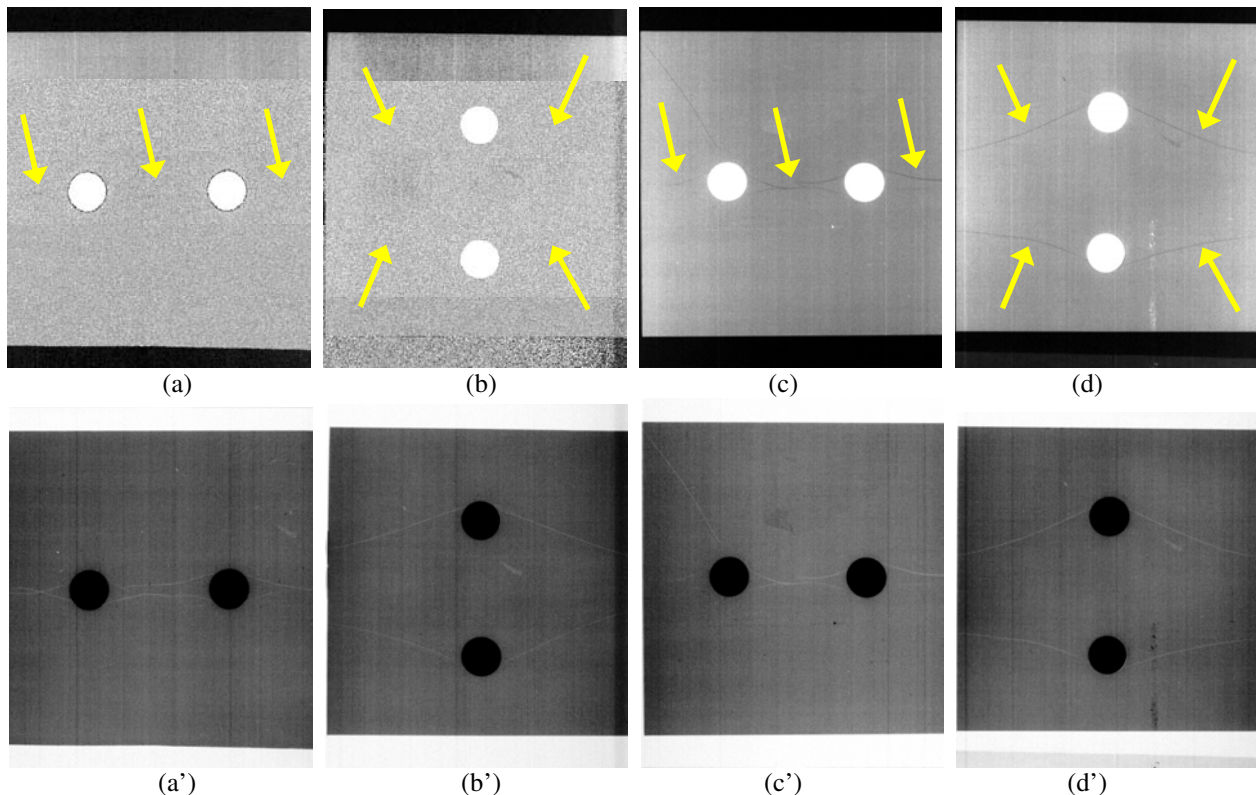
Figure 6. Positive and negative modes of conventional film X-ray images of four riveted specimens listed in Table 1: (a,a') RTP 19; (b,b') RTP 29; (c,c') RTP 111; (d,d') RTP 211. Detected cracks are arrowed in yellow.

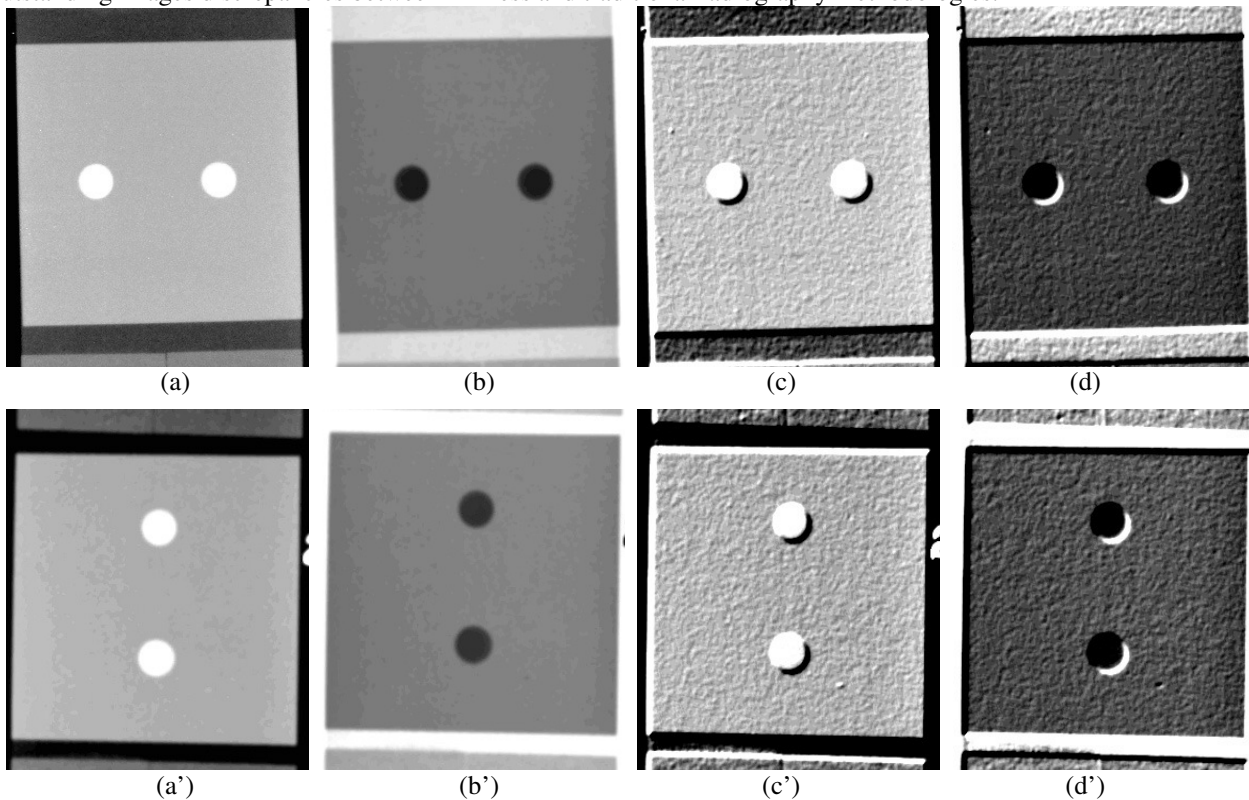
Figure 7. IP-digital radiography images (equipment originally destined to odontological application) of RTPs 111 (non-aligned rivets) and 211 (aligned rivets): (a) Standard image; (b) Corresponding reverse tone; (c) Embossed image; (d) Corresponding reversed tone.

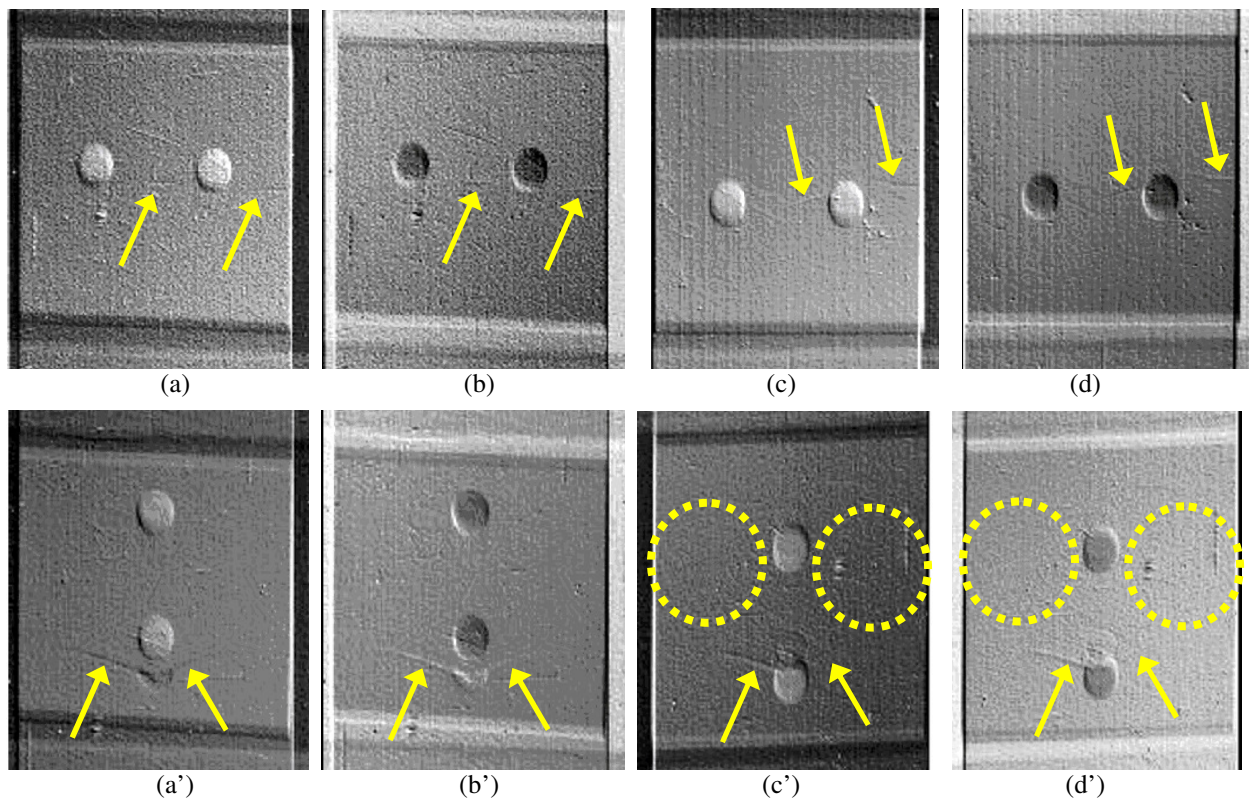
Figure 8. IP-digital radiography images (industrial equipment) of RTPs 111 (non-aligned rivets) and 211 (aligned rivets): (a) Emboss Filter; (b) Corresponding reverse tone (a&b refer to a 45° incident X-ray beam); (c) Emboss Filter;

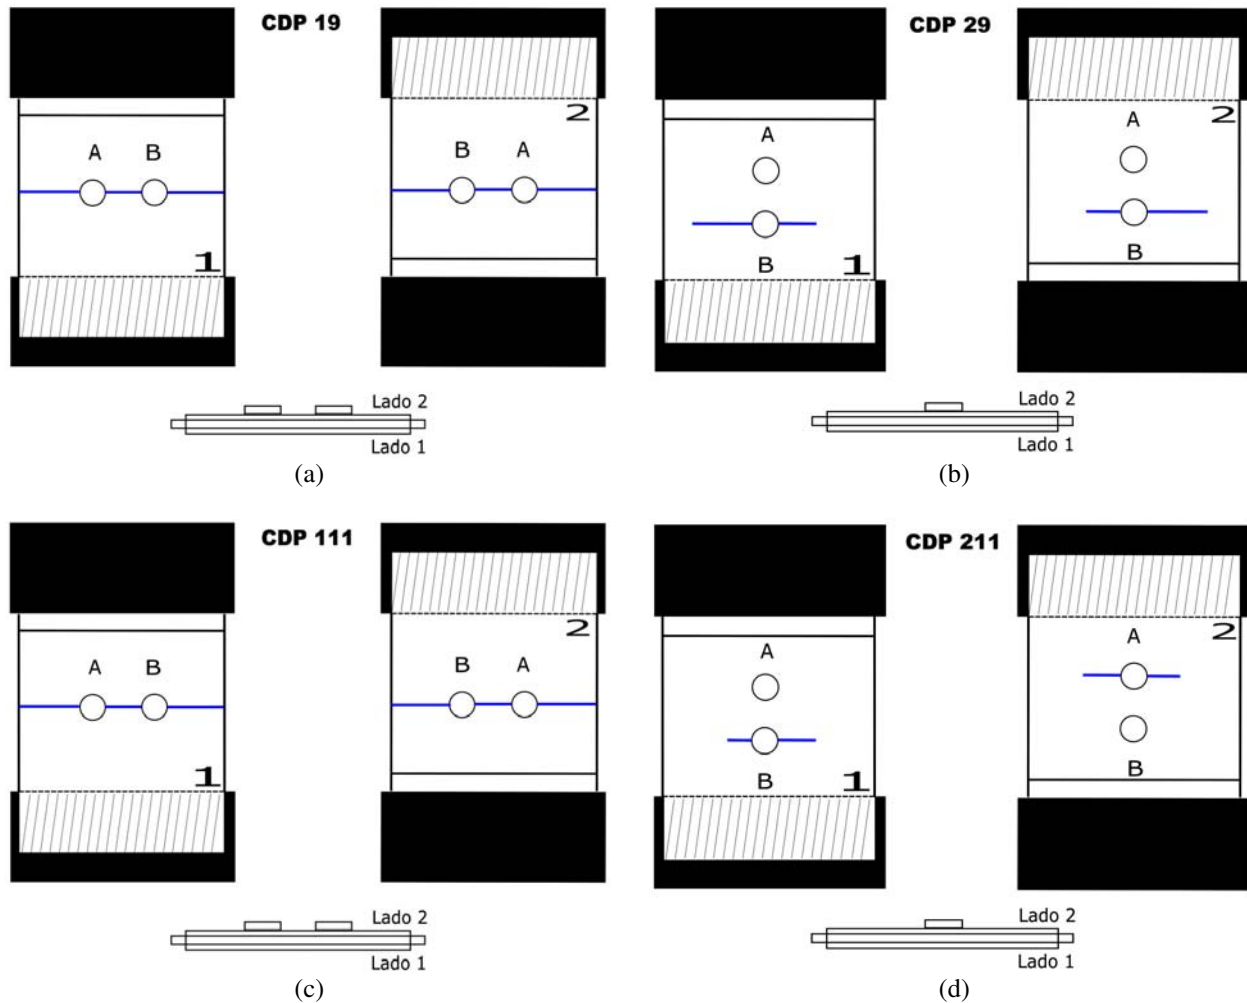
Figure 9. Schematic results of eddy current testing, with no prior calibration, considering both the front (1) and backside (2) of riveted test specimens: (a) RTP 19; (b) RTP 29; (c) RTP 111; (d) RTP 211.

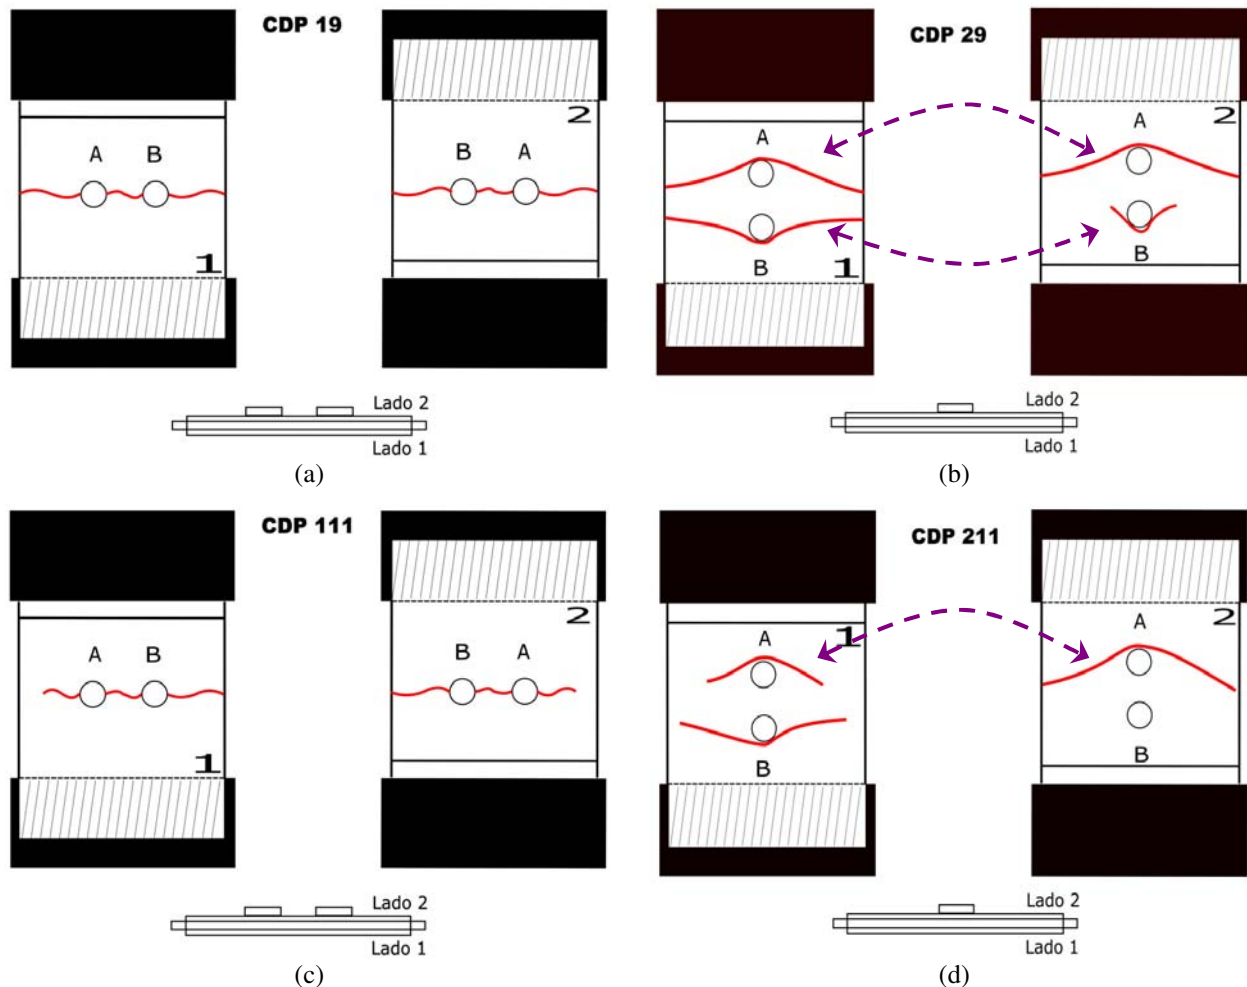
Figure 10. Post-calibration eddy current testing results considering both front (1) and backside (2) of riveted test specimens: (a) RTP 19; (b) RTP 29; (c) RTP 111; (d) RTP 211.
