FINITE ELEMENT FAILURE ANALYSIS OF AN INTERNAL COMBUSTION GAS ENGINE INSERT

Abstract. *Internal combustion engine components experiment severe thermomechanical loading cycles. This complex loading history can promote the nucleation and propagation of cracks in mechanical components. Residual stress has an important role in the structural integrity of a mechanical component subjected to such loading. In this work, numeric simulations with a thermoelastic finite element model are used to estimate the residual stress distributions that are present in a stainless steel gas engine insert after the assembly process. This component is assembled in the prechamber engine cylinder head with interference through a process involving subzero cooling, which promotes the development of residual stresses. The numerical results indicate that the presence of residual stresses promoted by the assembly process modify significantly the stress distribution in the component during operation and contributes to the nucleation and propagation of cracks in some critical areas. Metallographic and surface fracture analyses of an insert that failed after 6000 hours of operation shown the presence of cracks in

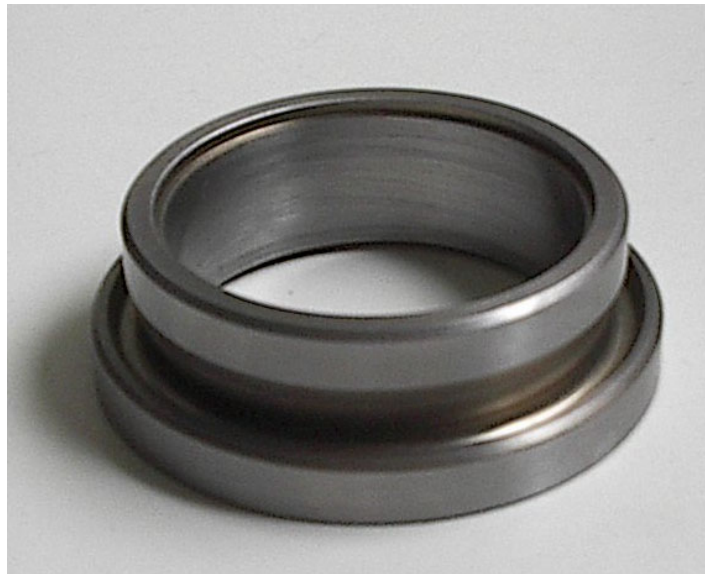
Figure 1. Internal combustion stainless steel gas engine insert.

This work presents a failure analysis of an internal combustion martensitic stainless steel gas engine insert. This component is assembled in the prechamber engine cylinder head with interference through a process involving subzero cooling. The component is made of SAE 51410 martensitic stainless steel and is shown in Fig. (1). Figure (2) shows the geometry and dimensions of the component. Several engines failed after about 6000 hours of operation. During the engine disassembly, it was found the presence of through-thickness cracks in the prechamber insert. It is believed that these through-thickness cracks allowed the leakage of engine cooling fluid to the engine prechamber resulting in the premature failure of the equipment. The failure analysis started with a material characterization, involving chemical, hardness and metallographic analysis followed by surface fracture analyses. Finally, numeric simulations with a thermoelastic finite element model were used to estimate the residual stress distributions present in a stainless steel gas engine insert after the assembly process with interference and the stress distribution during operation.

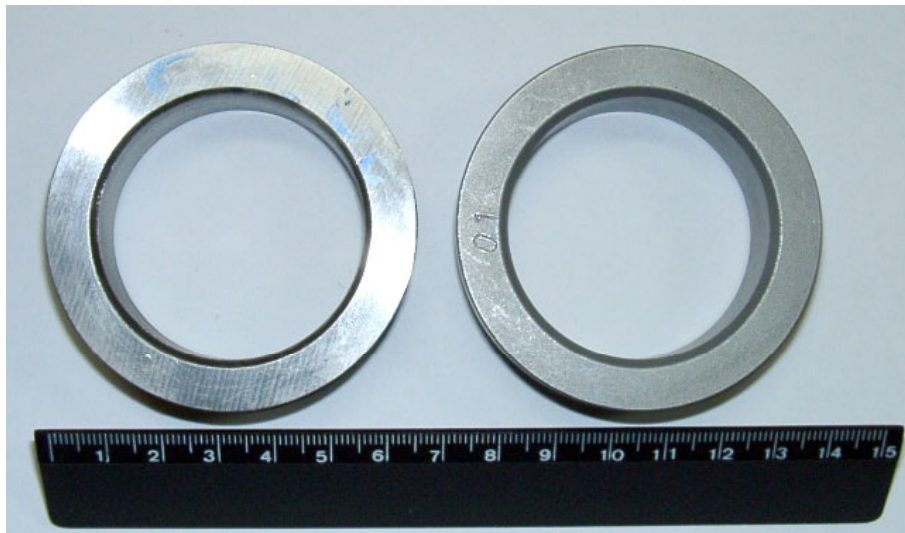
Figure (3) shows the general appearance in the as received condition of the samples that failed in service. Insert 1 was cleaned by shot penning, and insert 2 is shown in the as disassembled condition.

Figure 3 – General appearance of the samples insert 1 and 2 in the as received condition.

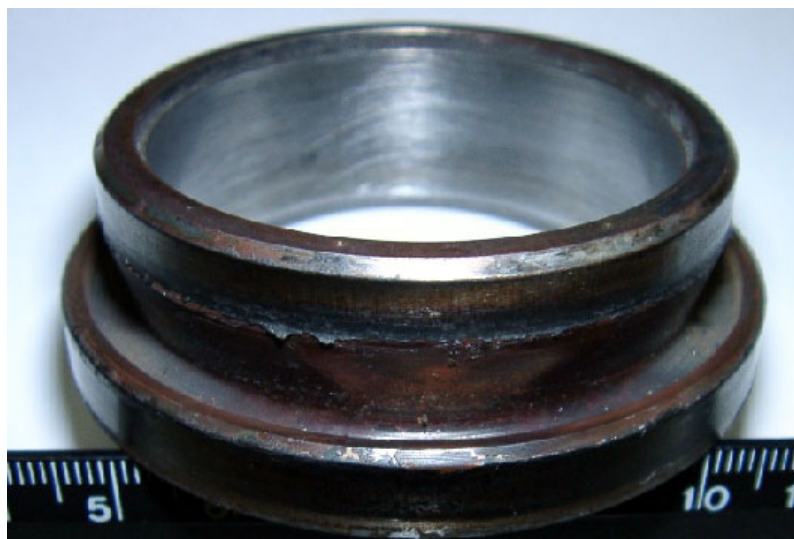
Macrographic examination of insert 2 shows an oxidation layer probably resulting of the contact with oil from the engine. It can be observed in Fig. (4) the occurrence of corrosion product deposition in the cooling groove.

Figure 4 – Aspect in the groove region of insert 2 with corrosion product deposition.

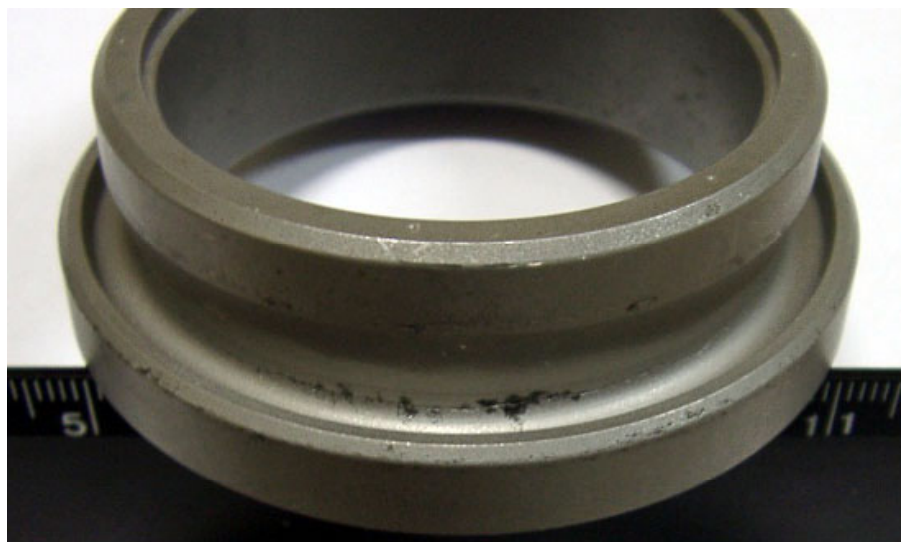
Figure 6 – Corrosion pits associated to cracks observed in insert 1.

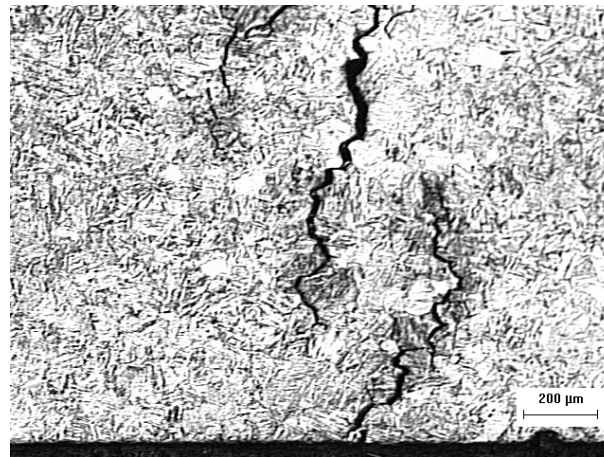
Figure 10 – Detail of internal cracks showed in Fig. (8). Etching: Vilella.
