ERROR ANALYSIS OF PIPES SUBJECTED TO INTERNAL PRESSURE USING THE ISHIKAWA DIAGRAM

Abstract. *The use of steel pipelines in industries is generalized and adopted worldwide. In order to optimize the design and the use of these components, there are experiments that are being carried out and the identification of sources of errors is an important issue. Many techniques can be adopted to determine and control a list of causes of errors. In this work, the Diagram cause-effect of Ishikawa and the Method of 5M, will be used in an experiment with low carbon steel pipes, closed with flat ends at both extremities and subjected to hydrostatic internal pressure. The specimens were machined in the central region, to simulate a defect (i.e. thickness loss) and repaired with a carbon/epoxy composite.*

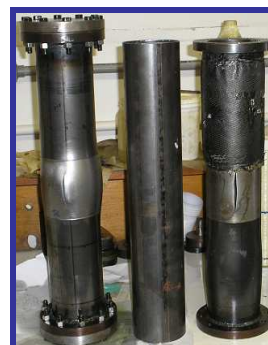
Figure 3. Three specimens used.

TUBE 1	Perfect pipe, without barbs, covered in the two extremities.
TUBE 2	Pipe roughed-hew mechanically in the central region (length of the machined region = 100 mm and depth of the machined region = 1.15 mm), without barbs, covered in the two extremities.
TUBE 3	Pipe roughed-hew mechanically in the central region (length of the machined region = 100 mm and depth of the machined region = 1.25 mm) and repaired in the same central region with composite material, without barbs, covered in the two extremities.

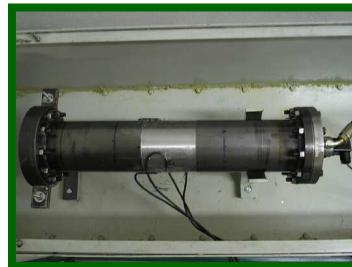
Figure 7. Specimens fixed in the test rig with supports.

POSITION OF THE SPECIMENS IN THE TEST RIG: The disturbances and vibrations in the two supports can modify the experimental results. Moreover, these supports can not be accurately in the same height, modifying the position of the pipe. Moreover, there is friction between the support and the pipe, mainly during the axial displacement of the specimen. This friction is not considered in the theoretical analysis and can modify the experimental results. Moreover, as the left support is fixing the pipe and the right one is not (as shown in Figure 7), the extremity of the pipe in contact with the left support doesn't have the same deformation than the other side (harming a homogeneous deformation of the pipe). For next analysis, the two supports must be, exactly, of the same type.

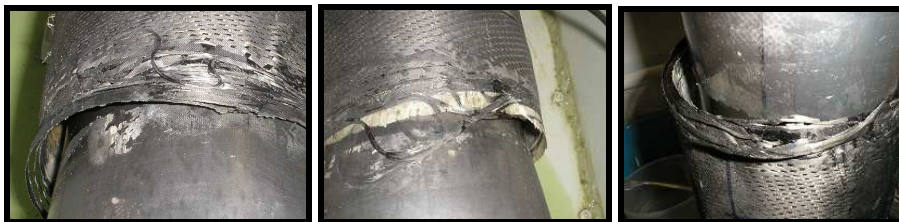
Figure 9. Repair delamination.

REPAIR OF COMPOSITE MATERIAL: It has high efficiency, low weight and accessible cost. However, after suffering high pressures, it can delaminate and modify its mechanical behavior (as presented in Figure 9). Moreover, the composite has variations due to hygrothermal effects. The hygrothermal analysis in the repaired pipe with different materials can be developed in future studies.

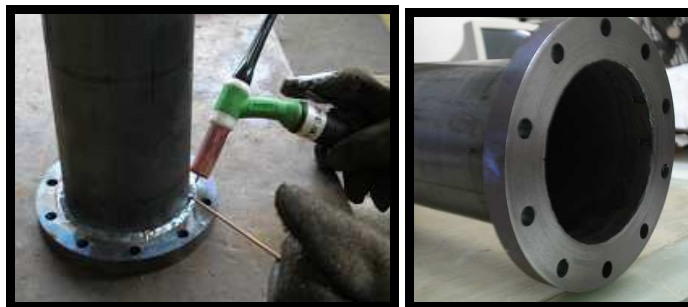
Figure 10. Preparing the covers.

COVERS OF THE PIPES: Exactly after facing of the covers, it can remain barbs, that increase the superficial rugosity and difficult the covered of the pipe. Moreover, the TIG welds of the covers, as illustrated in Fig. 10, can have pores and problems that could hinder an adequate internal pressurization. Before the pressurization of the pipe, an inspection with a penetrating liquid in the weld of the covers can be done.

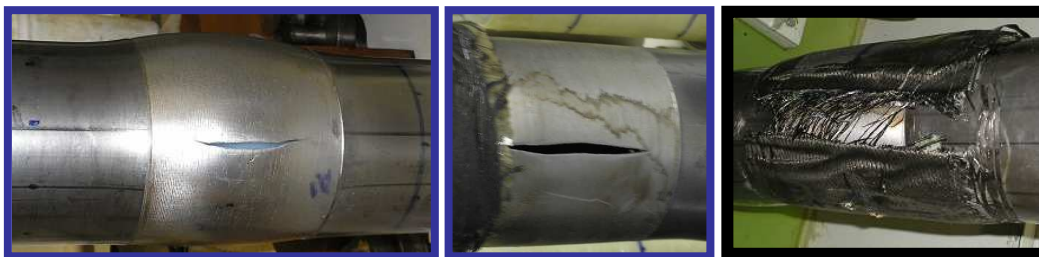
Figure 11. Place of the rupture in the steel pipe.

PLACE OF THE REPAIR FAILURE AFTER ITS RUPTURE PRESSURE: It depends on the position of the sewing (failure occurs far from the weld) and the position of the failure of the steel pipe (normally the failure of the repair occurs next to the region of the pipe failure, because it is the place of higher deformation, as shown in Fig. 11).

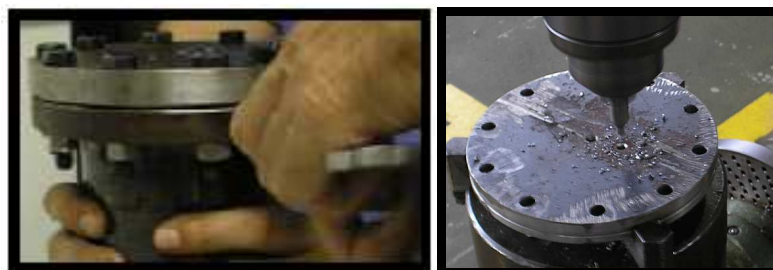
Figure 14. Preparing the Covers.

THE SETTING OF THE COVERS WITH SCREWS IS MANUAL: Any screw badly pressed (see Fig. 14) can modify the experiment. The maximum torque admitted must be calculated to avoid problems.
