## FAILURE COSTS IN THE DEVELOPMENT OF ELASTOMERIC COUPLINGS

**Abstract.** *This paper's objective is to demonstrate that any activity not carried through in a correct way causes non conforming products. And these cause costs to the company that are called failure costs. It is directed to businessmen and professionals involved with the design and development of new products and purports to show the importance of adopting procedures that accordingly will make use of Quality tools for the development of products, aiming at a larger probability of success and consequently the reduction of Quality Costs and especially the increase of clients' satisfaction. The Operational Costs are the addition of failure costs and conformity costs. These costs end up being incorporated to the products' costs, otherwise companies would not be able to absorb such costs. It is required good management and good classification of such Quality Costs, followed by a reliable collection of data and procedures that use quality tools adjusted to the organization profile and acting in the failure causes, in order to obtain the desired costs' reduction. This paper reports the launching of a product without an adj

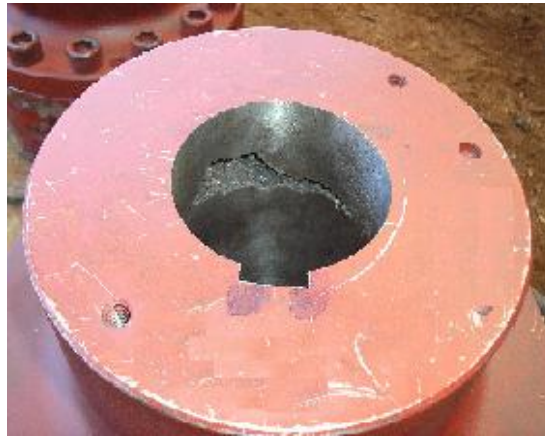
Figure 4. Internal porosity

This type of failure, which consists of pores in the inner region of the raw material, and which not always becomes apparent in machining, was the first to be detected after the release of the product. Figure 4 clearly illustrates porosity detected when drilling a hole.

- Failure in the supplier's casting process, and inadequate location of the liquid metal supply, which does not guarantee the required quality;
- Failure in the engineering selection of the right material for use in the manufacture of the retaining rings, since the plastic ring was not strong enough to withstand the centrifugal force in the cylindrical elastomeric elements.

- Submit 100% of the stocked cast iron raw materials to ultrasonic testing;
- Provide customers with an immediate solution for the flaws encountered in the field involving the rupture of the containment ring. Accordingly a new steel containing ring was designed as a split ring, see Figure 7. This unique solution was adopted exclusively to address these shortcomings, since it was produced at very high costs. The split ring format made it easier to immediately solve the clients' problems in place, without the need for axle removal. Therefore, it caused minor inconvenience to customers, and being made of steel resulted in a more robust equipment.

- The supplier of the cast iron raw material was requested to improve the process and to submit 100% of parts to ultrasound tests, in order to prevent defects detected during machining or by customers. Process improvement was surveyed by staff members of our Process Engineering sector who required some changes and corrected models developed for casting.
- To perform research studies in collaboration with the supplier, in order to find a cheaper solution for the flaws detected in the containing rings, as regards the raw material used to manufacture them.

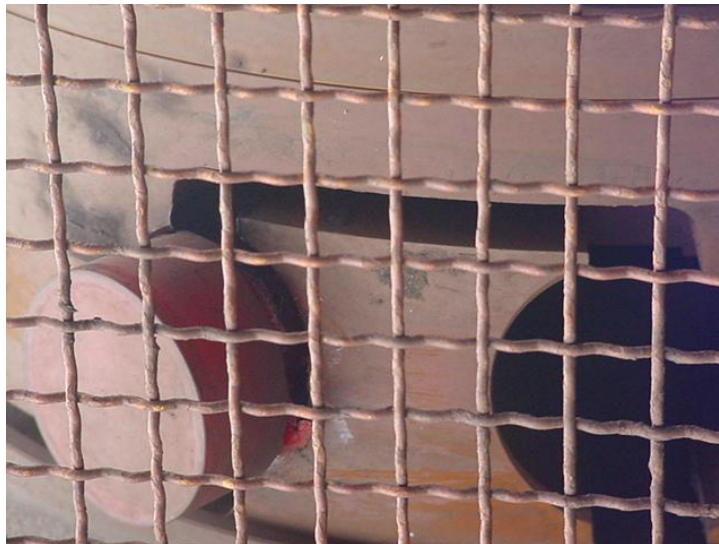
Figure 5. Release of an elastomeric element in service.

This failure occurs with the rupture of the retaining ring. As a consequence, the elastic elements are released from their housings and prevent the equipment from continuing to operate.

Since this type of failure can only occur in service conditions, it was invariably detected by clients while operating their machines and equipment. This fact caused serious damage to the company's image, and therefore demanded an immediate action of contention. Besides, it generated additional costs, such as those involved with the displacement of technical personnel and transmission components for replacement. Figure 5 shows a device that had a failure on the containment, resulting in the release of elastic elements.

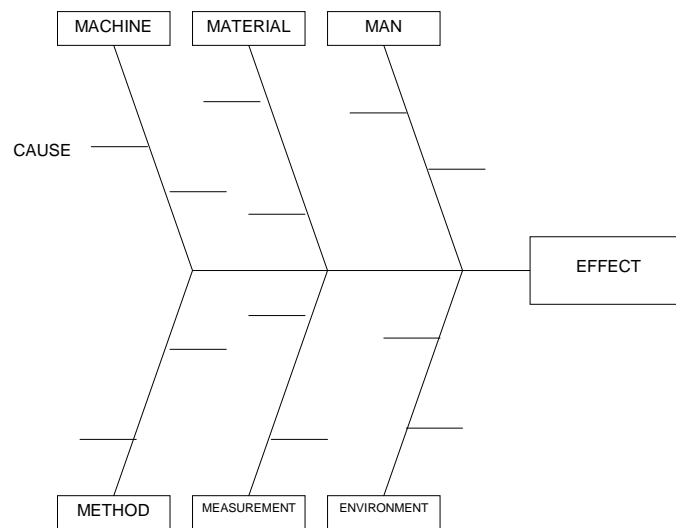
Figure 6. Ishikawa or fishbone diagram.

2. For best viewing and control of decisions an Ishikawa diagram was used, such as the one shown in Figure 6, which allows greater accuracy when defining actions to be taken.

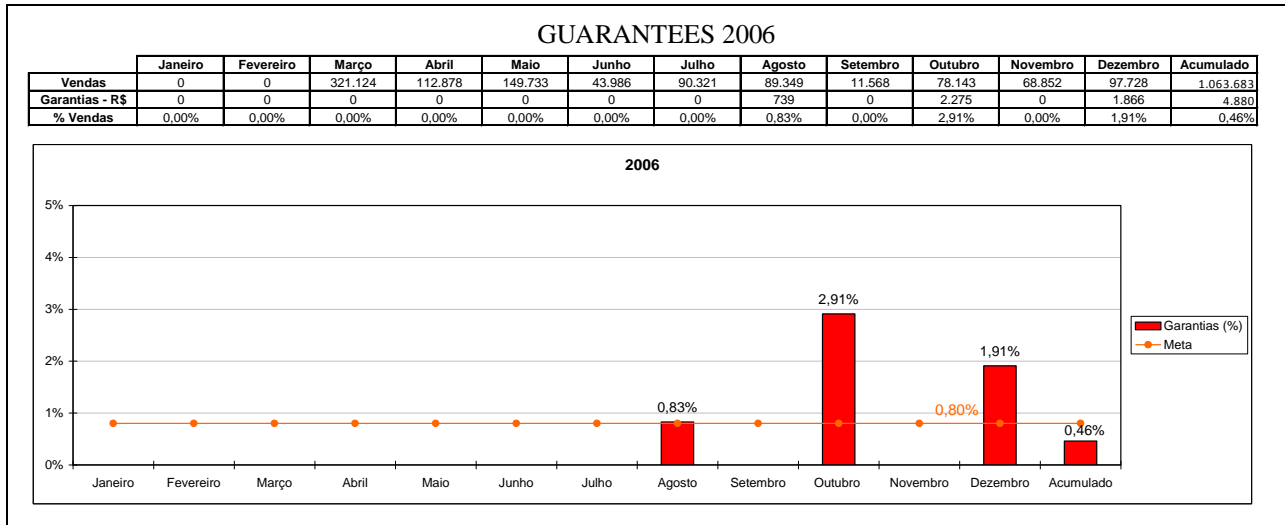
Figure 8. Guarantee costs for 2006

Guarantee costs referring to failures in couplings are shown in Figures 8 to 10, according to the year when costs were incurred. Sales (*Vendas*), Guarantees in Brazilian currency, Reais (*Garantias-R\$*), and % Sales (*%Vendas*) are shown for each month from January to December. Aggregate values (*Acumulado*) are also shown.

Analyzing the guarantee amounts for 2006 (Figure 8), it is possible to see that after five months of the new product release start appearing the first cases of failures. However, the aggregate result over the months does not compromise the goal of 0.8% since the annual aggregate was 0.46%. The organization took no action at that time because it did not consider the flaws to be critical and had no idea of what lay ahead.

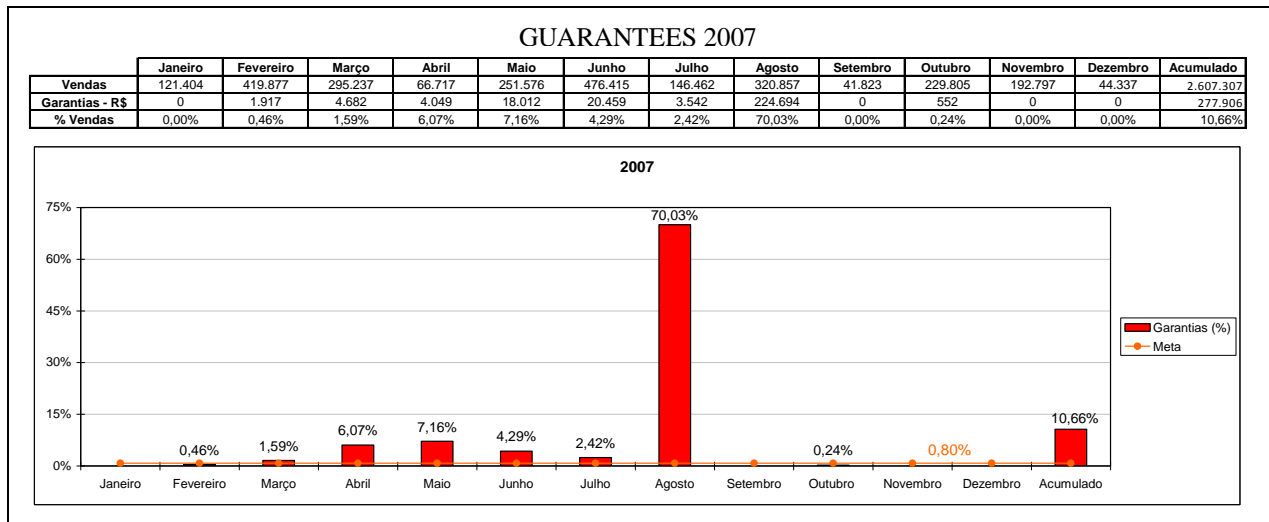
Figure 9. Guarantee costs for 2007

The year 2007 (Figure 9) in its first two months, exceeded in value the entire year of 2006, which forced the organization to rethink guarantee values and perform stronger action involving all sectors responsible for launching the product. It may be noted in the chart that in August there was a peak that refers to a "recall" held by the organization of all products that could be flawed.

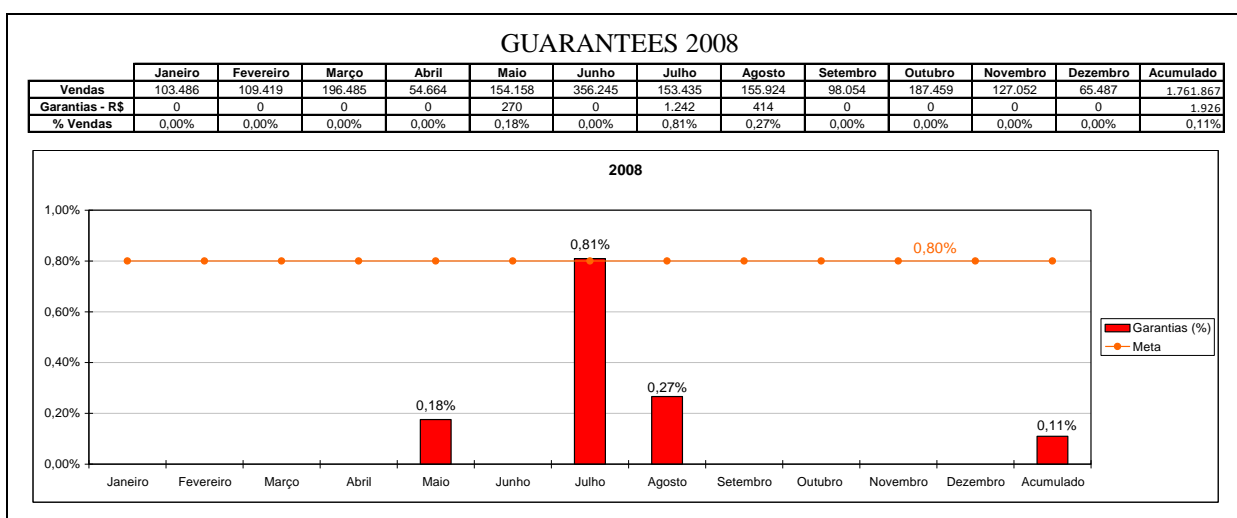
Figure 10. Guarantee costs for 2008

The year 2008 (figure 10) clearly shows what happened after the execution of corrective actions, i.e., showed that certain actions by the organization were so effective as to reduce the accumulated cost of failure from 10.66% in 2007 to 0.11% in 2008.

Considering the previously mentioned charts, one reaches the conclusion that the actions taken by the organization were very effective, because the proportion of failure costs from 2007 to 2008 was reduced around a 100 times. This fact reinforces the importance of properly using quality tools, particularly activities aimed at monitoring the costs of quality in order to determine when and how to make investments in quality.

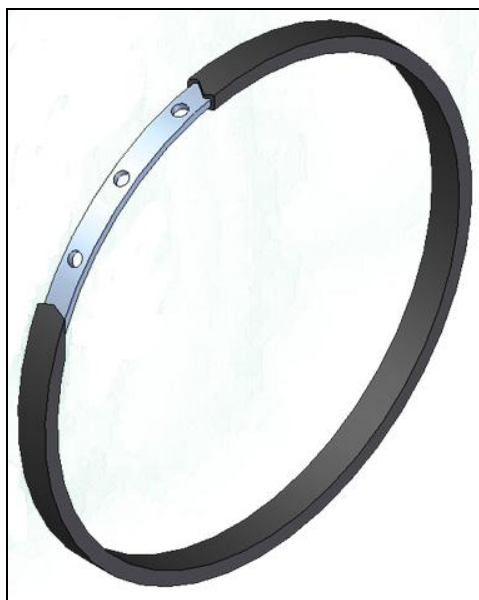
Figure 11. Plastic lined steel ring.

As a result of this experience, the company decided to adopt more permanent measures to avoid similar problems in the future, and created a section called D & D (Design and Development). This new sector has immediately added significant value by participating in the intensive development of improvements applied to the supplier's casting processes. As for the containing rings, the company has developed a joint work with the vendor that resulted in a market differential, the plastic lined steel ring shown in Figure 11.
