TRIBOLOGICAL BEHAVIOR OF NITRIDED STAINLESS STEEL AGAINST CAST IRON UNDER SEVERE TEST CONDITION

Marcia M. Maru
Deniol K. Tanaka
Amilton Sinatora

Escola Politécnica da Universidade de São Paulo
Mechanical Engineering Department
Laboratório de Fenômenos de Superfície - LFS
Av. Prof. Mello Moraes, 2231 Cid. Universitária
05080-900 – São Paulo, SP, Brazil
mmmaru@usp.br – dktanaka@usp.br – sinatora@usp.br

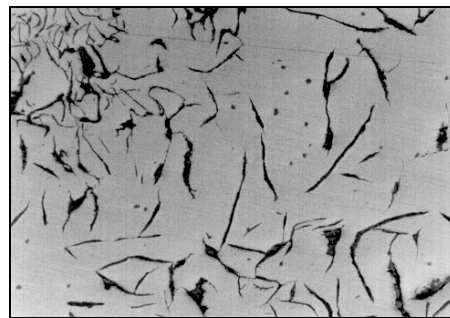
Plate material was a pearlitic gray cast iron with graphites of A and B types and 4 to 7 grain sizes (Figure 2), with average hardness of 250 HB.

Figure 2: Optical image of gray cast iron plates graphites (200x).

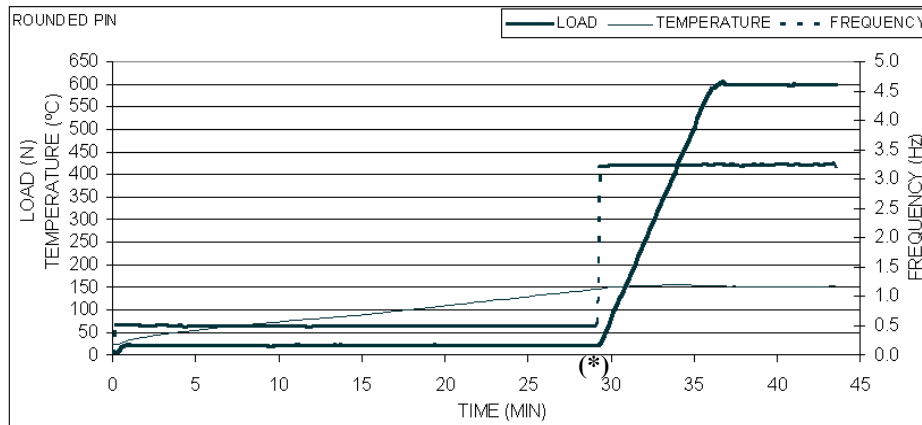
The second step was carried up with 3.2 Hz oscillation frequency. The load was applied, at 2 N/sec rate to the final load of 600 N. Figure 4 shows the test conditions curve for a test at 150 °C.

Figure 4: Testing conditions curve (load, temperature and frequency) for a rounded pin tested at 150 °C. (*) Test step changing.

All tests were carried out in two steps. The first step was under 0.5 Hz oscillation frequency and 20 N normal load, to ensure enough time to heat the test up to the selected testing temperature (100 °C or 150 °C). The machine heating rate was 3 °C/min.

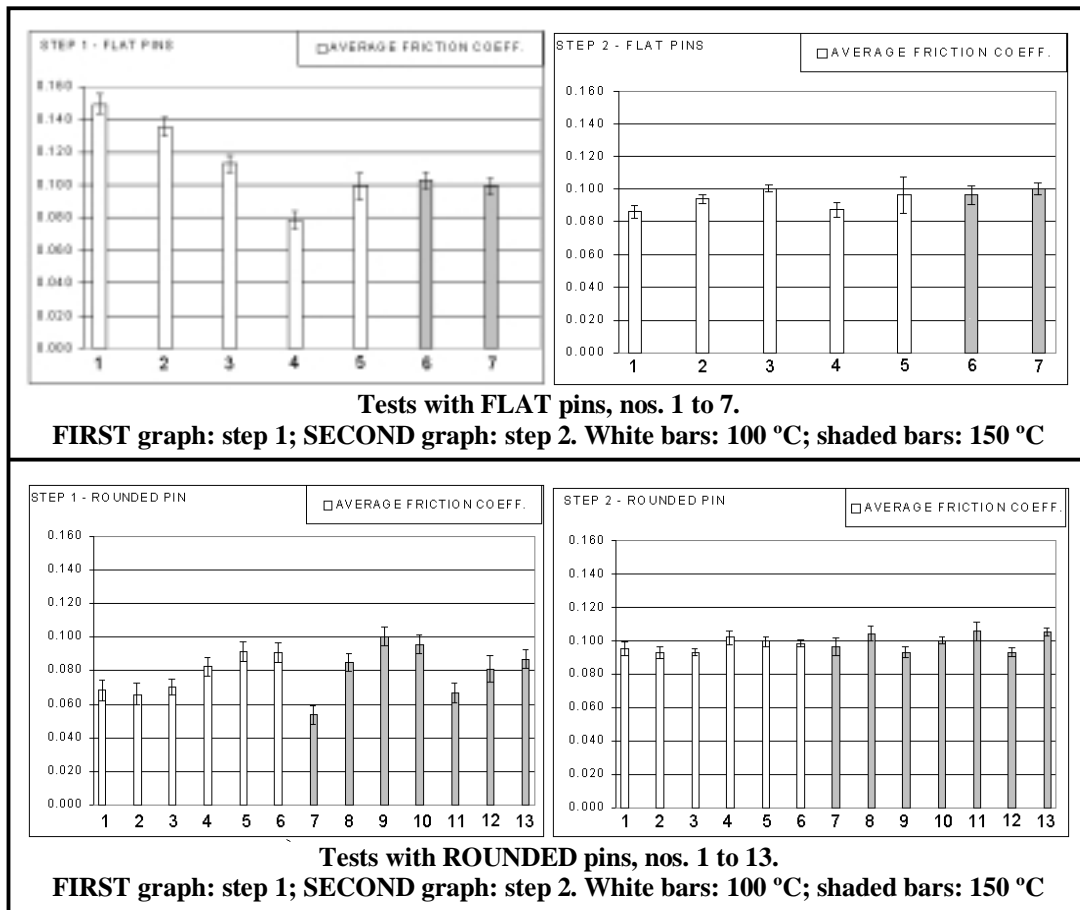
The average friction coefficients for all tests are presented in Figure 5 and in Table 3.

Figure 5: Average friction coefficient of flat and edge-rounded pins.

From Figure 5 and Table 3, it can be observed that there were no remarkable temperature influences on the friction coefficient.

Comparing the bars between steps in Figure 5, it can be observed in general, that step 1 values (left side graphs) were more scattered than those of step 2 (right side graphs). It suggests that there were influences of the transient testing condition of step 1 on average friction coefficient values. Since lubricant viscosity is temperature dependent, and the testing temperature increased during step 1, the acting lubrication regime would have been time dependent. The low load and speed levels of step 1 could have been able to promote influence of lubrication transient behavior on friction. Moreover, at beginning of tests, plate (counter body) surface roughness was higher, thus it is reasonable that friction coefficient was more erratic at step 1. After the end of step 1, it was visually observed some brightness increase of plate surface.
