ANALYSIS OF THE AISI D2 STEEL STAMPING TOOLS LIFE THROUGH THE APPLICATION OF PVD COATINGS

Abstract. *The use of titanium nitride coatings (TiN), applied by Physical Vapor Deposition (PVD) has shown a significant increase in the several areas of the industry where there is friction. The following study analyzed how this type of coating influences the process of tool tip wear down, with the intention of investigating how the punch tools life, used for making holes in thick sheet of metals can be increased. Therefore to make some tests, two groups of punch tools and dies were manufactured in AISI D2 steel. Two of them were thermally treated (hardened and annealed) and the other two, besides the thermal treatment, were PVD coated with TiN. The tests were made by punching holes in laminated sheets of LNE600 (NBR 6656) steel 7 thick using an automatic hydraulic press. The obtained results showed the great benefit of using this type coating and the life of the tools increased 60% in relation to the punch tools without the coating.*

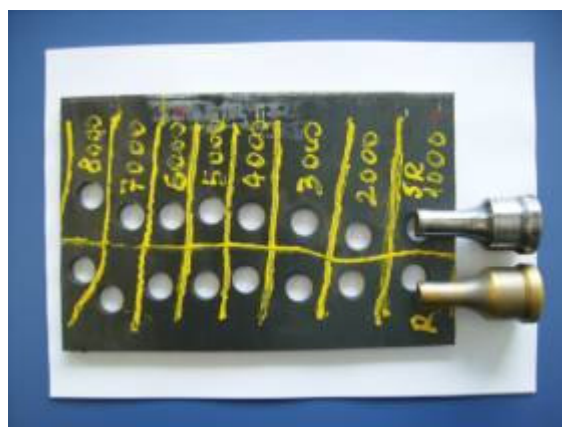
Figure 3 – Example of a Punched specimens

Punched specimens of **LNE600** were analyzed after **1,000** holes. An example of the steel strip obtained during process is presented in Figure 3.

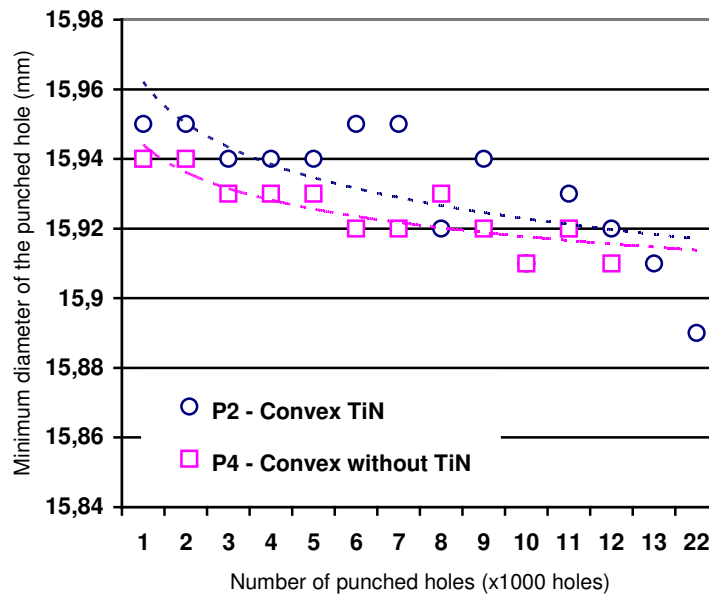
Figure 7 – Diameter variation of the punched holes in relation to the number of them

The diameter of punched holes tends to decrease with the increase of tool wear. For the control of this reduction, punched holes were measured. The minimum diameter condition for punched holes with increase of the holes number is shown in Figure 7. It can be observed that after **12,000** holes the decrease in diameter for punch tools **P2** and **P4** is just **0.03mm**. This shows that **TiN** coating does not influence the wear rate. Tool **P4** worked up to the **12,000th** hole and then broke.

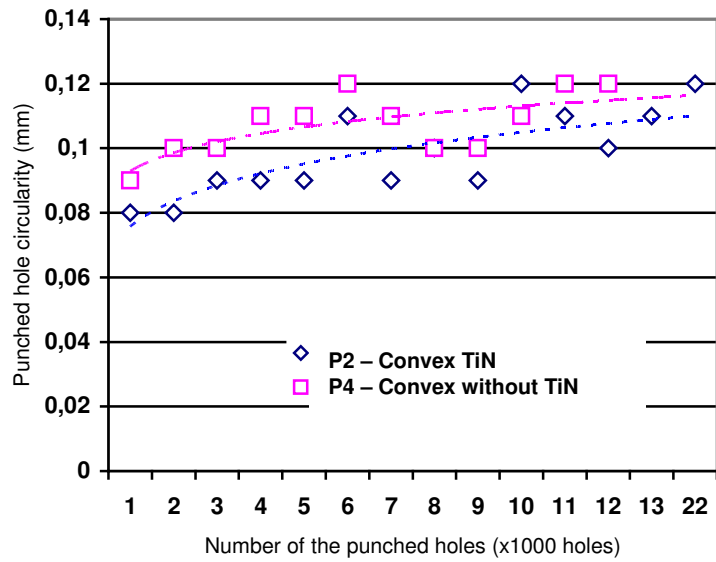
Figure 8 – Punched hole circularity in relation to the number of holes

Tool deformation and wear, misalignments during assembly, machine instability among other factors could cause differences between minimum and maximum punched hole diameter and also affect the dies. This variation compared with number of holes can be seen in Figure 8.

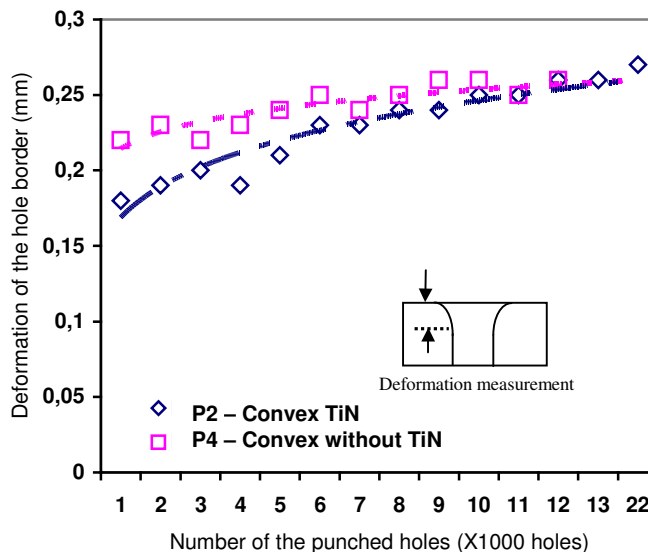
Figure 11 – Punched hole border deformation for tools P2 e P4.

In punching, the first step in the cutting process is tool compression against the work piece to produce surface deformation. If the deformation is high, ex. 1 mm, the quality of the hole is not acceptable. The variations in the border deformations of the holes when using convex tools with and without TiN coatings are shown in Figure 11.

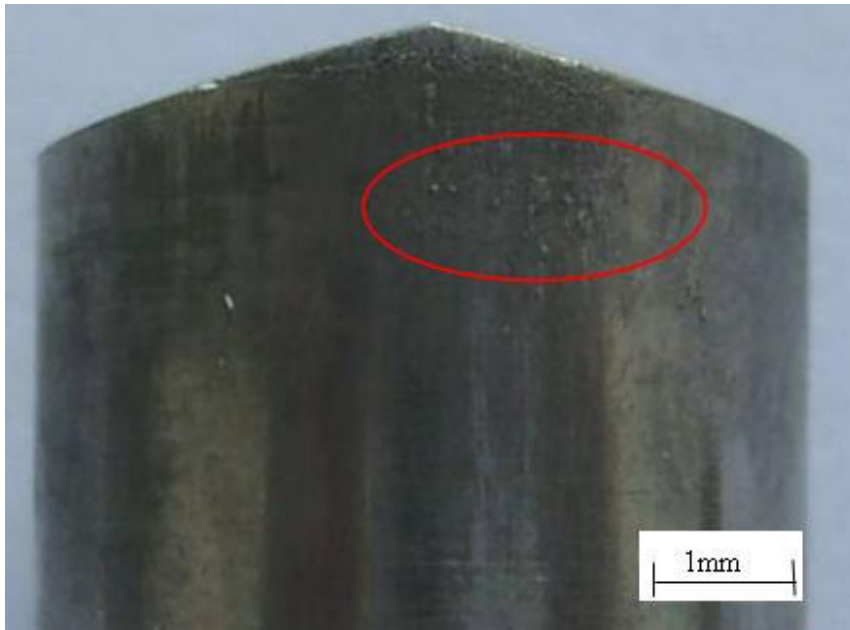
Figure 12 – Lateral Wear of the Punch Tool **P4**.

Usually the axial cutting force is high in punching processes. This makes tool side wear down during punching. In Figure 12 it is possible to see a convex tool side without **TiN** coating (**tool P4**) and in Figure 13 convex tool side with **TiN** coating (**tool P2**). Tool **P4** presented lateral wear due to mechanical adhesion mechanism or to the welding of cut material's layers in punch sides. This mechanism will progressively increase the friction force and that can cause micro-fractures in tool sides. This is the typical tool wear due to adhesion, and the sequence of this mechanism can lead to the abrasive wear. In that case once the material's layer adhered to the tool it can be detached. For tool **P2**, only lateral wear of the coating can be observed due to abrasion (micro-ploughing), without adhesion or material welding, this confirms the benefit of **TiN** coating, although there was a wearing down of the cutting edges. Therefore, the combination of cyclical loads and abrasion wear are the causes of tool lateral wear, which reduces the nominal hole diameter and increases the clearance between punch and die.
