## OIL ANALYSIS OF INTERNAL COMBUSTION ENGINE

**Abstract.** *All engines must be lubricated in order to preserve the integrity of the system for its designated lifetime. The extreme temperatures in internal combustion engines make lubrication complex. The lubricants that are suitable for use in these engines are expected to reduce friction, dissipate heat from internal parts, minimize deposit formation, and prevent corrosion and wear. Its main function is to reduce friction by forming a film between two moving surfaces. The strength and durability of this film is related to the viscosity of the lubrication and to the speed and load experienced by the moving surfaces. Analyzing the lubricant of an internal combustion engine one can foresee what is happening inside it. For instance, wear between the valve and seat is thought to occur primarily due to relative motion when the valve is seated, due to cylinder pressure that forces the valve into the seat, causing slight deflections of both valve and seat. In order to study the predictive maintenance in an internal combustion engine, through wear particle oil analysis, it was constructed two tests rig composed by an engine coupled to a

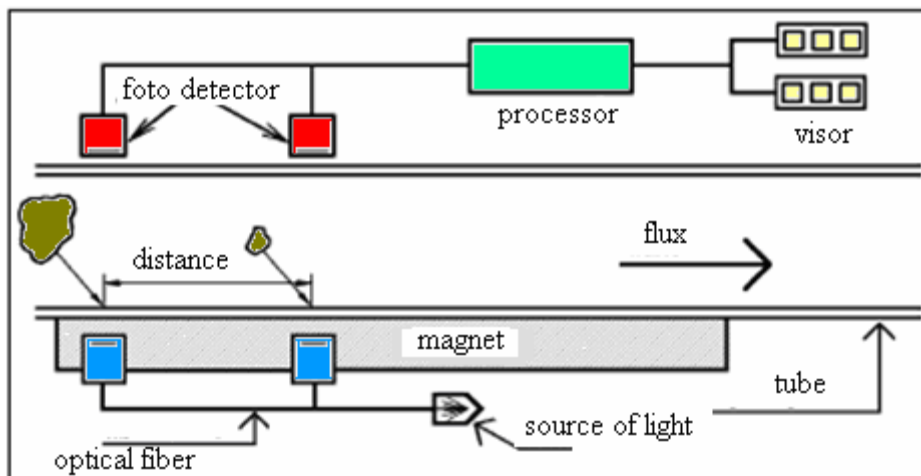
The direct reading ferrography consists of a quantitative measurement of the particle concentration in a fluid through the precipitation of this particle in a glass tube under a strong magnetic field. Two rays of transported light by optical fiber shock inside the tube in two positions that correspond to the big and small particles position that were deposited by the magnetic field. The light is reduced in relation to the deposited particle inside the glass tube and that reduction is electronically monitored and measured.

Two reading set are obtained (particle bigger than 5 microns and particle smaller than 7 microns). Generally more than 20.000 particle bigger than 7 microns indicate an alert and particle beyond 40.000 indicate problems in machine ferrous components (Rueda, 2005). Figure 2 illustrates a directing reading ferroscopy.

Figure 2 – Direct reading ferrography schematic apparatus

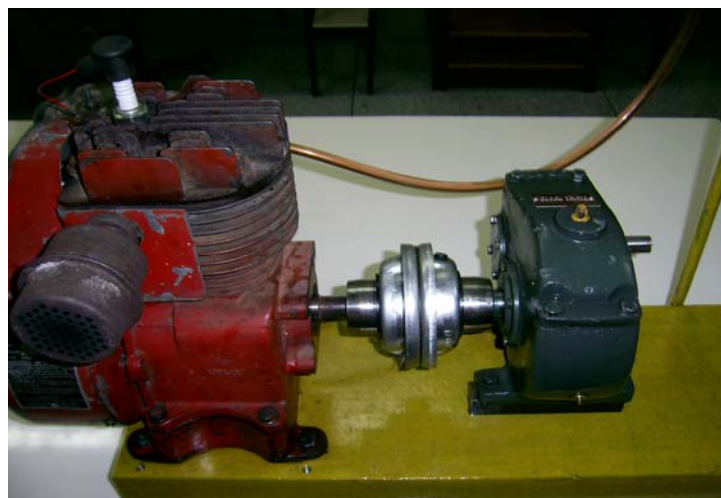
For this work it was built two tests rig composed of internal combustion engine coupled to reducer in order to give power to the engine. The power was given only by the internal friction of the reducer. Firstly an engine of Montgomery brand was used. The potency was 3.5 HP, for stroke, 1300 rpm and with reservoir capacity of 800 ml. The engine was coupled to a reducer from Cestari brand with 5 CV, 1750 rpm capacity, reduction of 1:2. Only one test was made with this test rig because the engine presented some problem during the operation and it was discarded. Figure 3 illustrates the test rig with this kind of engine.

Figure 3 – Test rig built with Montgomery engine and Cestari Reducer brand

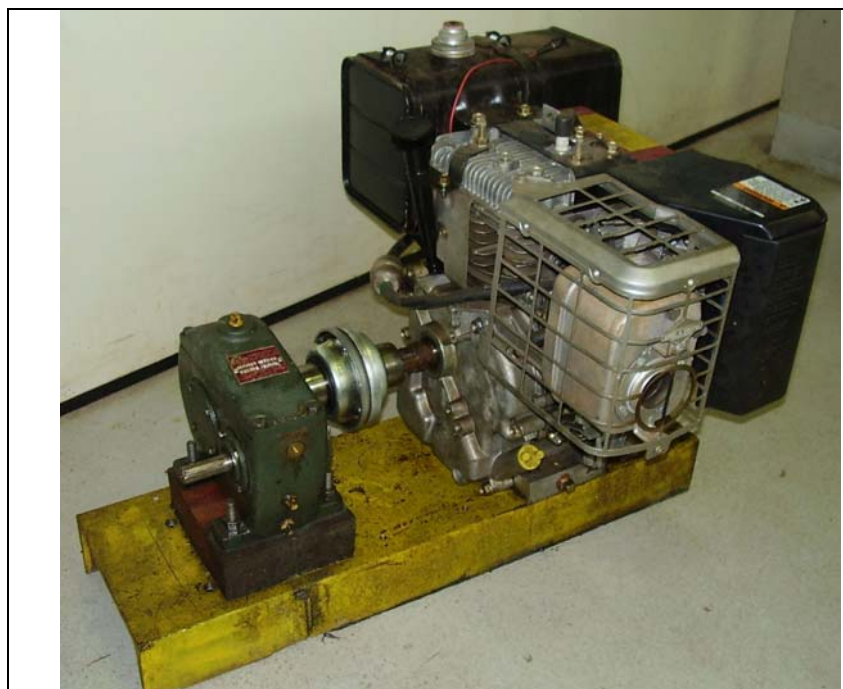
A second test rig was built with a new engine of Briggs & Stratton brand. Its power was 8 HP, four strokes, reservoir capacity of 800 ml, 3000 rpm. The engine was coupled to a reducer from Cestari brand with 5 CV, 1750 rpm capacity, reduction of 1:2. Figure 4 illustrates this test rig.

Figure 4 – Second test rig constructed

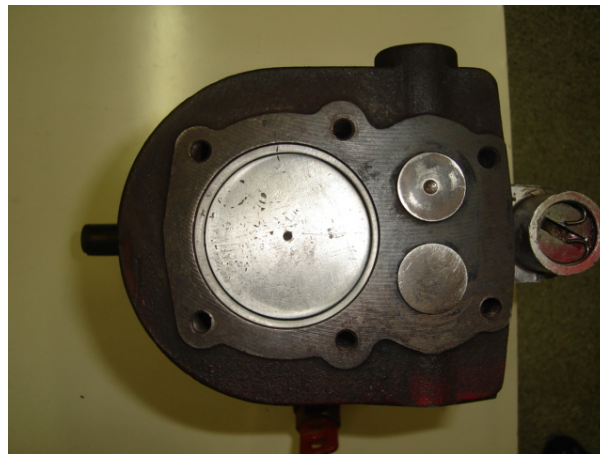
The figure 6 presents the piston head of the engine after the experiment.

Figure 6 – Piston head of Montgomery engine after the test

The higher Al content in the first test rig indicates a higher piston wear. That was confirmed by the picture on the Figure 6 where one can observe the advanced wear in this part.
