WEAR EVALUATION OF ELASTOMERIC SEALS USED IN AN OIL WELL STUFFING BOX

***Abstract.** A beam pumping unit (commonly referred to as horsehead pump), used in petroleum production, converts the rotary mechanism of an electric motor to a vertical reciprocating motion to drive the pump shaft, through sucker rod lines. The pump is located underground in the oil reservoir and raises deriving fluids to the surface. In this work, an experimental test rig was built to simulate the sealing circumstances of the tribological pair rod-seal package of a oil pumping unit in a 1:1 scale. A friction evaluation was carried out by fitting an axial and circumferential mesh of thermocouples to the stuffing box with the objective to get a thermal mapping of cylindrical external surface and thus mapping the temperature field around the seals. The interrelation between the temperature field and the contact pressure of rod-seal is discussed. The work attempt to identify eventual misalignment of the polished rod in relation to stuffing box what may cause a oil leakage. Scanning Electron Microscope (SEM) analysis of seal contact surface were carried out before and after experimental tests trying to associate

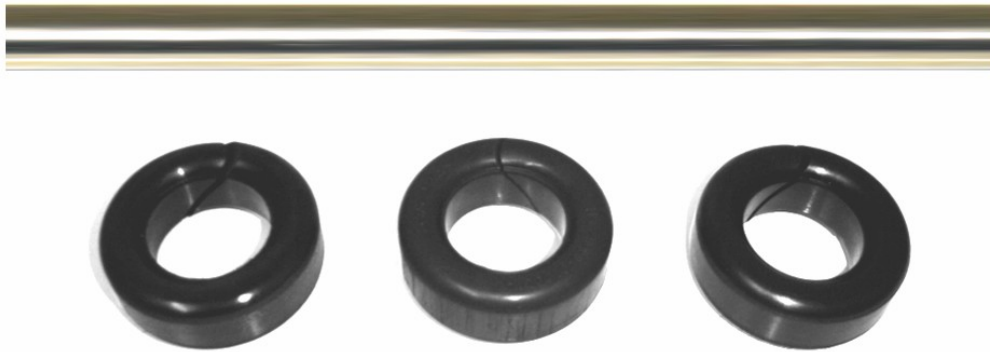
A package with three acrilonitrile-butadiene rubber (NBR) seals, filled with silicon dioxide (SiO₂), was used in the experiment, with dimensions of 0,05715 m X 0,03175 m X 0,02222 m and a Shore A hardness of 85. An AISI 316 stainless steel polished rod, with diameter of 0,003175 m and 1,0 m long, with a roughness $R_a = 0,43 \mu\text{m}$ is used against the seal package. Both elements are shown in Fig. 1.

Figure 1. AISI 316 stainless steel polished rod and NBR seals

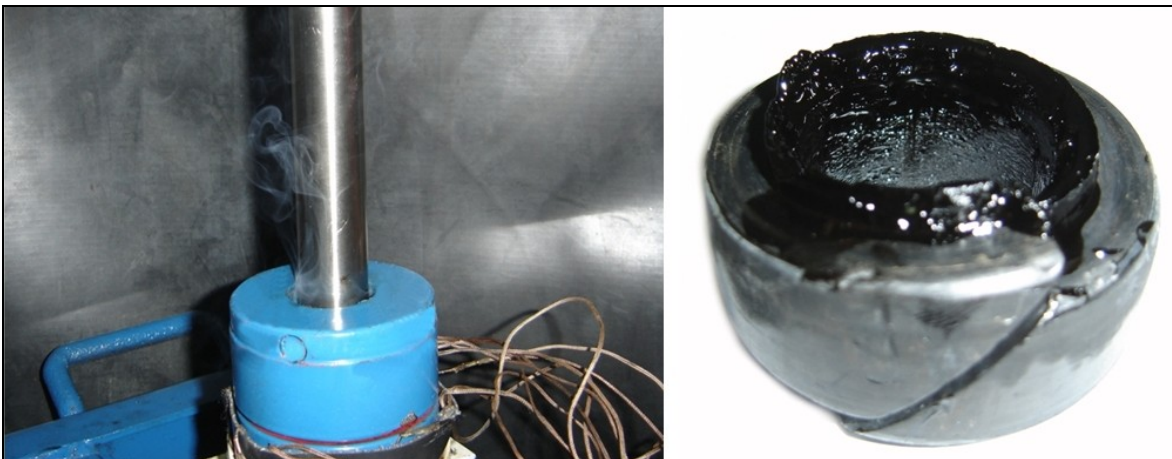
Figure 8. Smoke generated in contact surface, and fusion of the sealing surface of top seal.

In this graphic a running-in period can be identified up to the first 13000 seconds. After that the seal package failed and then a oil leakage happened. This event cool the contact surface what reduced the registered temperatures along the test until reach a steady-state period, after 35000 seconds. This situation determined the end of test criteria. The seal packing failure is observed in Fig. 8 which shows the smoke generated in contact surface, resultant of the fusion of the sealing surface of top seal.
