## TEMPERATURE VARIATION OF OVERHEAD ELECTRICAL CONDUCTORS AS FUNCTION OF ALUMINUM WIRE RUPTURE

**Abstract.** *The Brazilian transmission system is characterized by installations that average 20 years of operation. Competitiveness of the energy sector, lack of resources for new investments and the aging of the system lead to the necessity of not only to reform but also to optimize it in order to face the increasing demand of the Brazilian energy market. The overhead electrical conductor is naturally the most important element on the transport of electrical energy and requires careful predictive and preventive maintenance programs. Therefore, it is of fundamental importance to predict the operational life of overhead electrical conductors using mathematical models so that their energy transport capacity can be optimized. However, it is necessary that such models be validated by test programs so that their estimates can be trusted. One of the most important factors on the structural decay of overhead electrical conductors is the variation of the temperature profile in the event of the rupture of one or more of its Aluminum wires by fatigue or fretting. Thus, temperature profile mode

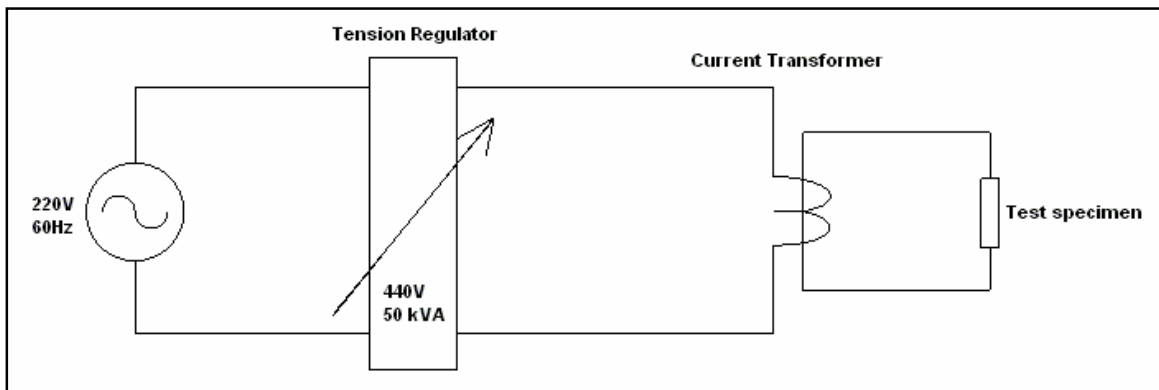
Figure 5. Test circuit

The heating of the test specimen was performed by the electrical circuit shown schematically on Fig. 5. The circuit was composed by a Varivolt and Tension Regulator (Anel Varivolt and Tension Regulator, tension 440 V, power 50 kVA) to control the tension of the primary circuit. The primary circuit was connected to a Current Transformer through which the test specimen was passed in order to induce high current at low voltage, for safety reasons. The induced current was then monitored at the test specimen by the clamp-on ammeter (GE, 0 to 800A). This current delivered the energy necessary for the specimen heating. The system, pictured in Fig. 6, was started at the nominal operational conductor current (325 A) and controlled to maintain it throughout the test. Data was acquired along the test using the data acquisition system showed in Fig. 7 (Agilent Technologies 34970A, accuracy 0.004% and resolution of 6½ digits).

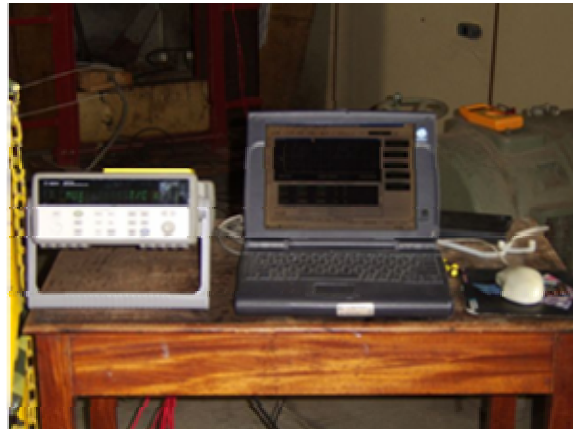
Figure 7. Data acquisition system

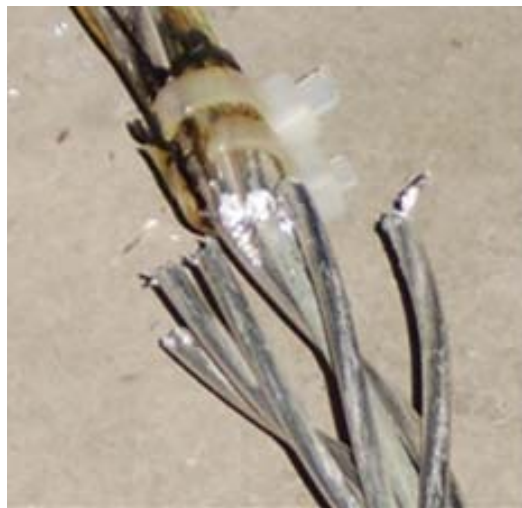
Figure 9. Test specimen after the 5<sup>th</sup> wire cut

As the test was developing, the increase in the temperatures promoted degradation not only on the nylon fixation clamps but also at the thermocouples insulation. This degradation eventually culminated in the failure of the sensor at the times showed on Tab. 4., which also shows the last temperatures measured by these sensors before failure. As it can be also seen on Tab.4, all sensors failed after the 5<sup>th</sup> wire was cut. Figure 9 shows the specimen after the 5<sup>th</sup> wire cut.

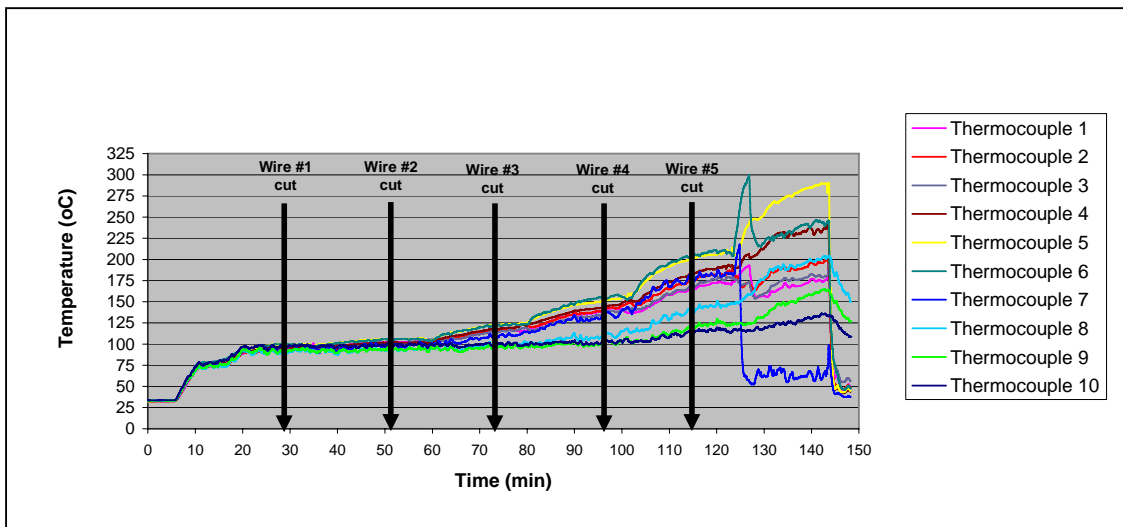
Figure 10. Temperature expressed as a function of time for all thermocouples along of test

Figure 10 shows all stored data along the test, from the beginning of the heating of the test specimen to the removing of the thermocouples. It represents the temperatures as function of time for all thermocouples.

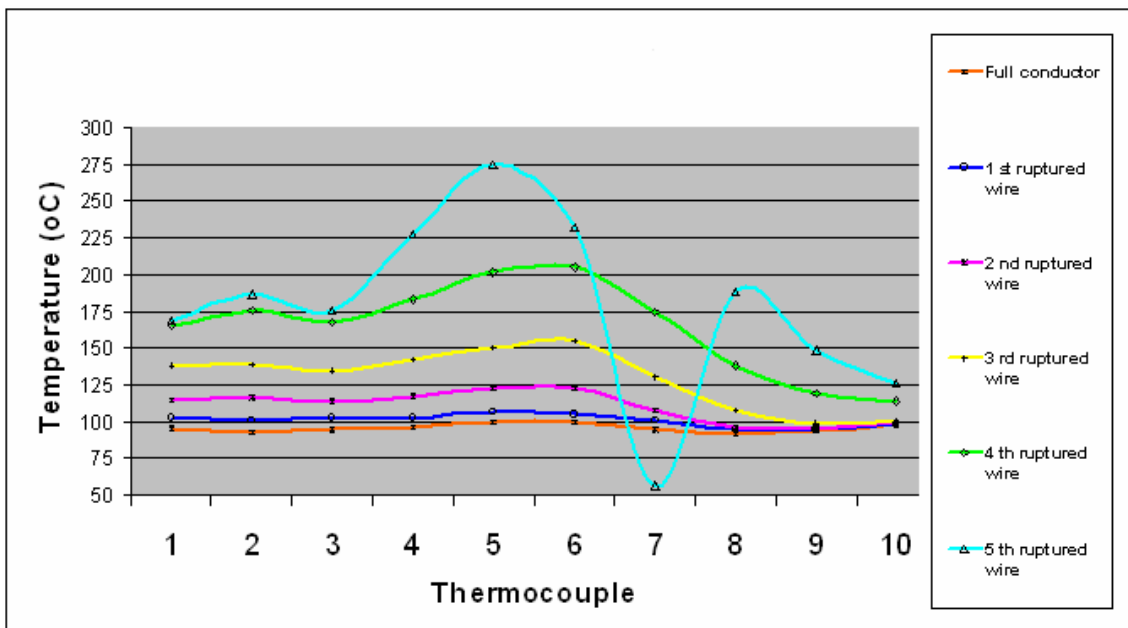
Figure 11. Maximum temperatures for selected stages up to 5<sup>th</sup> wire cut

Figure 11 shows the temperatures reached by the thermocouples up to the 5<sup>th</sup> wire was cut. It can be observed that at the 5<sup>th</sup> wire cut, thermocouples #1, #3, #6 and #7 were no longer working (Tab. 4). Thermocouple #7 signal was completely lost, while the other 3 signals presented no significant temperature increment as the core temperature of the rupture section has increasingly risen. After that the thermocouples started to fail, according to Tab. 4.

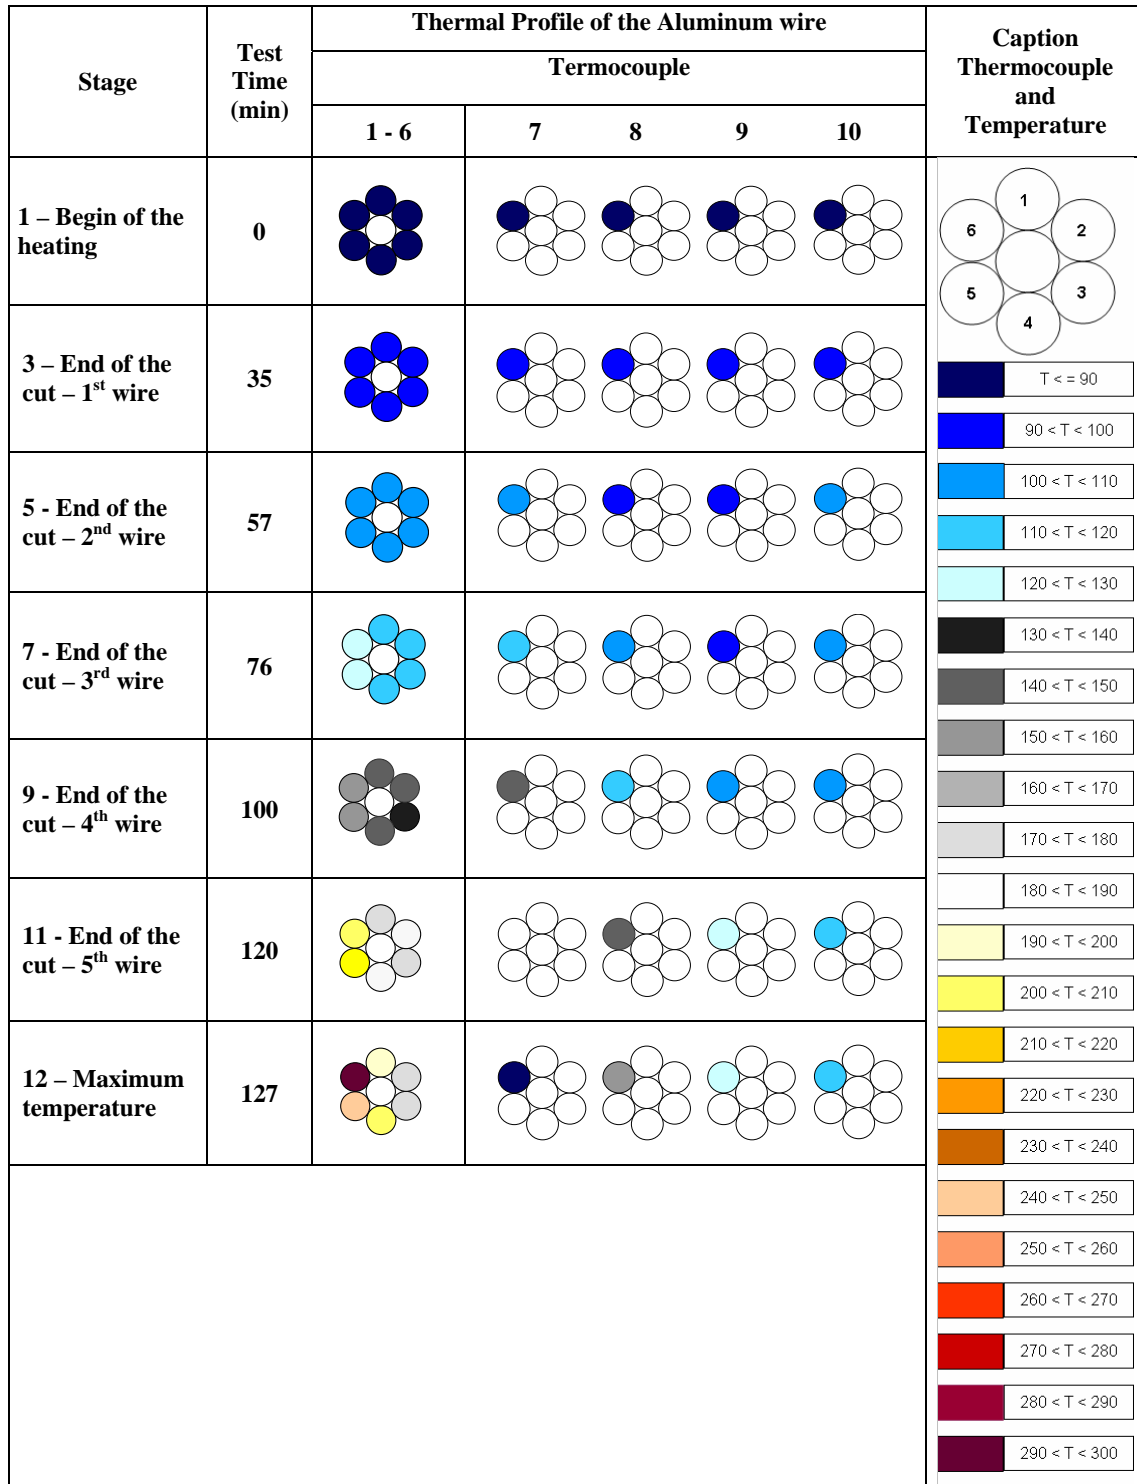
Figure 12. Temperature at each stage for thermocouples #1 to #6 along of test using a discrete palette of colors

Figure 12 indicates the variation of the temperatures of the Aluminum wires along of different stages of the test, through of a pallet of colors, respectively to thermocouples #1 to #6 (circumferential) and #7 to #10 (axial).

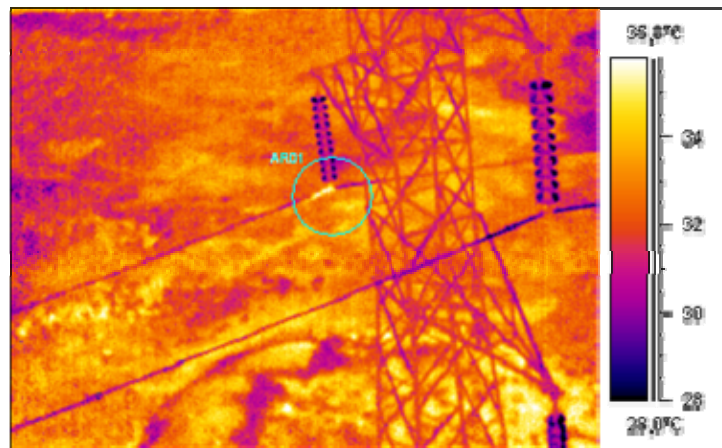
Figure 13 – Hot point detected during the overhead thermo graphic inspection (Resende, 2001)

The comparison of the thermal profile of the conductor with thermo graphic images obtained in overhead inspection of overhead transmission line (Fig. 13) could help the analysis of hot points in conductor connections, identifying, thus, the occurrence of rupture of Aluminum wires.
