GRP ASSESSMENT AS STRUCTURAL REINFORCEMENT OF API 5L GR B PIPELINES

Abstract. *Corrosion by environmental factors is a type of defect almost inevitable in pipes used in oil industry. The rehabilitation of pipelines due to corrosion damage with fast and low cost methods has been a challenge, in the past years. This work aims to evaluate the efficiency of a composite material (GFRP) sleeve as structural reinforcement for strain reduction in steel pipelines, submitted to internal pressure, used as hydrocarbon transport. The study of polymer matrix composites as structural reinforcement is characterized as an alternative for repair of metallic pipelines which operates in limited conditions of temperature and pressure. A comparative analysis between strain values obtained analytically and experimentally was performed, in order to verify the applicability of polymer matrix composites as structural reinforcement. Strain measurements were performed for both conditions – GFRP reinforced and unreinforced pipe.*

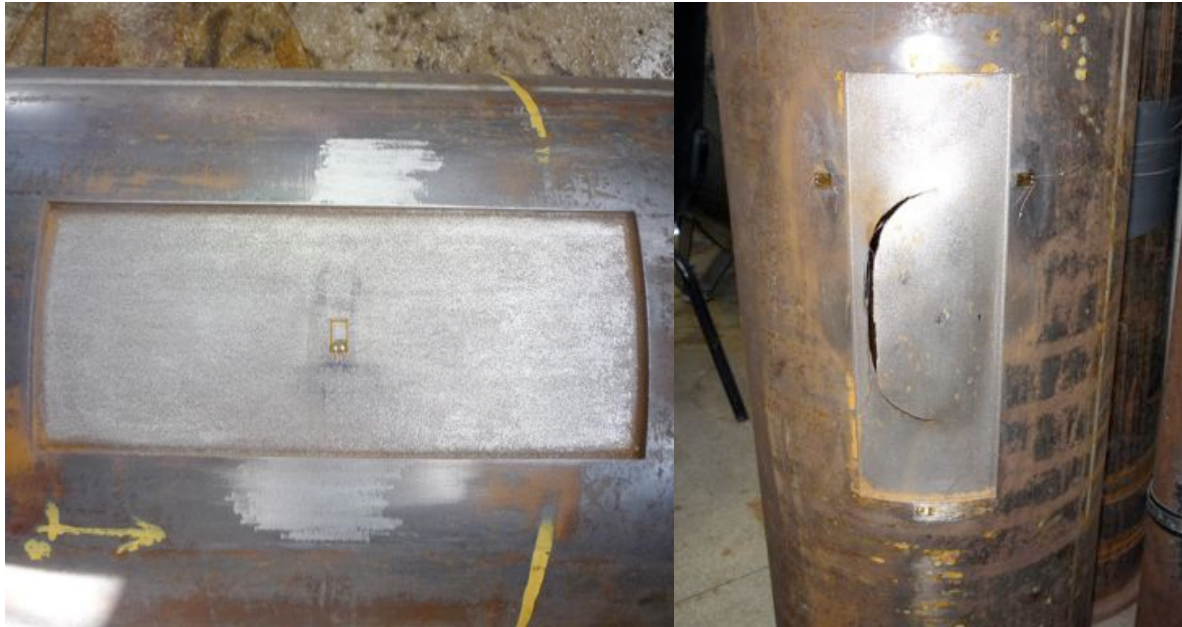
Figure 1 displays the geometry of the external defect introduced to the tubular specimen without composite reinforcement.

Figure 1. External defect of a specimen without composite reinforcement, also showing the strain gage and burst pipeline

Simulated defects were machined into the pipe wall using defects with a longitudinal length of 300 mm (11.81 in.), and a depth to 80% of the wall thickness (5 mm or 0.20 in.). In the hoop dimension defect lengths are 100 mm (3.94 in.).

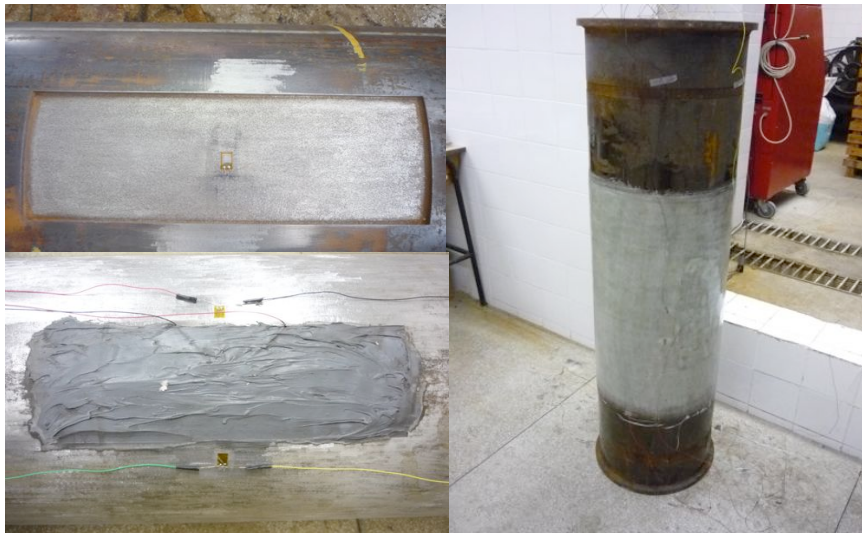
Figure 2. Composite sleeve installation

Once the defects were created in pipe test pipes, the steel was sandblasted to a near-white finish and placed on a support structure to allow the repair system to be applied. An electric strain gauge was attached to the surface in order to measure the strain during the test. Then, the two-part high viscosity putty was mixed using a paddle and applied to fill the defect. Again, two strain gauges were attached to the pipe outside the created defect to measure the strain in the non-defect surface, see figure 2. The glass fabric was impregnated with the premixed low viscosity epoxy/amine hardener using an adhesive roller. After the fabric was properly saturated, it was wrapped around the test pipe and the freshly applied putty using hand tension to pull the wet fabric, while keeping the centerline of the wrap with the center of the defect. A total of 8 layers of glass/epoxy wrap were used to cover the flaw, giving the repair (excluding the epoxy putty) a thickness of 1.5 mm (0.059 in). Once the wrap was applied the epoxy was allowed to cure for at least 24 h, in a room temperature environment, before testing began. A picture of a completed instrumented with strain gauges pipe is shown in Fig. 2. The composite thickness repair thickness was calculated according to Costa-Mattos et al. (2009).

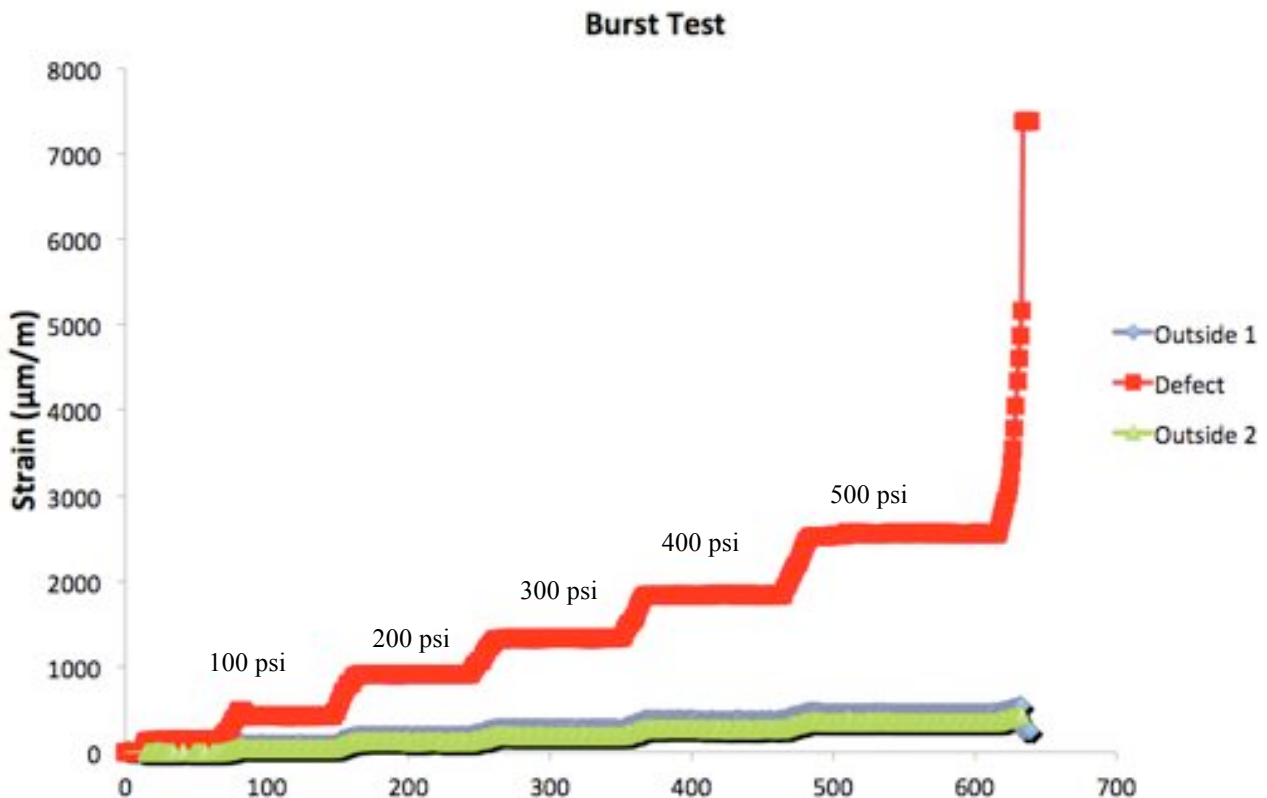
The internal pressure test of the unwrapped pipe is presented in figure 3 where outside 1 and 2 means the non-defect measured area and Defect means the reduced thickness area.

Figure 3. Pipe test pipe burst test

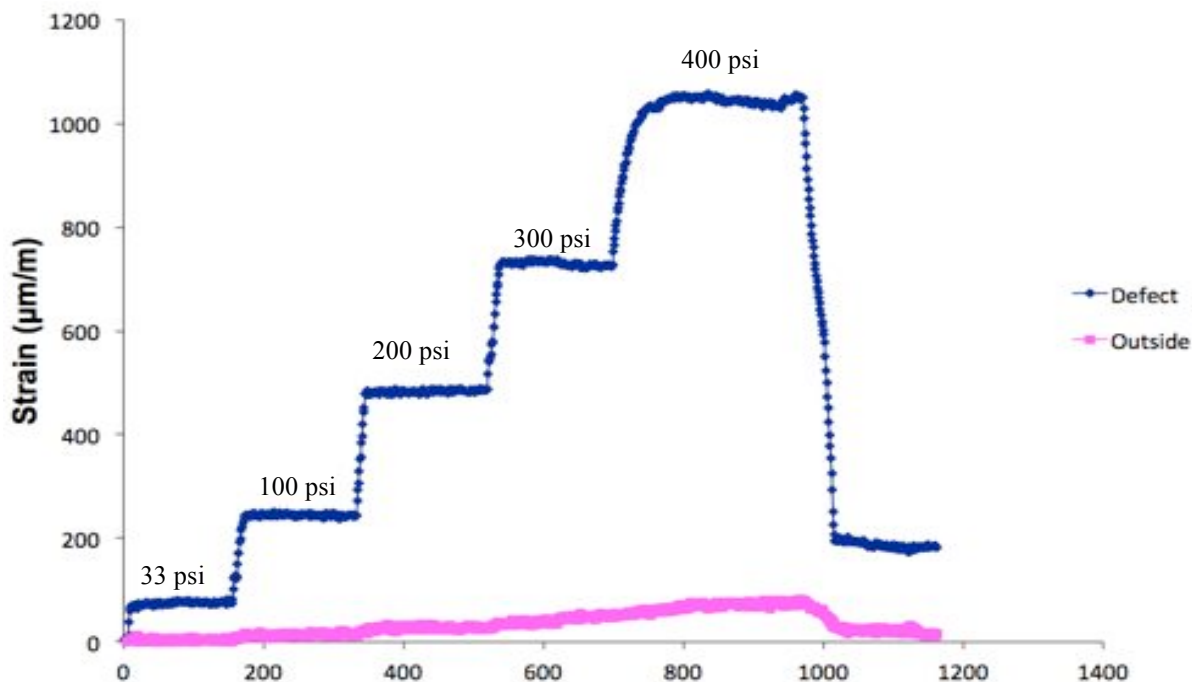
Figure 4 displays the repaired test sample.

Figure 4. Hydrostatic test on the wrapped pipe

The effectiveness of the repair can be evaluated by comparing the burst pressure 3.8MPa (552psi) of the repaired pipes with the predicted burst pressure of an unrepaired pipe. The burst pressure of an unrepaired pipe can be calculated by the ASME B31G criterion (1991) or using the RSTRENG technique, both well established methods for assessing corroded pipelines (with the ASME B31G criterion known to be overly conservative). For the defect analyzed in the study, these methods (which do not take into account the circumferential length of the defect) result in a predicted burst

Table 1 present the average strain measured in the unrepaired and in the repaired test pipes. Comparing the burst test (unrepaired pipe) result with repaired pipe a considerable diminish of the strain in the defect area is measured. In the defect area an average reduction of 44.6% is reported and in the outside area the strain lowered 78.3% in average.
