STUDY OF POLLUTER ACTIVITY POTENTIAL OF LIQUID FUELS RESALE IN THE CITY OF NATAL (RN): JUSTIFICATION FOR THE IMPLEMENTATION OF ENVIRONMENTAL LABELLING (GREEN SEAL)

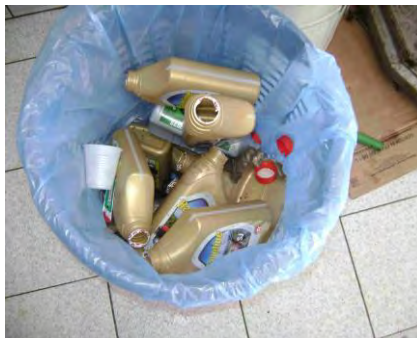
The daily life of a retail fuel station involves multiple processes that may result in the disposal of accidental and trivial materials such as fuel, lubricating oils, gases, waste water with contaminants, combustible materials (grease storage cans, used tow etc.) shown in Figure 3, among others.

Figure 3. Improperly discarded materials in a retail fuel station.
Source: State Prosecutor.

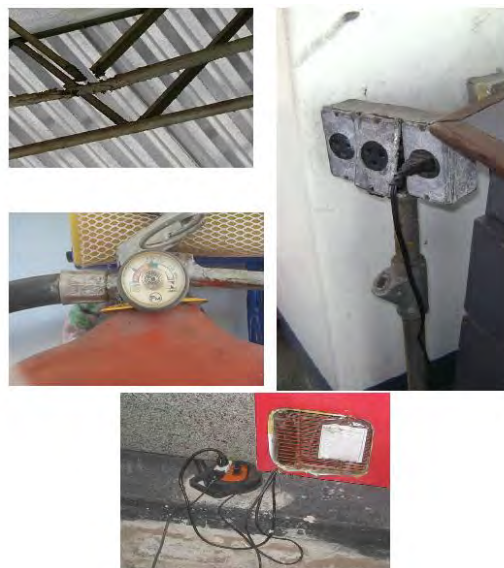
Several sale stations feature a poor operating structure due to the lack of a proper maintenance plan (as shown in Figure 4), the training of staff involved in the procurement process and other environments of the post, obsolescence of equipment and systems used in supply and storage processes, as well as being observed that the leak detection systems do not have reliable fuel Council (CONAMA 273rd, 2000).

Figure 4. Details of the metal structure of a retail fuel station; the charge level of a fire extinguisher located in a retail fuel station; electric system found in a retail fuel gas station and electric system found in a gas fuels reseller.

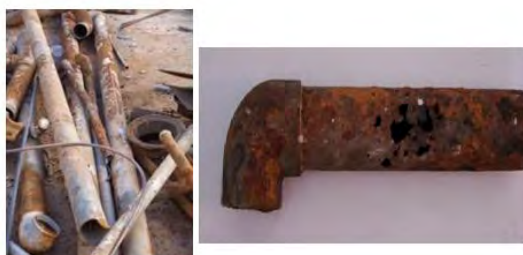
Were counted one hundred and nine stations that had leaks along their lines (pipes) and their connections. Leaks in pipes are due to corrosive attacks on buried pipes or air. Figure 5 shows details of the state of a pipe used in gas stations in inspections.

Figure 5. Details of the status of pipe used in gas stations.

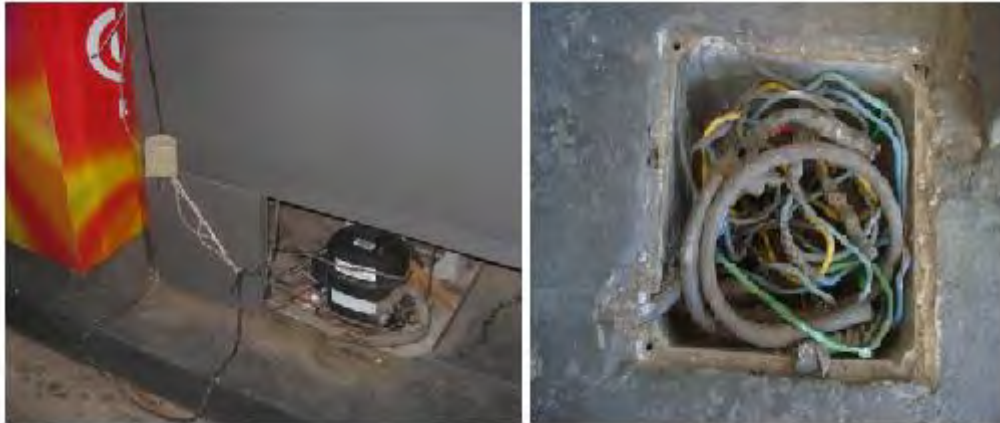
During the observations, the engineers and technicians noticed some elements outside the safety standards, such as: installation of electrical systems outside the normative parameters, electrical equipment for purposes of refrigeration (refrigerators, freezers etc.). Next to the gas station, there was a lack of grounding or improper grounding in certain electrical elements, among others, as shown in Figure 6. Thirty-six sites were indicated with at least one inconsistency cited.

Figure 6. Wiring and electrical system found inappropriate in a retail fuel station.

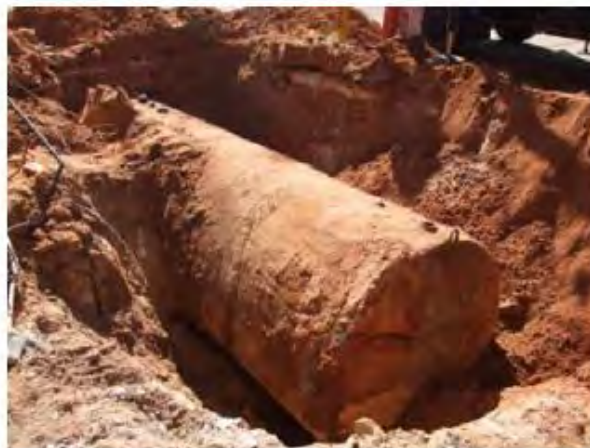
In the set of stations observed, three tanks for used oil storage were banned. They were built of brick with tile flooring. During the research carried out by UFRN and state prosecutors technicians, has been found a metallic underground tank, intended to fuel storage, which showed leak more than 100 liters of gas in less than 10 hours. The Figure 7 shows the state of corrosion of a tank buried for storing liquid fuel at a gas station in Natal (RN).

Figure 7. Corrosive state of a buried tank used for the storage of liquid fuel at a gas station in Natal (RN).

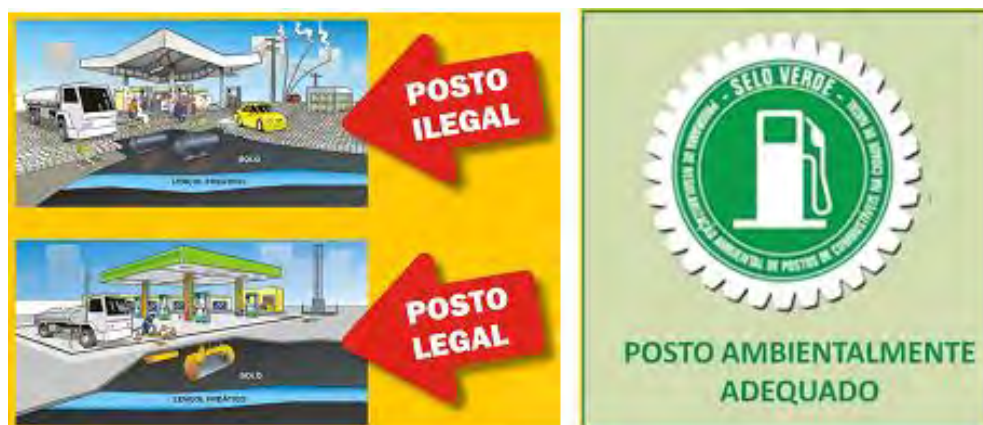
Green Seal is awarded to the post that has all the equipment required by ecological standards, as shown in Figure 8. To purchase Green Seal, the post should have an Operating License (LO) valid and pass the Compliance Test, when the prosecution experts check if all the facilities are in accordance with the corresponding standards. Of the 110 posts of Natal, only 44 have been adequate and environmentally acquired the Green Seal, also shown in Figure 8, until the closing of this research.

Figure 8. The legal and illegal jobs and adhesive featuring an environmentally friendly gas.

For a station be able to receive the Green Seal is necessary that it meets certain requirements, among them: **the presence of checkvalve to prevent possible leaks; replacement of metal pipes for HDPE pipes; installation of containment units (sumps) units supplying, installation of Chamber Sidewalk Spill Containers; use of jacketed tanks with interstitial; adequacy of concrete floor and installation of channels; installation of separating oil and water box; installation of discharge assembly sealed with seal in the nozzle; installation of anti-overflow valve; adequacy or installation of vapor recovery valve; adequacy of electrical installations in hazardous areas; installation or adequacy of electrical discharges protection systems (lightning rod); installation or adequacy of systems against collision of breathers with terminals containing vapors.**

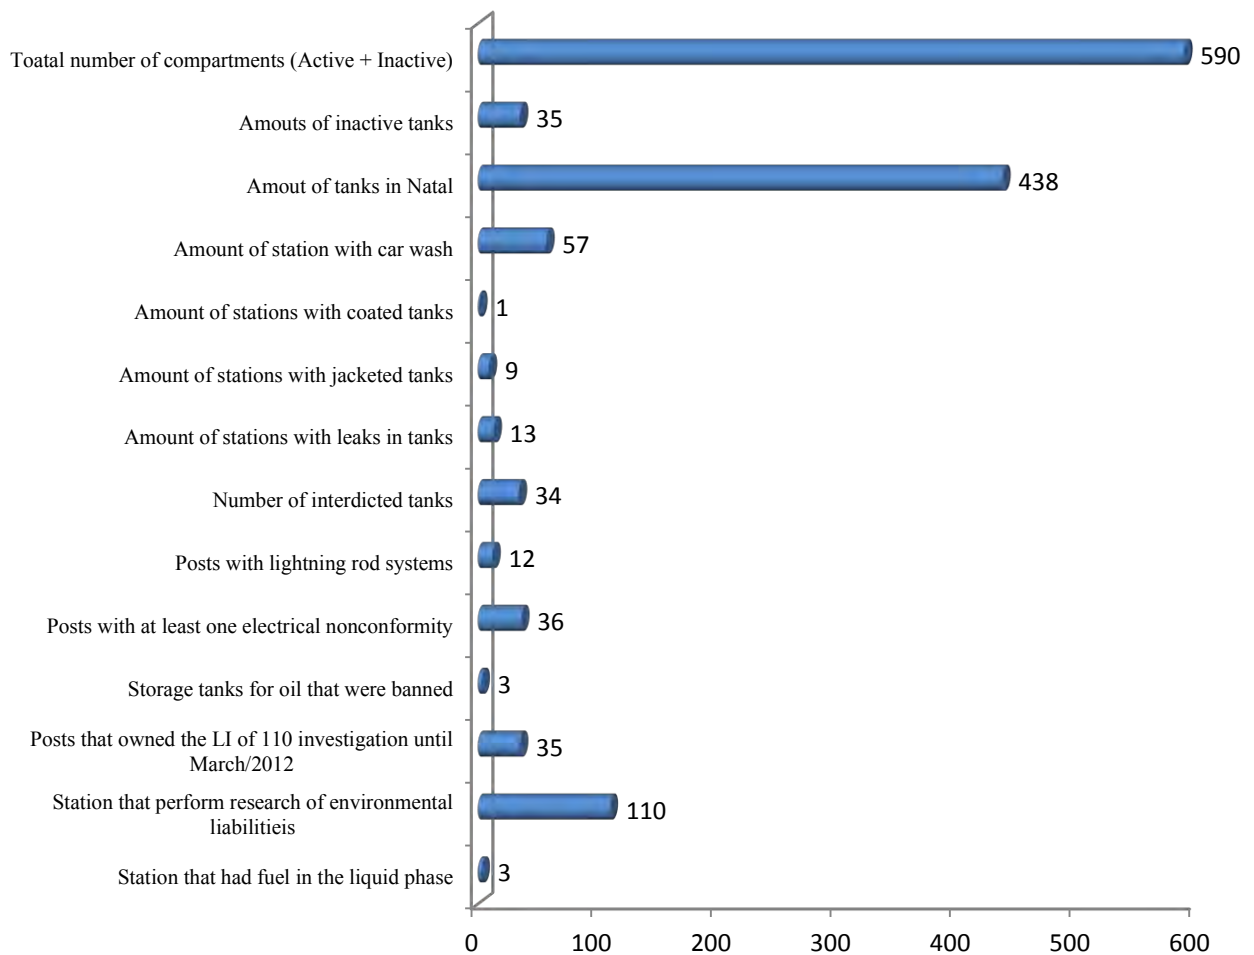
Figures 9, 10 and 11 show the situation of unfilled liquid fuel resale at Natal city regarding the parameters analyzed during entire inspection phase.

Figure 9. Situation of liquid fuels gas storage in the city of Natal.
