FATIGUE BEHAVIOR, ABRASIVE WEAR AND CORROSION RESISTANCE OF AISI 4340 STEEL COATED WITH HARD CHROME ELECTROPLATING AND WC-10Co-4Cr AND CrC-25NiCr HVOF THERMAL SPRAY COATINGS

Abstract. The objective of this research is to compare the influence of the WC-10Co-4Cr and CrC-25NiCr coatings applied by high velocity oxy fuel (HVOF) process and hard-chromium electroplating on the fatigue strength of AISI 4340 steel with and without shot peening, abrasive wear and corrosion resistance. S-N curves were obtained in axial fatigue tests for the base material, chromium plated, WC-10Co-4Cr and CrC-25NiCr coated specimens. The results showed that the coatings were damaging to the AISI 4340 steel behavior when submitted to fatigue testing, with the WC-10Co-4Cr and CrC-25NiCr coatings showing the better performance. Regarding corrosion and abrasive wear tests, a good corrosion and abrasive wear resistance was obtained for the WC-10Co-4Cr and CrC-25NiCr coatings. Scanning electron microscopy (SEM) was used to observe crack origin sites and the existence (or not) of a uniform coverage of nearly all substrates.

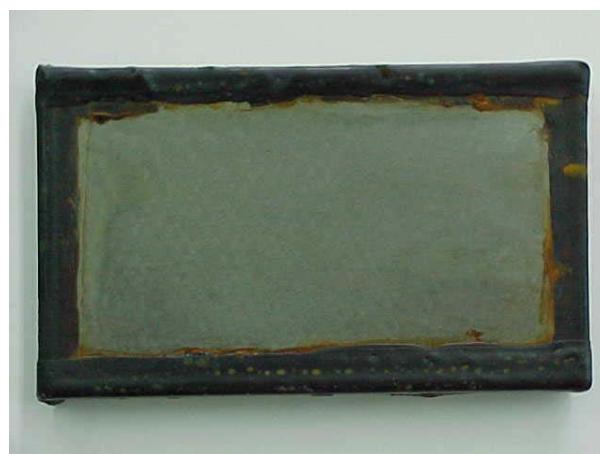
Figure 7. Salt spray test results, 100 μm thick after 750 hours.

The results of the corrosion testing, performed in a qualitative way, were obtained by visual inspection of the specimen surface after exposure to salt spray test. The salt spray test results for samples with WC-10Co-4Cr coating by HVOF spray process, 100 μm thick; WC-10Co-4Cr coating by HVOF process, 150 μm thick, WC-10Co-4Cr coating by HVOF process, 200 μm thick, CrC-25NiCr coating by HVOF process, 150 μm thick, and CrC-25NiCr coating by HVOF process, 200 μm thick, are indicate in Fig. (7), (8), (9), (10) and (11), respectively. No visual corrosion was observed on samples with WC-10Co-4Cr, 100 μm thick; 150 μm thick and 200 μm thick, and CrC-25NiCr, 150 μm thick and 200 μm thick, after 750 hours testing. This results showed to be in agreement with the article of Bodger et al, (1997), and Guilemany et al (1998), that affirms that the HVOF technique increases the corrosion resistance of a given coating-substrate system, because of the low porosity of the coating. The WC-10Co-4Cr and CrC-25NiCr coatings exhibit a very low porosity level; the metal matrix composition of the coating is another factor that plays an important role during corrosion, and it is known that the chrome has excellent resistance to corrosion.

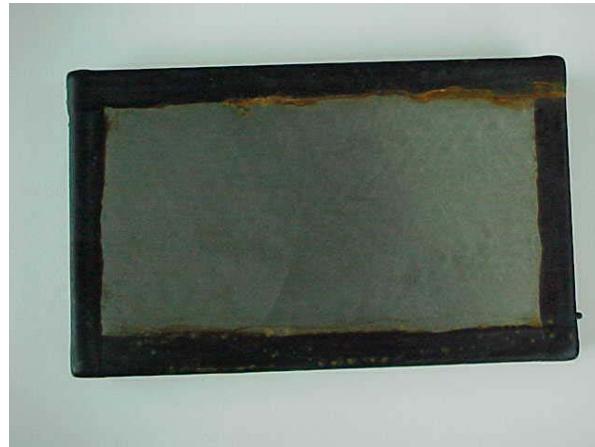
Figure 8. Salt spray test results, 150 μm thick after 750 hours.

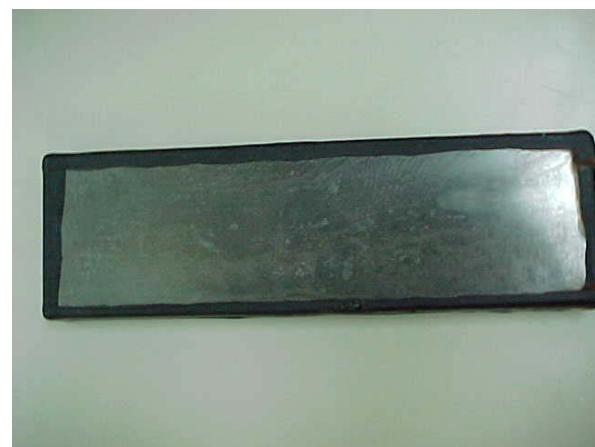
Figure 9. Salt spray test results, 200 μm thick after 750 hours.

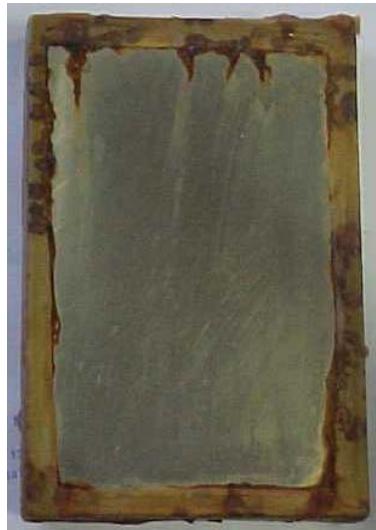
Figure 10. Salt spray test results, 150 μm thick after 750 hours.

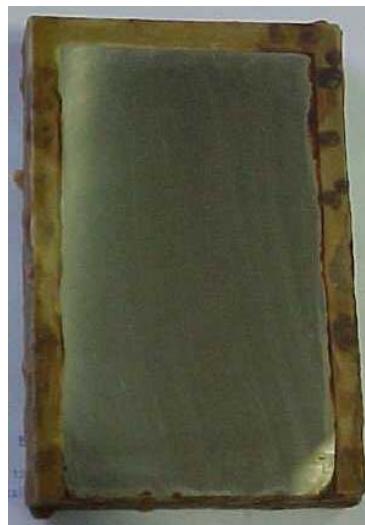
Figure 11. Salt spray test results, 200 μm thick after 750 hours.
