CAVITATION EROSION IN METALLIC MATERIALS USING THE ROTATING DISK DEVICE

Gil Bazanini

José Divo Bressan

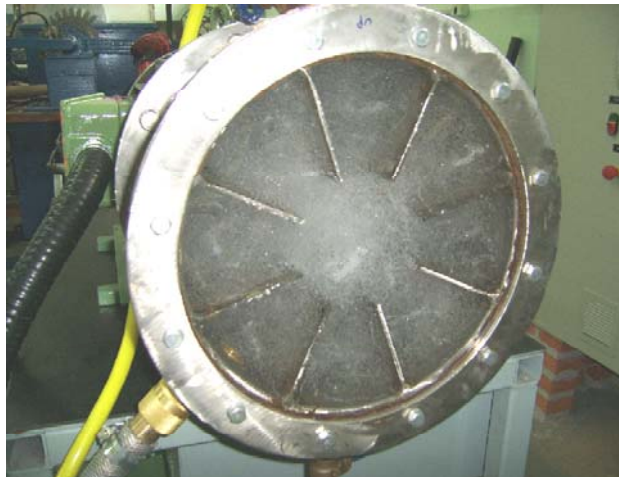
It was used a compact version of the rotating disk device with horizontal axis, now with a more compact chamber and a smaller disk (diameter of 250 mm). By employing an “intermediary casing”, commonly used to connect rotor pumps to electric motors, it was possible to avoid the use of bearing and the coupling, resulting in a shorter shaft. It has also the function to prevent water leakage by providing a sealing ring between itself and the chamber. That is, the chamber now replaces the pump. This reduces loss transmissions as well as alignment problems. A glass cover is mounted on the chamber to visualize the flow and the bubble formation inside it. Vibration absorbers were also used at the equipment foundations and the disk with the test specimens was balanced before the tests were performed. Eight baffles equally spaced were welded in the chamber, at a distance of 18 mm from the rotating disk to minimize half-body rotation of the test fluid. Although the baffles are welded, the distance of 18 mm can be reduced by using another set of **mobile** baffles mounted over the welded ones. But, in these preliminary experiments, that distance was kept constant at 18 mm. The test chamber can be seen in Fig. 1 below.

Figure 1. Cavitation test chamber

Connections for inlet and outlet of cooling water, temperature and pressure visualizations, water drain and air outlet are also provided. The baffles welded inside the chamber (seen in Fig. 1) also have the function to minimize half-body rotation of the test fluid and generate the desired cavitation formations at the inducer holes, thus, leading most of the bubbles to be confined in the region situated between the baffles and the disk, and to collapse over the disk surface.. A frequency inverter was used to control the motor and, thus, the disk rotation. For cooling purposes, a water reservoir was used to circulate the water inside the chamber. Inlet and outlet piping are provided by control valves and a filter to protect the pump from small particles resulting from the erosion process.

From the observed experimental results on cavitation erosion in metals carried out in the laboratory developed equipment, it can be affirmed that this more compact apparatus worked quite well, obtaining bubbles formation (as seen in Fig.1) and erosion by cavitation damage of the test specimens surfaces. The pits resulting from cavitation erosion can be seen in Figs. 3 to 6.

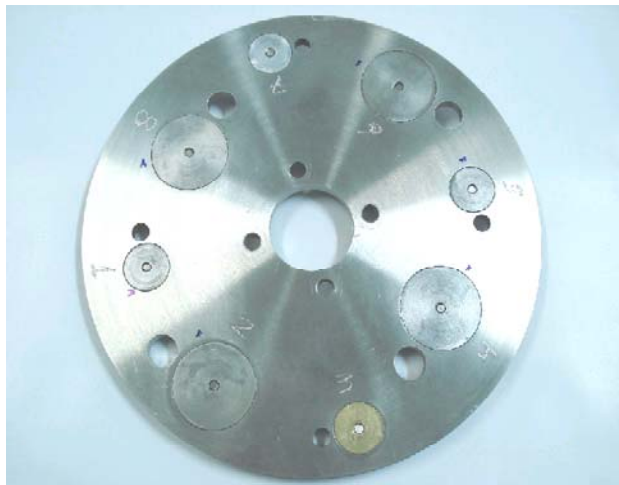
The cavitation test chamber shown in Fig.1, and the disk in Fig. 2 were fabricated in stainless steel which is more resistant to cavitation erosion. Details of the rotating disk, including the cavity inducer holes and some test specimens can be seen in Fig. 2 .

Figure 2. Rotating disk and the test specimens.
