ULTRAPRECISION LATHE QUALITY IMPROVEMENT THROUGH EFFECT ANALYSIS

Abstract. During the 90's, an ultraprecision lathe was assembled in the Precision Engineering Laboratory (LMP) at Federal University of Santa Catarina (UFSC), based on a design methodology to reconfigurable precision systems. This lathe was first designed to assure dimensional and surface quality for metallic conical mirrors to laser applications. All the quality requirements to produce these mirrors were accomplished, but some difficulties were found when larger pieces were needed, because the system has some limitations. In order to improve the machined parts quality produced by the ultraprecision lathe, an effect evaluation and analysis was conducted to identify all the main errors sources and permit actions to be done to eliminate or attenuate these errors sources. This analysis was based on vibration monitoring, where each machine system was tested and optimized to reduce the global vibration level to an acceptable level. All the procedures and results are shown, with a final comparison between machined parts before and after this evaluation and analysis.

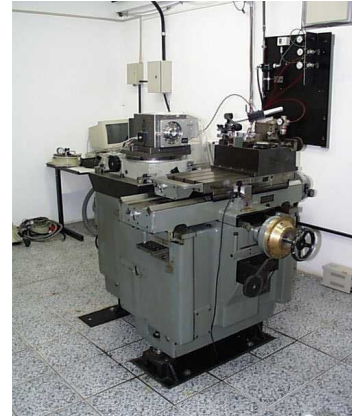
Figure 1. Original lathe conception and after retrofitting

The most critical component of the original machine is the 14 counts diameter spindle, that presents many drive and control difficulties. Therefore, a Kugler module based on an aerostatic spindle and a brushless CC servomotor substituted the original headstock. Moreover, the substitution of the X table drive was necessary, to permit velocity controlled movement during ultraprecision machining. A step motor was chosen because it is a simple and low cost alternative. In Z axle, responsible for providing depth of cut in the machining process, manual drive was enough to permit the work conduction. This axle is only for positioning the tool and it doesn't demand integrated movement with the remaining portion of the machine. The Figure 1 shows the machine after the first stage of retrofitting, with the main alteration, the substitution of the lathe spindle.

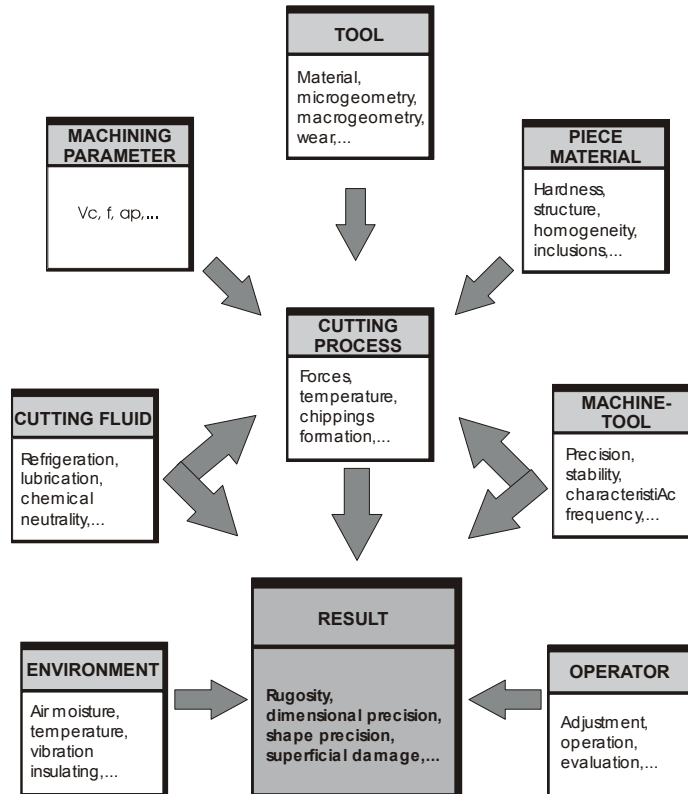
Figure 2. Factors that influence the quality of the ultraprecision machined parts (SCHROETER, 1997)

Starting from the list of limitations identified in the lathe, and also supported by the list of factors that influence in the machined parts quality in ultraprecision, presented by Schroeter (1997) and shown in figure 2, a list of parameters that must be monitored to optimize the machining process in the LMP lathe was generated:

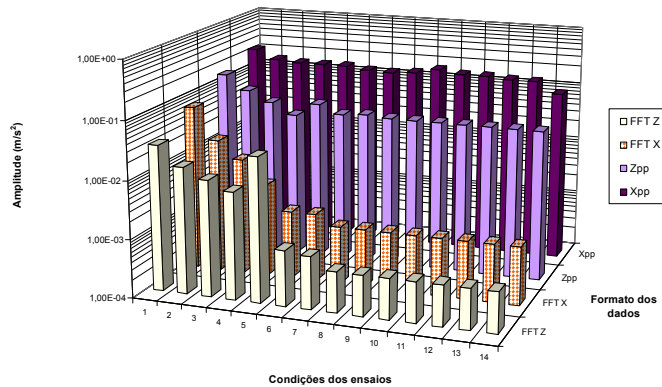
Test	Parameters	Fixture
1	8000rpm, 250mg unbalanced	Spindle
2	7000rpm, 250mg unbalanced	Spindle
3	6000rpm, 250mg unbalanced	Spindle
4	5000rpm, 250mg unbalanced	Spindle
5	4000rpm, 250mg unbalanced	Spindle
6	3000rpm, 250mg unbalanced	Spindle
7	2200rpm, 250mg unbalanced	Spindle
8	8000rpm, balanced	Spindle
9	7000rpm, balanced	Spindle
10	6000rpm, balanced	Spindle
11	5000rpm, balanced	Spindle
12	4000rpm, balanced	Spindle
13	3000rpm, balanced	Spindle
14	2200rpm, balanced	Spindle

Figure 3. Results from unbalancing experiments (GUIMARÃES, 2004a)

Many experiments were made using accelerometers and vibration analysis program. These experiments showed the contribution of each part of the machine in different operation conditions and, with a comparative method the worst factor of influence could be detected. After this analysis, a machine global vision was possible. The figure 3 shows the experiments results with vibration head unbalancing variations.

Figure 3 shows the importance of a good balancing in high precision machining. A small unbalancing amplitude value can become a big source of vibration, harming the machined piece quality. The figure 3 shows that when a good balancing was applied the vibration level decreased.

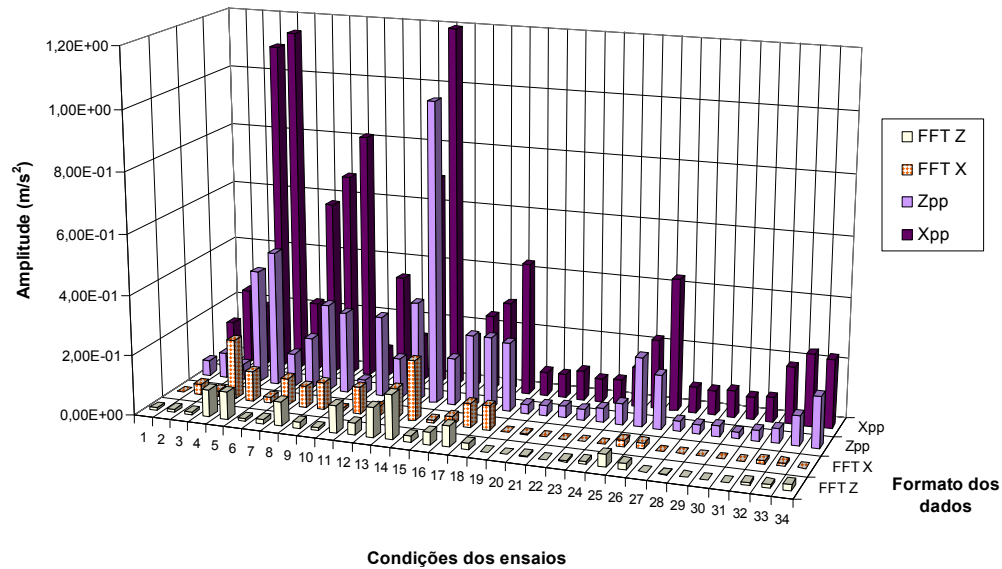
Figure 6. . Results from drive engine influence experiments (GUIMARÃES, 2004a)

Figure 6 shows two types of drive motors used to movement the main lathe guide. The step motor and the CC brushless motor were compared. As expected, CC brushless motor is better for this application.

Caution must be done to operate in optimized travel speed range. Even using the best motor solution, in some speed values the vibration levels are high enough to influence the machining quality.

The vibration response tests were done also with sensors fixture in tool place and in the spindle, which are the main positions to define final machining quality.

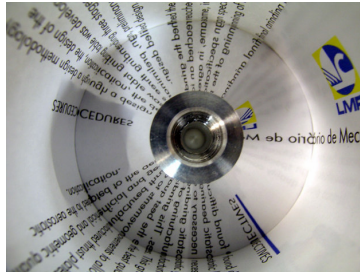
Figure 7. Machined part after the lathe optimization

Figure 7 shows the machining final results after the optimization of appraise aspects of lathe. The shown piece could not be machined with the adjusted quality using the lathe with the previous configuration. Quantitative values of form and surface quality could not be measured because there was no adequate equipment to do it. Conclusions must be done in a qualitative way, due to the absence of an adequate surface roughness measurer.

The machined part quality can be attested by its application in a measurement optical device. The part consists in an external conical mirror with a diameter of 80 mm and 40 mm of height. It has the function of reflecting a perimeter image to compose a planar vision of a cylinder area as a disk format. This reflection must have most possible fidelity, with no distortions. The mirror quality could be assured by the measurement device performance, with clear and precise images. This part dimension could not be machined in the previous lathe configuration.
