## EVALUATION OF HIDRAULIC AND THERMAL FIXATION SYSTEMS USING HARD METAL DRILLS IN A FIRE MOTOR HEAD

**Abstract.** *Companies concerned with cost reduction seek alternatives to be more competitive. Cutting tool fixation systems, as well as machine-tool dynamic stability and tool-holder stiffness constitute a group of great importance, which directly influences the quality of the machined piece, and also the associated costs. Currently, companies use the hydraulic fixation system for its better handling during pre-mounting, tool change and tool assembly repeatability to the hydraulic. This adjustment after pre-mounting allows a 0.003 mm runout tolerance, however with high cost, both in serial or non-serial machining processes. New technologies, such as thermal fixation, are used in order to obtain lower costs and achieve tolerances closer to those of the hydraulic fixation system. This work compares the hydraulic and thermal fixation systems, using hard metal drills in a motor head made of high pressure Al-Si alloy, evaluating product tolerances and tool wear. In this study, optical and scanning electron microscopy and with EDS analyzer were used to monitor tool wear, geometric dev

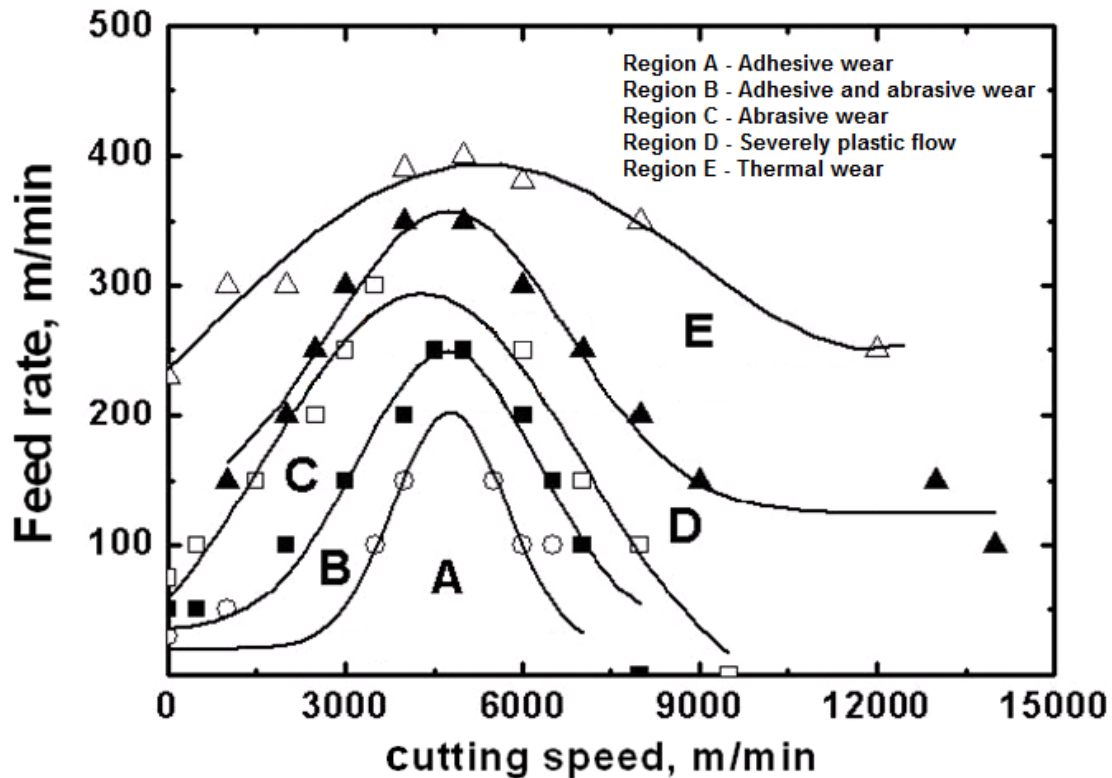
Figure 1. Al-Si alloys wear map for dry drilling process (Zhang *et al*, 2001).

The map of the mechanisms wear is a powerful tool on the choosing and selection of tribology parameters. Zhang *et al* (2001) defined four separate regions by outlines of 0.3 (log VB / cutting distance) intervals in dry drilling of Al-Si alloy pressure casting with high-speed steel. On this map, Fig. 1, there is a lesser wear cutting zone for the high-speed steel drill on Al-Si alloy drilling.

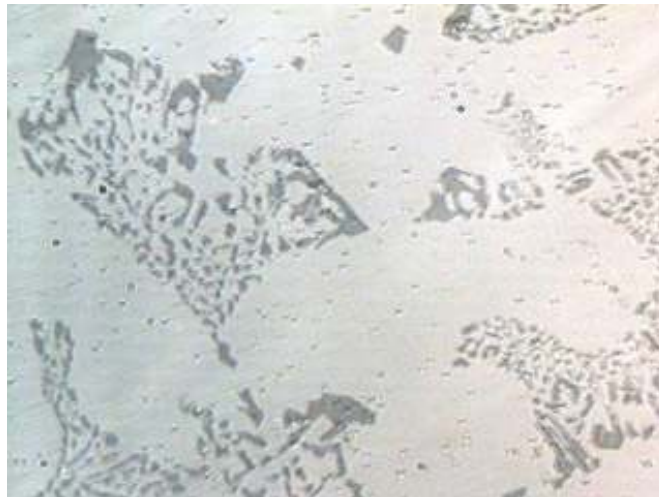
Figure 2. Microstructure of the Al-Si alloy, evidencing the light phase rich in aluminum and eutectic.

The microstructure has consisted in a rich Alfa phase in aluminum and eutectic, as shown in Fig.2. The intermediate eutectic phase is  $\text{Al}_5\text{Cu}_2\text{Mg}_2\text{Si}_6$  or  $\text{Al}_{15}(\text{FeMn})_3\text{Si}_2$  (Teer, D.G, 2005). The silicon content in the alloy means that, the alloy has primary particles which promote the tool wear due to abrasion, when compared to others aluminum alloys.

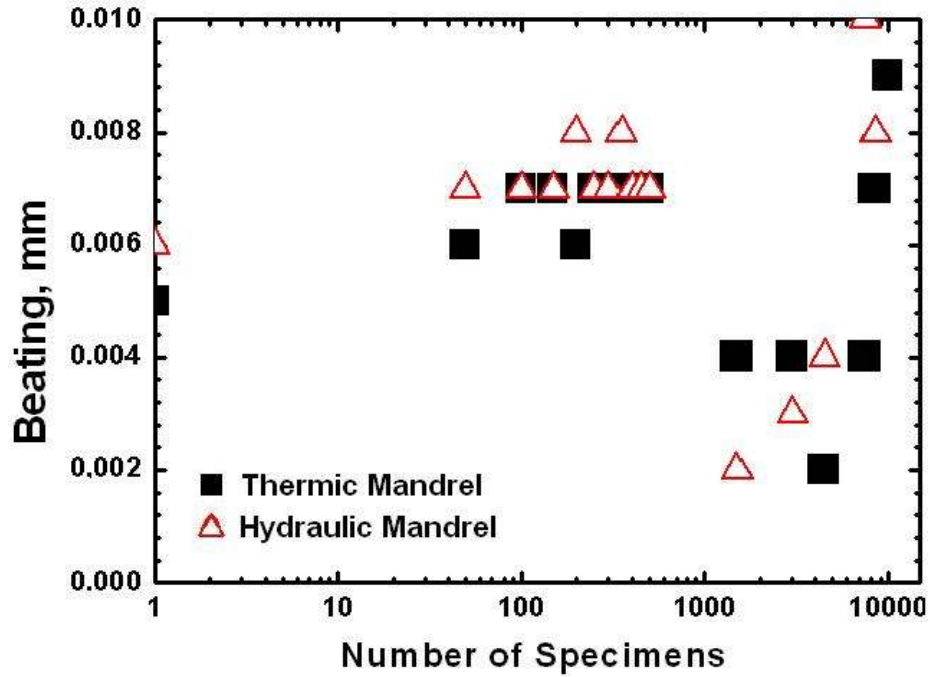
Figure 3. Evolution of the tool beating related to the number of machined parts until 11500.

The Figure 3 shows the evolution of the tools beating error fixed on the thermal systems and hydraulic after the drilling of the parts 1, 50, 100, 150, 200, 250, 300, 350, 400, 500, 1000, 1500, 2000, 3500, 5000, 6500, 8000, 11500.

It is verified that, the maximum beating of the thermal system was lesser than the hydraulic beating until the part 300 and after, hitched the value of 0.007 mm at the part 500. The error rising possibly occurred due to the tool replacement at the chuck seat, in reason of the group vibration. It could be observed that, the error evolution didn't experiment consistent growth with the number of machined parts, with the exception of the parts 3500 to 11500. The Fig. 4 shows the wear aspect verified on the drill flank in optical microscope for thermal and hydraulic systems on faces 1 and 2.

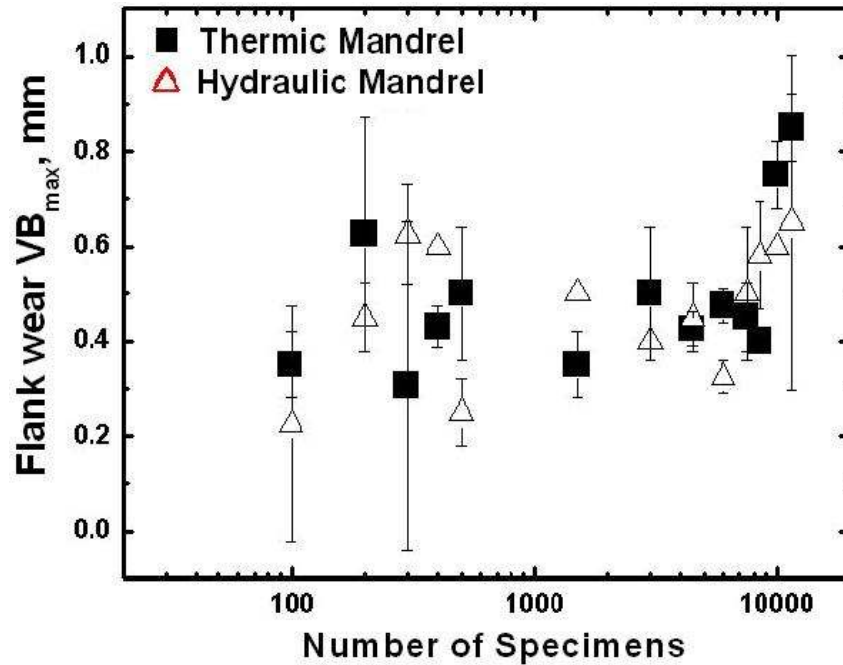
Figure 5. Analyses of the  $VB_{max}$  wear at the fixed drill of the cutting edge on hydraulic and thermal systems.

On Figure 5, the wear evolution is shown measured by the  $VB_{max}$  in function of the number of machined parts until 11500.

The wear value, for both systems, is practically constant between the parts 500 to 8500. From the part 8500 on, the rise of  $VB_{max}$  was verified for the hydraulic system. The aspect of  $VB_{max}$  curve in function of the number of parts shows similarity with Quick *et al* (2003) purpose, where three stages of the helical drill wear process exists, which are progressive lost, constant wear rate and catastrophic failure.

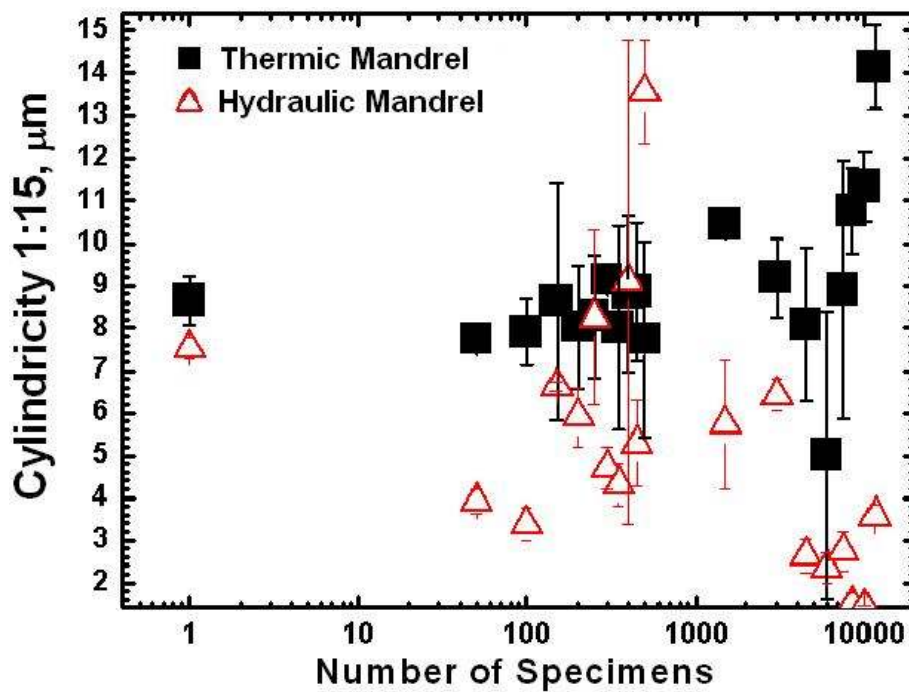
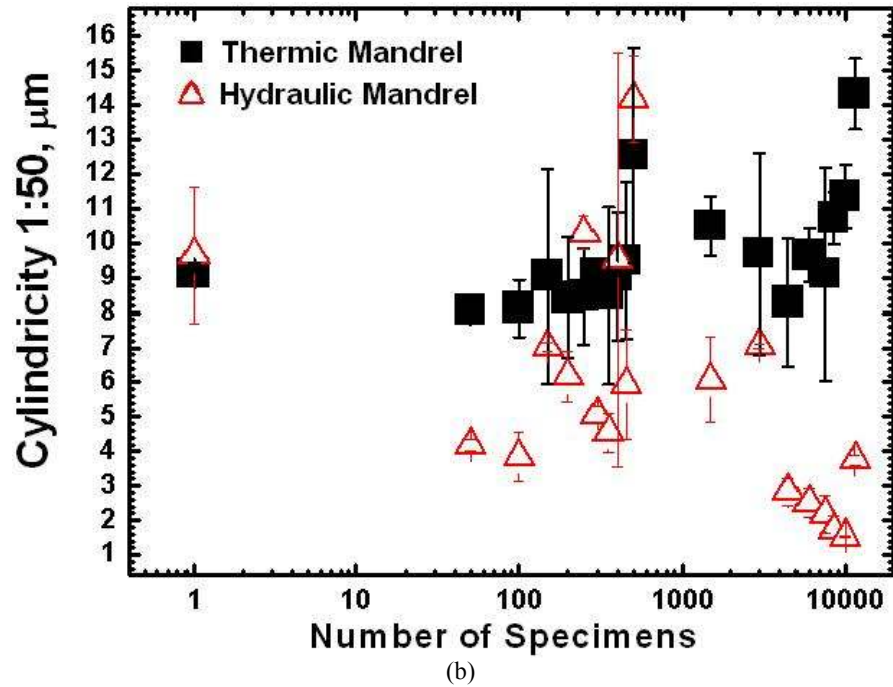
(b)  
Figure 6. Analyses of the holes cilindricity generated by the fixed drill on the thermal and hydraulic systems evaluated in the Gaussian filter 1:15(a) 1:50(b).

On Fig. 6 the cilindricity evolution is shown with two Gaussian filters, respectively 1:15 and 1:50 in function of the number of machined parts. The Gaussian filter 1:15 emphasizes the results dispersion in a bigger intensity when compared with the filter 1:50, though was verified that the filter 1:50 has presented itself in conditions of revealing the difference in cilindricity between both fixation systems, thermal and hydraulic.

It also has been observed that, the thermal chuck presented medium values and standard deviation lower than hydraulic values. After the thousandth machined part, this discrepancy became more marked, what it hasn't been justified by the beating.

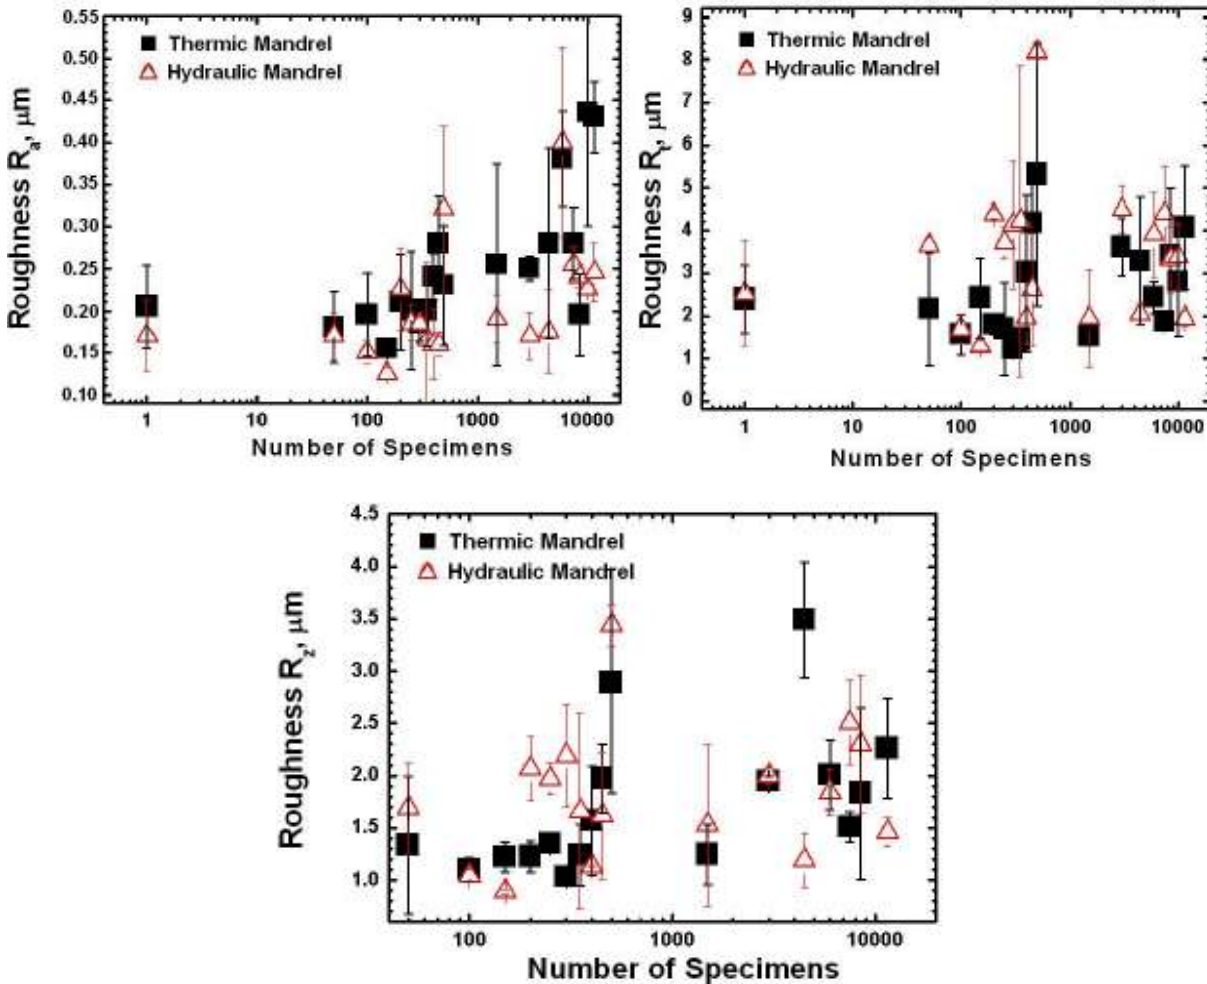
Figure 8. Surface analyses  $R_a$ ,  $R_t$ ,  $R_z$  of the generated holes by the fixed drill on thermal and hydraulic systems.

The average and dispersion of the analyzed surfaces through the parameters  $R_a$ ,  $R_t$  and  $R_z$  for the thermal and hydraulic systems, didn't show marked variations until the part 250 with the average, respectively, of 0.3, 4 and 2  $\mu\text{m}$ . The surface parameter  $R_a$ , evidenced that, during the process, the averages and standard deviations of the thermal system became emphatic for machined parts superior then 1500. The performance of these systems was compared through a result distribution to a 95% confidence level. Although the average test has confirmed that the thermal system is more efficient, a conclusion of the material influence adhered on surface parameters, wasn't possible.

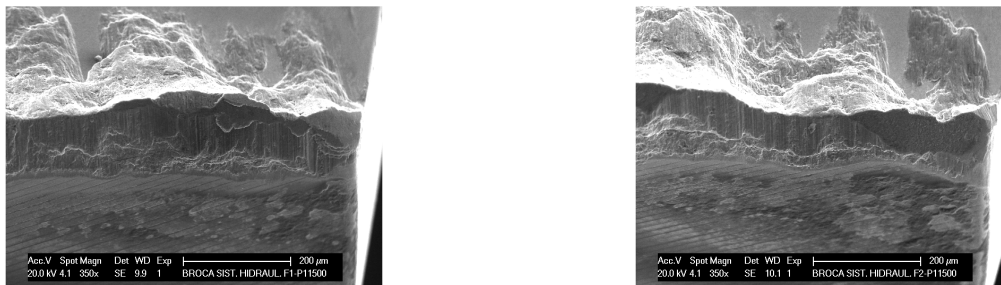
Figure 9. Presence of material parts on drill faces 1 and 2 of the hydraulic system part 11500

The Fig. 9 shows the aspect of the surface of drill faces 1 and 2 on the scanning electronic microscope on different observation angles and increases of 160 and 250X for hydraulic system.

It is observed the presence of peaks and valleys throughout the thickness of wear region and the difference of this thickness value throughout the depth. The chemical analyses made on scanning electron microscope of the material present on the drill faces 1 and 2 of the fixation system after the part 500 showed the presence of Al and Si, as shown in Fig. 10.

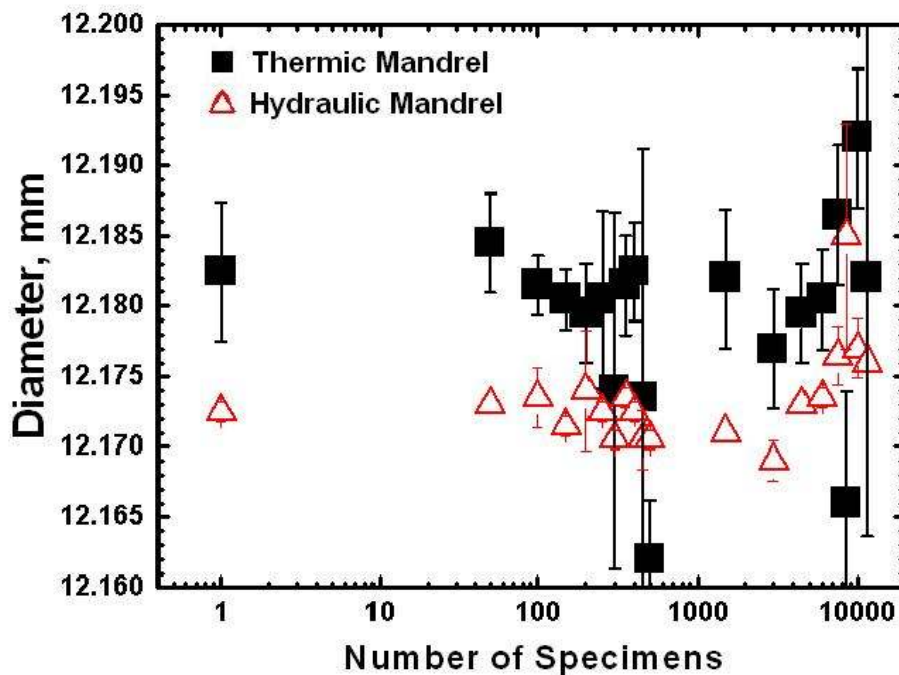
Figure 14. Reference bushing fixation hole diameter in function of number of parts.

It could be confirmed that the chemical analysis is representative of the drill material, it means, Co-WC. On Fig. 14 is shown the variation of the averages and standard deviation of the diameter generated by the fixed drills on hydraulic and thermal systems. It is observed that, the holes average is in agreement with the project specification 12.20 (+0.0 -0.1) mm. So, it could be possible to verify that, the beating error hasn't interfered on the dimensions of the hole. The heating signs with grooves on the cutting edge increased with spalling and craterization on the cutting edge, changing the diameter of the hole near to the specified superior limit (12.20 mm), what has contributed to delimit the drill life.
