## **EVALUATION OF THE PROJECT BY THE ENGINE OF MAINTAINABILITY FOCUS: THE CASE OF FLUSH TOILET**

***Keywords:** maintainability, mechanical project, flush toilet*

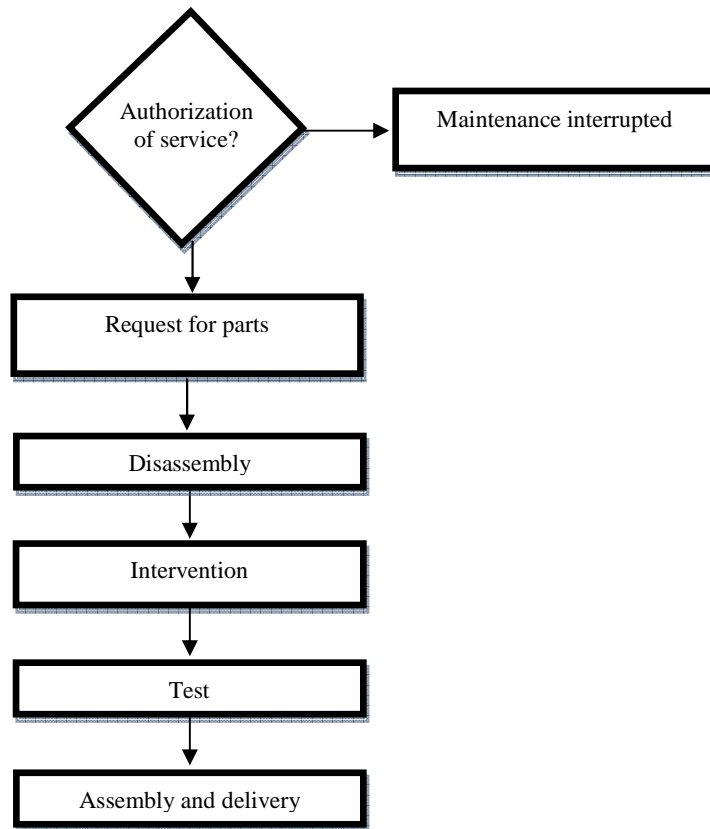
Figure 1: Flowchart of maintenance

The maintenance of sanitary discharges, and the maintenance of the vast majority of machines (read corrective maintenance), the process can be modeled with a flow chart that includes: service request, diagnosis of the problem, budget, authorization of service, application of parts, disassembly, intervention, test, assembly and delivery.

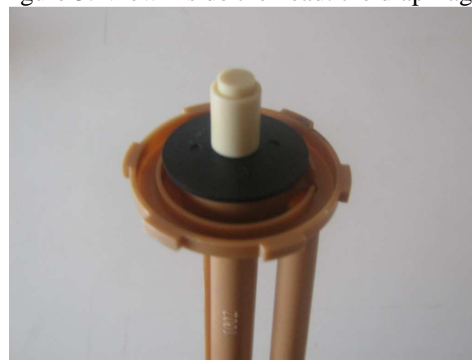
Figure 3: View inside the head: the diaphragm

The diaphragm is the element that controls the entry and exit of water in the housing coupled through the tower entrance. He is inside the head and is composed of a drive pin and a rubber. What happens is that due to the force that water rises through the tower of entry than the low purity of the water (highly chlorinated water and debris), the rubber diaphragm has a premature wear and function of control input / output of water is compromised. This is a common problem, but low criticality, since the repair is easy and cheap.

The diaphragm is located at the top of the tower of entry, especially in the head. He is the element that controls the entry and exit of water in the box attached. The wear of the rubber diaphragm, and was reviewed previously is due to the force that promotes water on the diaphragm, in addition to the low quality of water that is chlorinated and has too many debris, which eventually causing premature wear of the rubber.

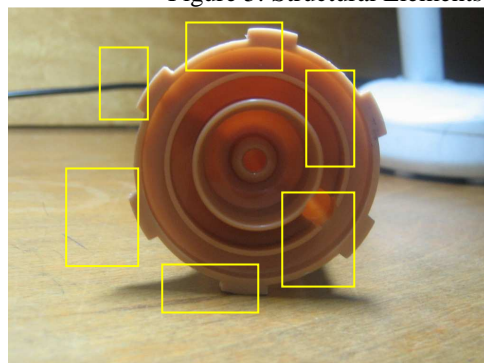
Figure 5: Structural Elements

The head is fixed to the tower of entry through the structural elements of lock. What happens is that because the force of water over years of use of the discharge, this element has broken, preventing the correct setting of the head in the entrance tower, which ends up compromising the input / output of water in the box attached. This is a problem of low frequency, but with high criticality. While the problem of wear of the rubber trade is only the diaphragm (keeping the tower of entry), this problem requires the exchange of the whole tower of entry (most expensive component of the discharge).

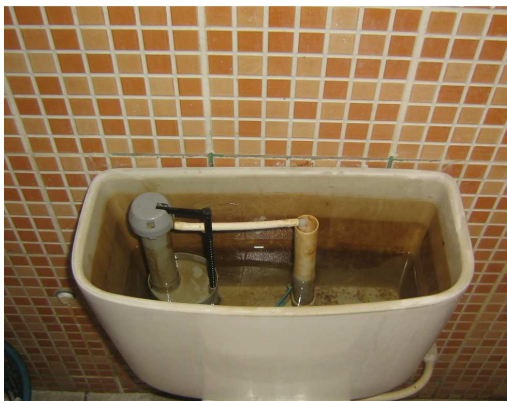
Figure 6: Discharge DECA

Accessibility, as already mentioned, is a priority in the maintenance of sanitary discharges. The structure of the discharge of Deca is the float attached to the tower of entry, with the float rod and lifting of the buoy, which ultimately save reasonable space in the box attached, allowing greater mobility of the maintainer in the box. The fact of having a more compact structure is a determining factor for access to components of the discharge. While you have access to the

head, the mark must be Celite Unscrew the stem of the float in the fall, as these elements are already engaged is not necessary, facilitating the maintenance and requires less time for intervention. For this reason Deca was given to a note rather than the Celite.

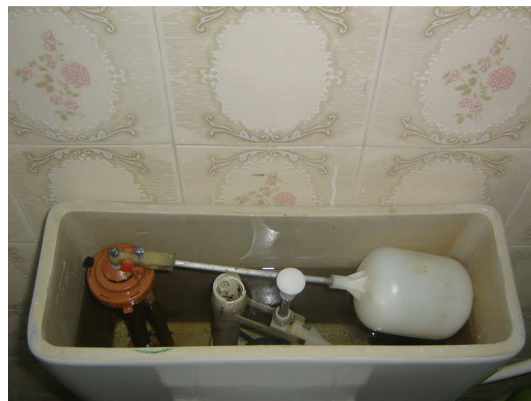
Figure 7: Discharge CELITE

If on the one hand, the fact of the discharge of the coupled Deca helps accessibility, the other has depreciated its ease of diagnosis. The fact of the discharge Celite have their isolated components facilitates the visual identification of where the problem is. For this reason has been given notice over Celite.

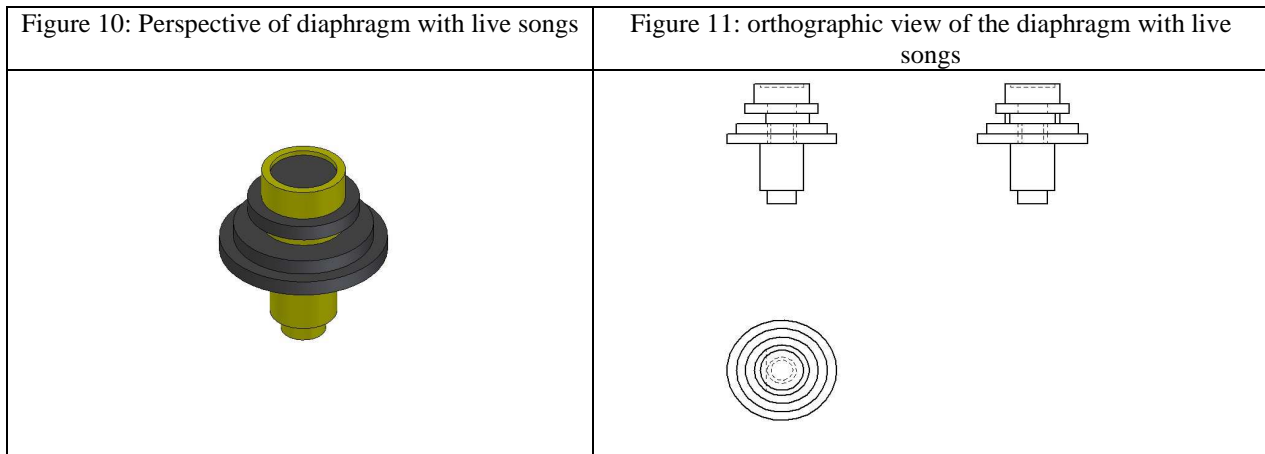
##### Current: Diaphragm with straight edges

The morphology of the rubber in this application has great influence on the premature wear. Cantos promote live known as the effect of stress concentration, which ultimately nuclear and cracks propagate, leading to wear / fracture (William Callisto, 2001). Therefore, this problem can be alleviated by changing the geometry of the rubber to replace the songs live for curved corners. Thus, resistance to fracture / wear would be greater, which extend the useful life of rubber.
