Technical Assistance to the Manufacture, Construction and Assembly of Osorio-Canoas Oil Pipeline Flow Pumps

Abstract. This paper reports the experiences acquired through the modifications and improvements implemented in the manufacture, construction and assembly of the oil flow centrifugal pumps of the Osorio-Canoas Oil Pipeline (OSCAN 22”), located in Rio Grande do Sul. The OSCAN 22” pumping capacity expansion was conceived aiming at meeting the Alberto Pasqualini Refinery (REFAP) processing increase project from 20,000 m³/day to 30,000 m³/day, besides changing the product profile from processed product to national high viscosity national oils. Due to this reason, a new pump park at the Almirante Soares Dutra Terminal (TEDUT) and a new intermediate pump station named Estação de Santo Antônio da Patrulha (ESPAT) have been erected. Thus, the oil received by a tanker and stored at TEDUT was now pumped to ESPAT and then to REFAP through a 97 km long and 22 inch diameter oil pipeline named OSCAN 22”. *In order to get such oil flow done, 03 new main pumps have been installed at TEDUT, one of them being a stand-by one, and other 03 pumps at ESPAT, one of them being also a stand-by one.

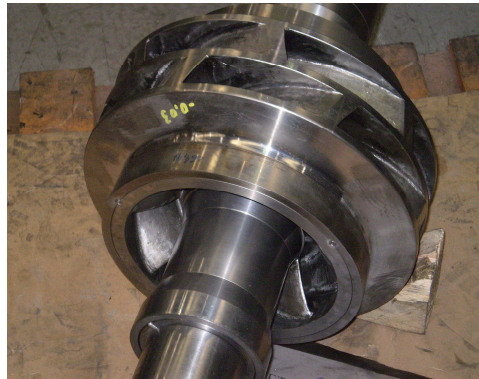
Figure 6: Impeller detail

The replacement of the impellers originally melted in sand mold for components melted in ceramic molds aimed at eliminating the maximum of dimensional deviations (of approximately 20%) in the impeller fluid exit areas. A greater dimensional uniformity in this region provides a better radial distribution of pressure and, consequently, a greater rotor hydraulic balance.
