THERMOGRAPHIC INSPECTION OF POLYMER MATRIX COMPOSITE LAMINATES SUBJECT TO IMPACT DAMAGE

Abstract. *Thermoset and thermoplastic polymer matrix composites were impacted with different energy levels. The damaged laminates were evaluated by active infrared thermography in transmission mode. Thermograms from the thermoplastic matrix laminate showed more clear and delineated damage indications as compared to the thermoset matrix composite images. The convective heating of the samples by hot airflow was more efficient than via radiation, using filament lamp. Longer heating times improved damage visualization, whereas the positioning of the specimen's impacted surface regarding the infrared camera and the heating source did not affect the thermograms quality. It has been concluded that infrared thermography is a simple, robust and trustworthy methodology for detecting impact damages as slight as 5 Joules in composite laminates devised to aeronautical application.*

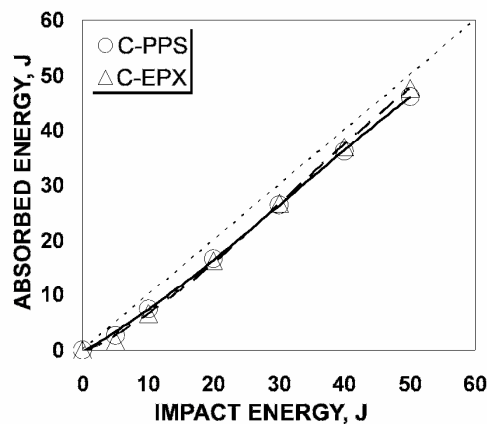
Figure 6. Absorbed energy by the PMC laminates as a function of impact energy.

In Figure 6 the impact testing results are plotted in terms of the absorbed energy versus the energy apportion during the mechanical shock. The experimentally determined data fully corroborate the aforementioned statement in regard to damage resistance of the laminates, since data points reveal that despite the considerable difference between the indentation width and depth in the front face of the C-EPX and C-PPS composites, the absorbed energy levels are very similar and close to the impact energy. This indicates that the fracture mechanisms operating internally and in the rear surface of the laminate, and therefore not visible to the observer, contribute considerably to the consumption of impact energy, and must necessarily be more accurately identified and characterized in order to infer the overall performance of structural composite laminates.
