REHABILITATION OF CORRODED STEEL PIPELINES WITH EPOXY REPAIR SYSTEMS

Abstract:

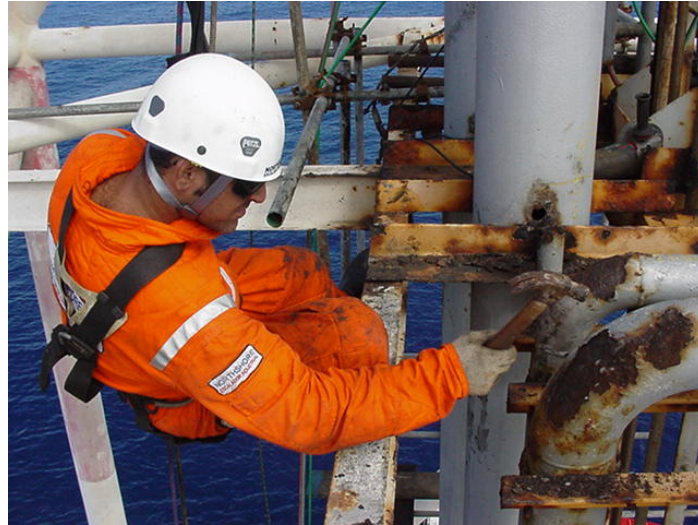
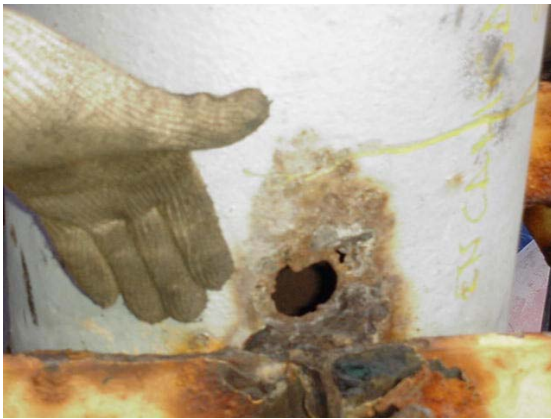
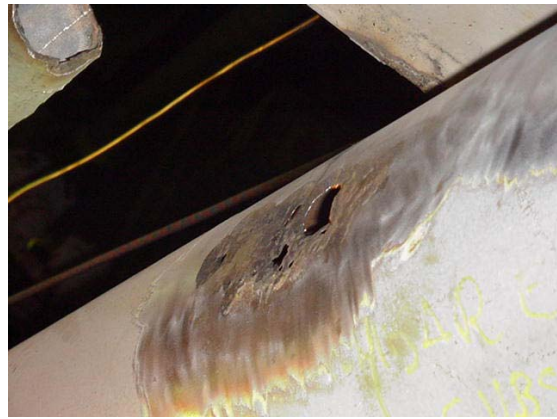
Figure 1 - Corrosion damage in produced water pipelines.

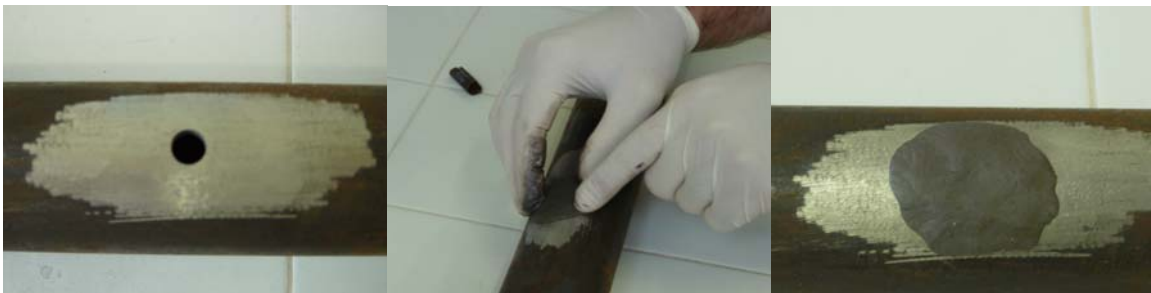
Figure 2 – Epoxy repair procedure

In order to obtain the previous properties, API steel pipe surface was roughened by power tool to achieve a white metal appearance and to remove some of the existing oxide layer (see figure). A final rinse with solvent was made to provide a free of oil, grease and dirt surface. After that the adhesive was mixed according to manufacture procedure and then the pipe was repaired.

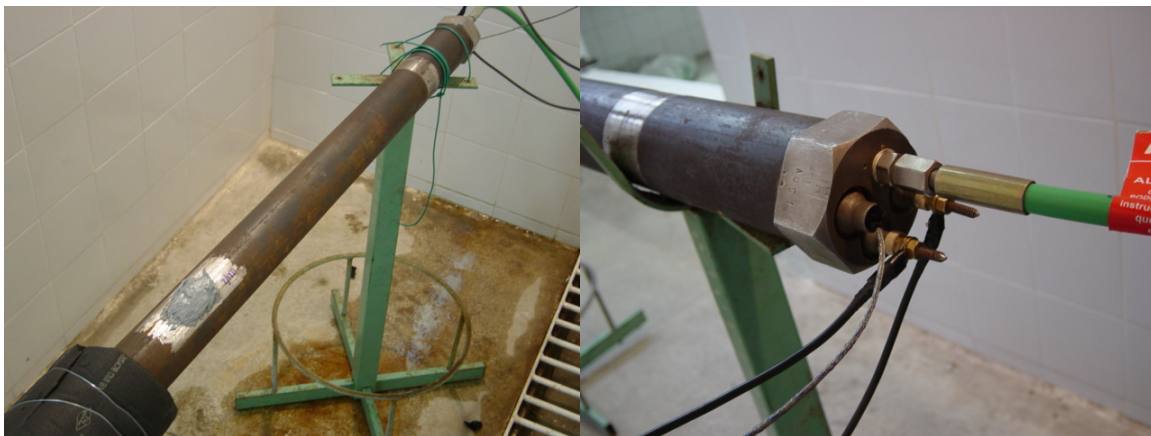
The repaired pipeline was then submitted to a hydrostatic test to evaluate its strength and effectiveness. The hydrostatic testing machine uses air pressure to generate hydraulic pressure. The test set-up apparatus is showed in figure 5.

Figure 5 – Test Set-Up Apparatus

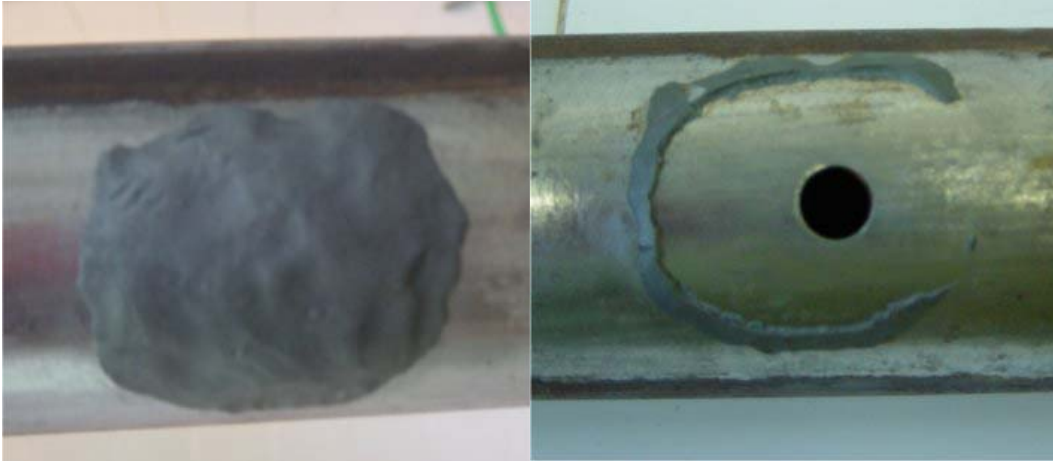
Figure 7 - Epoxy Repair System A

Figure displays the epoxy repair system A before and after the tests and figure shows the epoxy repair system B.

Repair system C supported very well both pressure and temperature. Repair system A can support the increase of temperature but did not support the increment of hydrostatic pressure with an average of $15,07 \text{ kg/cm}^2$. In repair system B the adhesive did not hold the increase of temperature failing just before reaching 50°C , except specimen 1 and also for low hydrostatic pressure $5,37 \text{ kg/cm}^2$ in average.

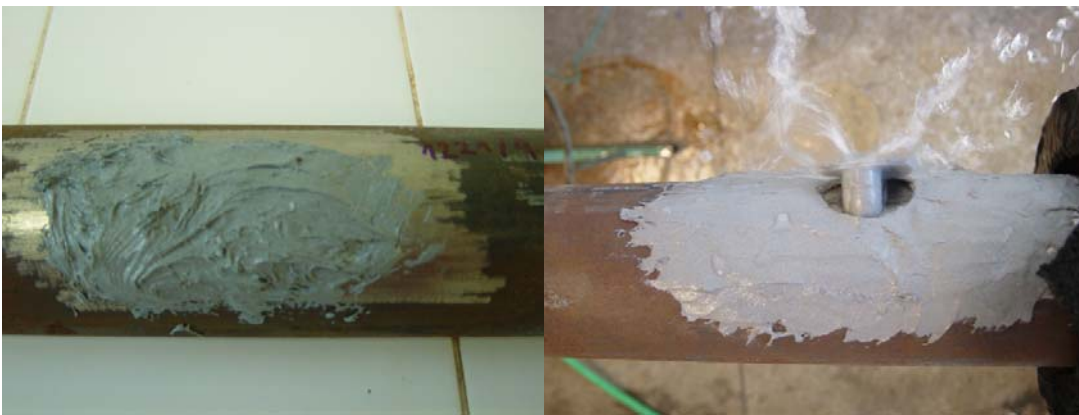
Figure 9 - Epoxy Repair System B

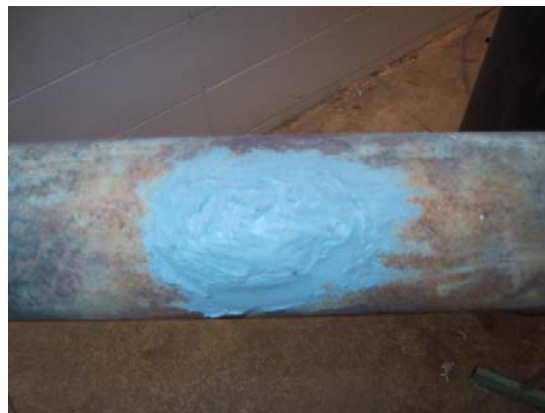
Figure 10 – Epoxy Repair system C

Epoxy Repair System C – Resisted 5 cycles of 1 hour at 80°C with internal pressure of 30 kg/cm²

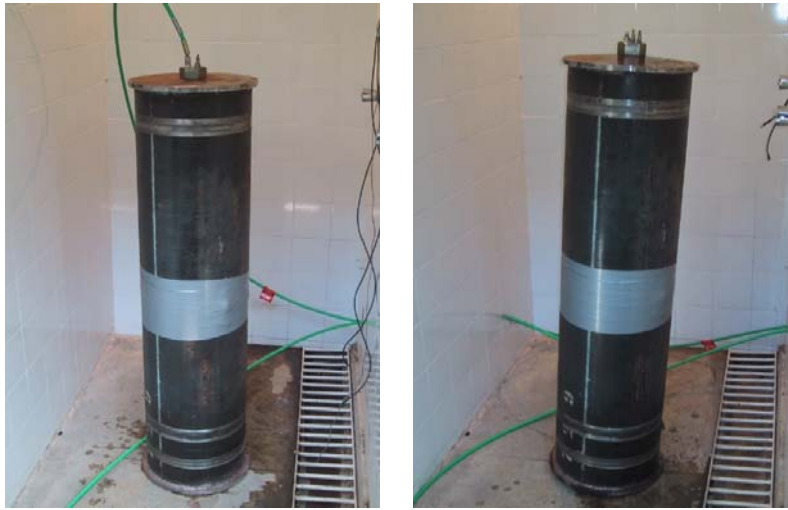
Figure 11 – 12" SCH 20 steel pipe with a repair of a hole of 10mm before and after testing

reliable and effective repairs, resisting pressure cycles of 1 hour with water at 30 kg/cm^2 and 80°C . More adequate procedures to apply the resin can assure stronger repairs. For instance, an hydrostatic test performed with water at 80°C in a 12" SCH 20 steel pipe with a repair of a hole of 10mm (system A) was interrupted when pressure reached 60 kg/cm^2 due to severe plastic deformation of the caps (figures 11 and 12). A systematic procedure with additional tools (composite sleeves, etc. [5-9] is in development at the LMTA-UFF (Laboratório de Mecânica Teórica e Aplicada - Universidade Federal Fluminense).

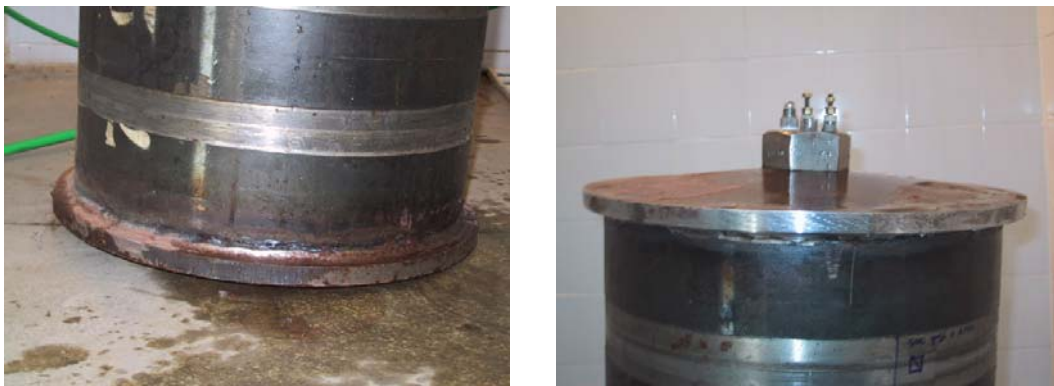
Figure 12 – Deformed caps after testing at 60 kg/cm^2 and 80°C .
