Rehabilitation of corroded steel pipelines with epoxy repair systems

Abstract

Keywords: polymer testing, epoxy repair, hydrostatic tests, offshore pipelines

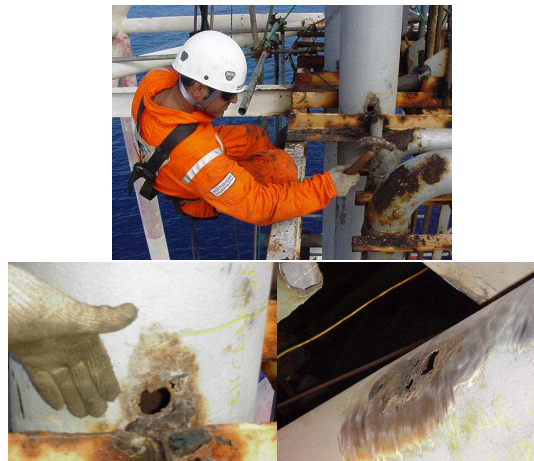
Figure 1: Corrosion damage in produced water pipelines.

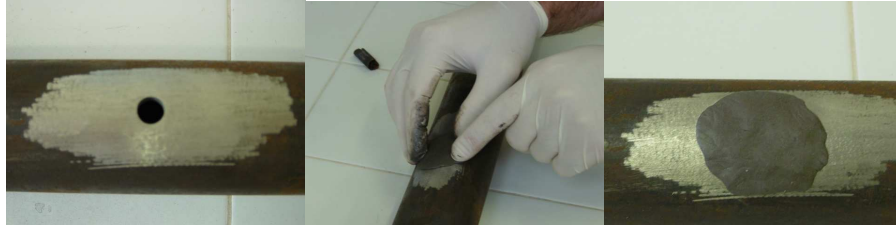
Figure 3: Epoxy repair procedure

In order to obtain the previous properties, API steel pipe surface was roughened by power tool to achieve a white metal appearance and to remove some of the existing oxide layer (see figure). A final rinse with solvent was made to provide a free of oil, grease and dirt surface. After that the adhesive was mixed according to manufacture procedure and then the pipe was repaired.

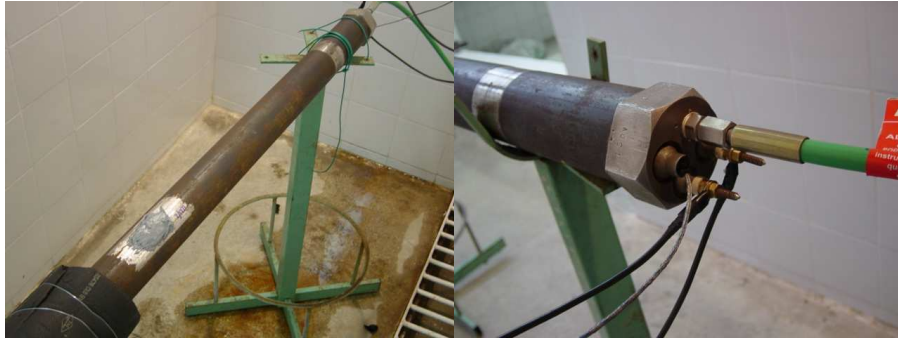
Figure 5: Test Set-Up Apparatus

The repaired pipeline was then submitted to a hydrostatic test to evaluate its strength and effectiveness. The hydrostatic testing machine uses air pressure to generate hydraulic pressure. The test set-up apparatus is showed in figure 5.

The complete experimental procedure is composed of two tests. In the first test, the the water is at room temperature and the pressure is increased up to 30 kg/cm^2 , pressure used in water disposal offshore platform pipeline, and left by an hour. After such procedure, if the repair don't fail brutally, the specimen is unloaded and inspected to check eventual small leaks or reinforcement rebounding.

In the second test the water temperature inside the specimen is increased until 80°C at atmospheric pressure. Such temperature level was chosen in order to simulate average offshore fluid condition. After temperature stabilization, the internal pressure is increased until 30 kg/cm^2 and maintained for

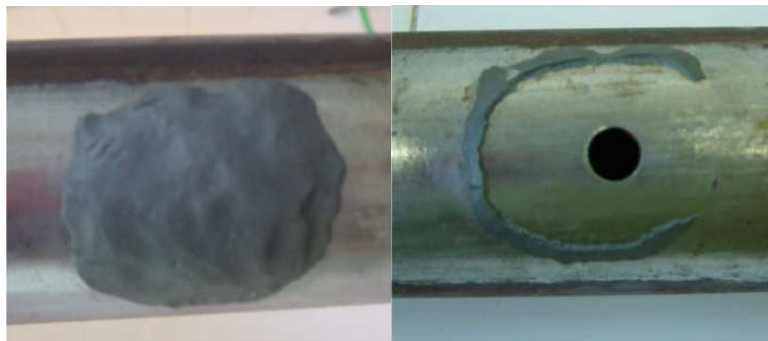
Figure 7: Epoxy Repair System A

Figure 7 displays the epoxy repair system A before and after the tests and figure 8 shows the epoxy repair system B.

Repair system C, displayed in figure 9, supported very well both pressure and temperature. Repair system A can support the increase of temperature but did not support the increment of hydrostatic pressure with an average of 15.07 kg/cm². In repair system B the adhesive did not hold the increase of temperature failing just before reaching 50 ° C, except specimen 1 and also for low hydrostatic pressure 5.37 kg/cm² in average.

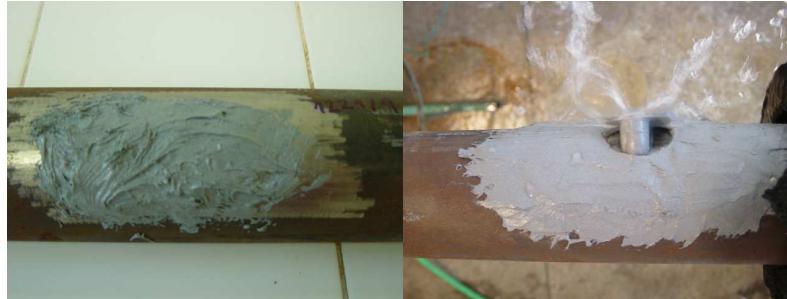
Figure 8: Epoxy Repair System B

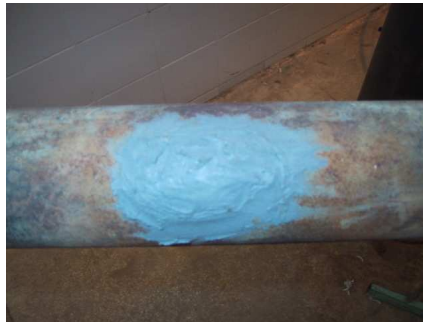
Figure 9: Epoxy Repair system C

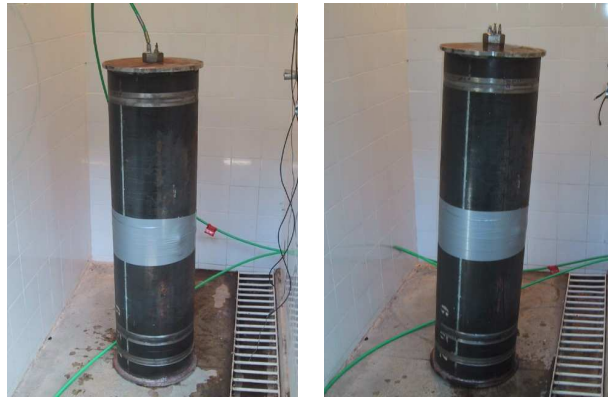
Figure 10: 12" SCH 20 steel pipe with a repair of a hole of 10mm before and after testing

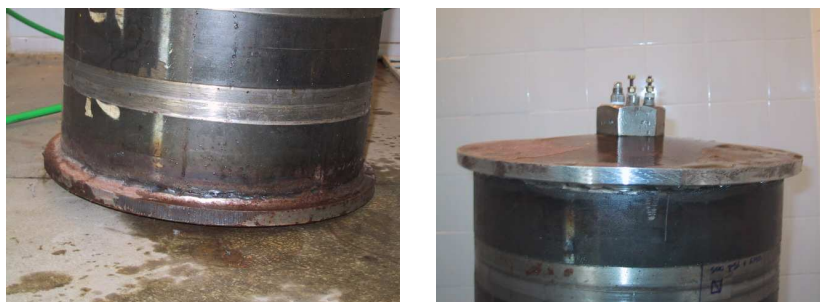
Figure 11: Deformed caps after testing at 60 kg/cm^2 and 80°C .
