## APPLICATION OF EPOXY REPAIR SYSTEMS IN CORRODED STEEL PIPELINES WITH THROUGH-THICKNESS DAMAGE

**Abstract.** *The rehabilitation of corroded pipelines with epoxy repair systems is now becoming a well accepted practice in the oil transportation industry. Laboratory hydrostatic burst tests and field practice of several years have shown that these repairs may be effective even for pipelines with trespassing corrosion defects. This research paper deals with laboratory tests carried out to validate epoxy repair systems applied in through-the-thickness corrosion defects in offshore produced water pipelines. The experimental tests aim to analyze the performance of different epoxy resins in real offshore platform repair situation. Although the operation pressure of produced water pipelines is not very high, the water temperature is between 60<sup>0</sup>C to 80<sup>0</sup>C, which can be a major shortcoming for the use of polymeric material as repair systems. Initial verification hydrostatic tests were performed to verify the repair efficiency, i.e. no leakage occurs. After this initial task temperature and pressure were applied to perform real produced water situation. Tests results sh

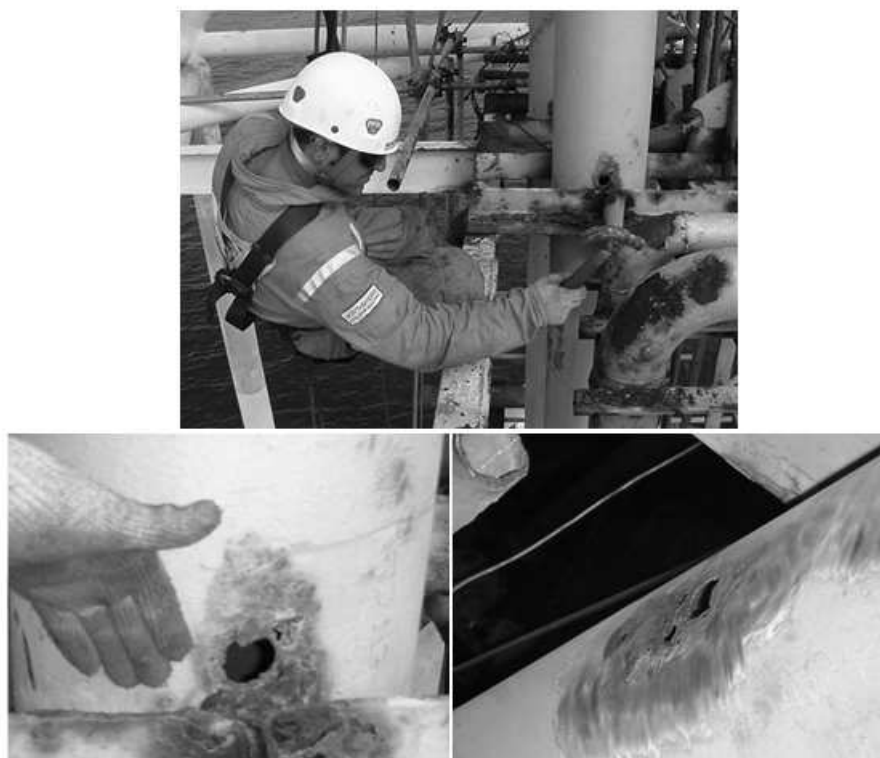
Figure 1. Corrosion damage in produced water pipelines

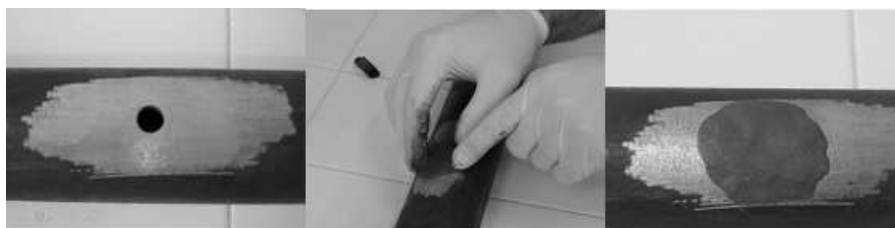
Figure 3. Epoxy repair procedure

Surface treatments often involve chemicals reactions, which produce surfaces modifications on adherends, or mechanical procedures, which improve adhesion by increasing mechanical interlocking of the adhesive to the adherend. By this way, the primary objective of a surface treatment is to increase the surface energy of the adherend as much as possible and/or improve the contact between the adhesive/adherend by increasing the contact area. Roughness or an increase in the surface area has been shown good results in improving adhesion. Subsequently, a relationship exists between good adhesion and bond durability. In order to obtain the previous properties, API steel pipe surface was roughened by power tool to achieve a white metal appearance and to remove some of the existing oxide layer (see figure 3). A final rinse with solvent was made to provide a free of oil, grease and dirt surface. After that the adhesive was mixed according to manufacture procedure and then the pipe was repaired.

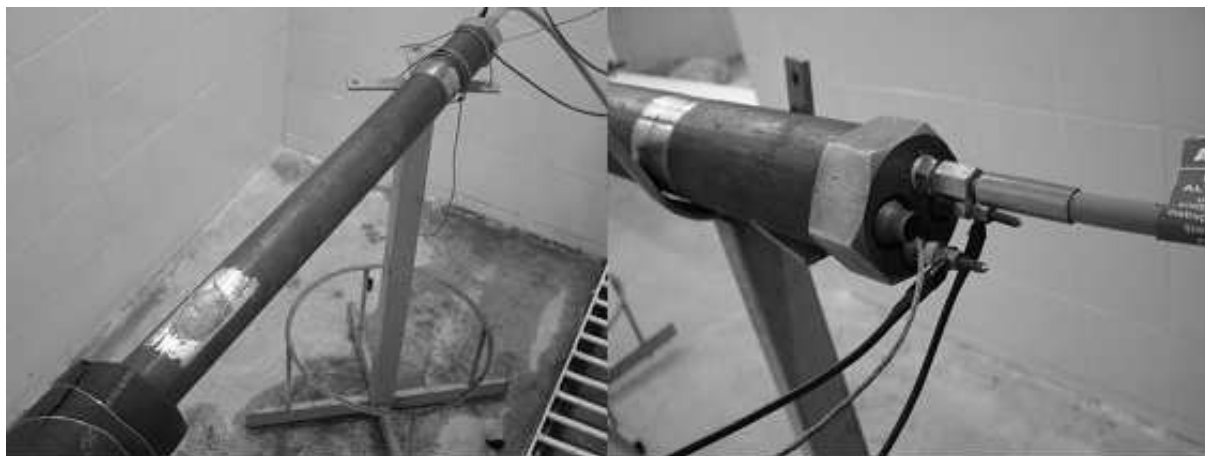
Figure 5. Test Set-Up Apparatus

For the leakage experiments, five samples were used for each resin. The combination of three resin and five specimens resulted in fifteen experiments. The repaired pipeline was then submitted to a hydrostatic test to evaluate its strength and effectiveness. The hydrostatic testing machine uses air pressure to generate hydraulic pressure. The test set-up apparatus is showed in figure 5.

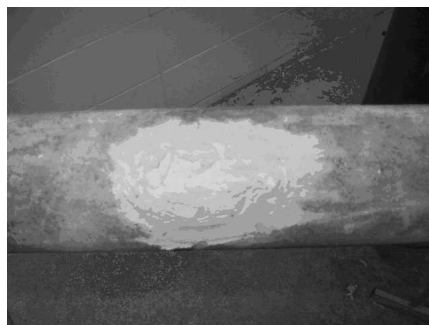
Figure 9. Epoxy Repair system C

Repair system C, displayed in figure 9, supported very well both pressure and temperature. Repair system A can support the increase of temperature but did not support the increment of hydrostatic pressure with an average of  $15.07 \text{ kg/cm}^2$ . In repair system B the adhesive did not hold the increase of temperature failing just before reaching  $50^\circ\text{C}$ , except specimen 1 and also for low hydrostatic pressure  $5.37 \text{ kg/cm}^2$  in average.

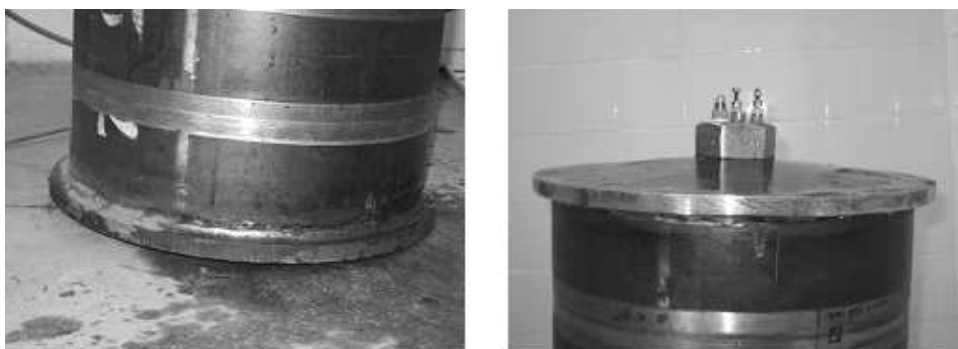
Figure 11. Deformed caps after testing at  $60 \text{ kg/cm}^2$  and  $80^\circ\text{C}$
