PRESENCE OF HOLE UNDER TENSILE TEST IN FGRP: FRACTURE CHARACTERISTICS AND ANISOTROPY

Abstract. *The damage mechanism of reinforced plastics may be present in many different ways, since it depends on many factors. Highlights may be given to the effect of stress concentration in the presence of geometric discontinuity in the sections of these structural elements, which in general always leads to certain characteristics of the fracture. In the case of plastics reinforced by glass fibers (FGRP) it is expected the same tendency, beyond the influence of reinforcement and its internal orientation in the layers (anisotropy). The aims of this research work is detailed study of the influence of the holes (longitudinal section) in the characteristic fracture in composite laminates based on glass fiber-E. All the study is conducted to tensile loading. Three different configurations of composite laminates were studied: two reinforced with E-glass fiber bidirectional textile fabric and the other only with short mats, also E-glass fiber. The orthophthalic polyester resin was used in impregnation of composite laminates. The results showed the influence of all parameters listed above in the final

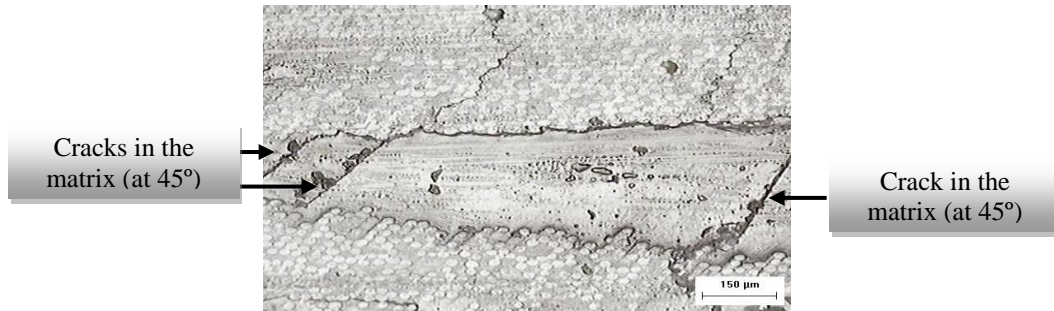
Figure 17. Matrix cracks in the reinforcement direction - **HFL ±45°** composite.

With respect to microscopic analysis, Fig. 17 shows that, in addition to reaching the reinforcement layer (intralaminar crack), initial cracking provoked matrix cracks that spread at approximately 45°, following fiber orientation.

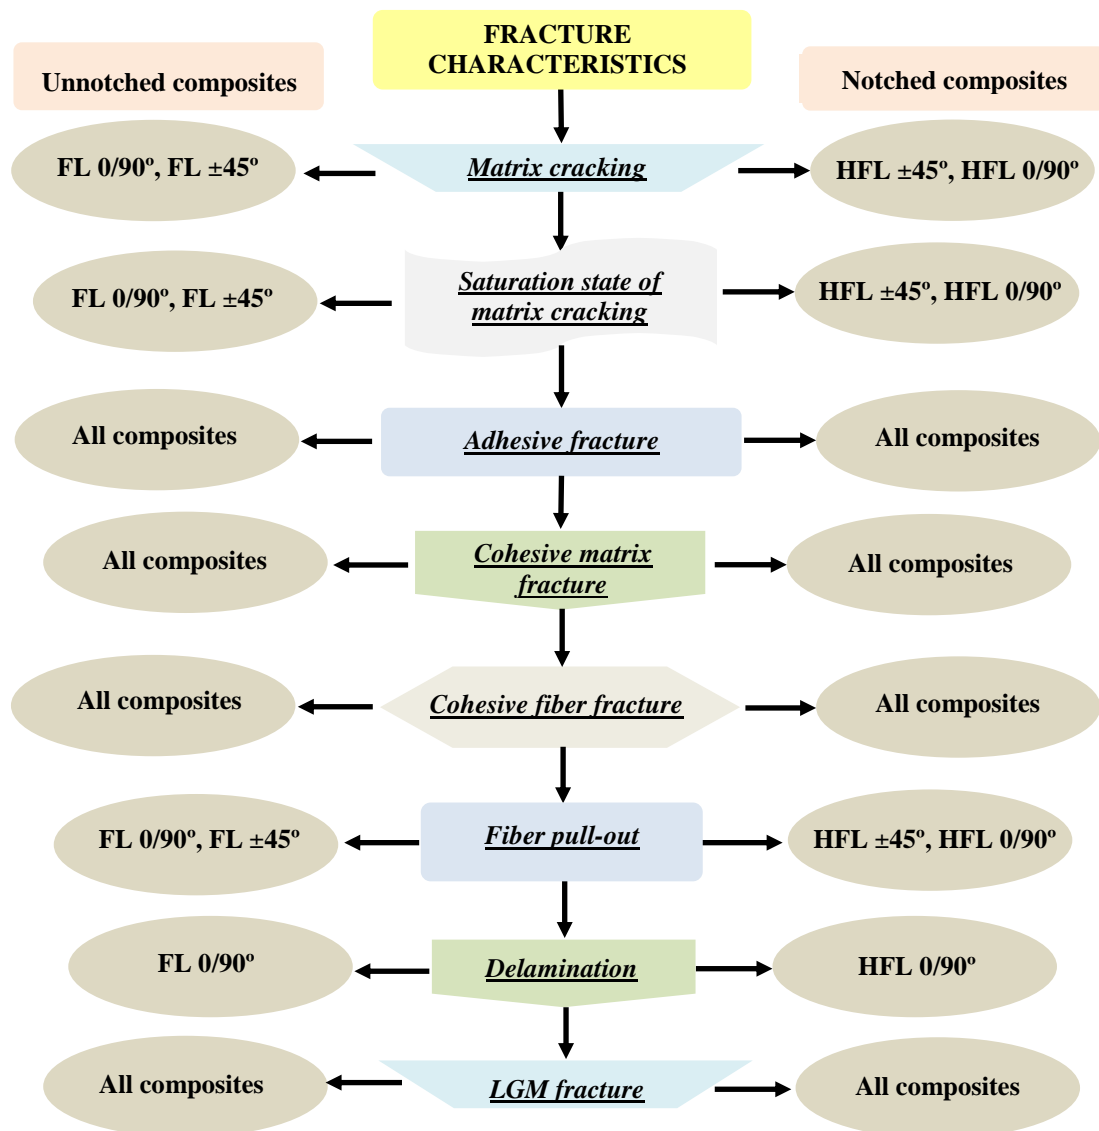
Figure 18. Comparison of damage mechanisms in the composites under study.

Figure 18 shows fracture characteristics observed in the composites under study, with the aim of determining the influence of the hole and/or anisotropy existing in the composite composites.

The presence of a center hole in the composites analyzed did not significantly change final fracture characteristics, but rather how it spread along the entire length of the test specimens. In the case of test specimens with geometric

discontinuity, fractures were concentrated in the region near the hole, where matrix cracks were spaced closer together due to the effect of stress concentration.

With respect to the configurations used, there were significant differences when all the composites were compared, given that fiber pull-out was only observed in composites with anisotropy. Delamination, another fracture characteristic, was observed only in the **FL 0/90°** composite.
