ADHESIVENESS STUDY OF POLIMERYC MATRIX COMPOSITE MATERIAL FOR PIPELINES REPAIR

Abstract. *The use of fiber reinforced polymer composites in the repair and rehabilitation of pipelines is a new concept that has the potential to improve the way we repair pipelines. The purpose of this paper is to discuss the adhesion of a glass fiber reinforced polymer matrix composite material used in pipeline repair on a steel substrate and some factors that could influence the metal/composite interface behavior, as the adhesive layer thickness, the cleaning of the surface and the adherent's surface treatment, as well as the study of the influence of humidity on the mechanical properties of the joints. The research was conducted in two stages. Firstly, selected surface treatments for the steel adherent were evaluated by single lap shear tests. For these tests, metal-composite adhesive joints were manufactured with different mechanical surface treatments with the dimensions recommended by the ASTM D 5868-01 standard, with different adhesive thickness. Specimens with the best surface treatments were subjected to hygrothermal ageing to evaluate the influence of the water on the mechanical properties o

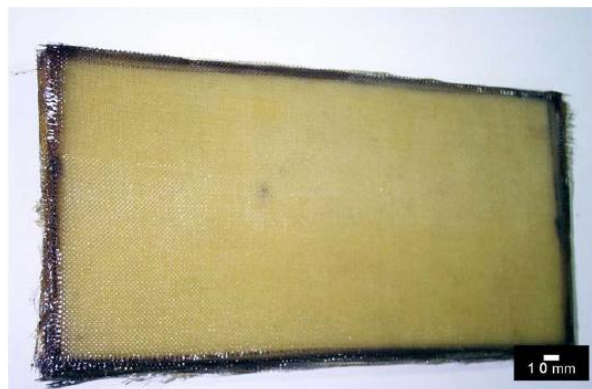
The composite used as one of the adherends was developed for pipelines repairs in the Laboratory of Composites Materials of UFRJ by Souza, 2002. The material was a fiberglass polymeric matrix reinforced composite, manufactured by the hand-lay-up method, in the proportion of 65% of fibers and 35% of matrix. As the matrix, it was used a thermosetting epoxy resin, called Diglicil Éter of Bisfenol A (DGEBA), belonging to the family of resins from Dow Química® with an flexible agent, DY104, produced by Ciba Geisy®. The reinforcement constituted of fiberglass (type E), in the fabric form with 120g/m², manufactured by Texiglass®. The composite presents about 3 mm of thickness constituted by 25 layers of the fiberglass fabric alternated with 27 layers of 5 grams each of resin. Four plates in the dimensions 150 x 500 mm were laminated for subsequent cut in the normalized adherends dimensions. The final aspect of the laminated plate can be seen in Fig.2, after cure for 24 hours at room temperature.

Figure 2 - Composite plate after cure for 24 hours at room temperature.

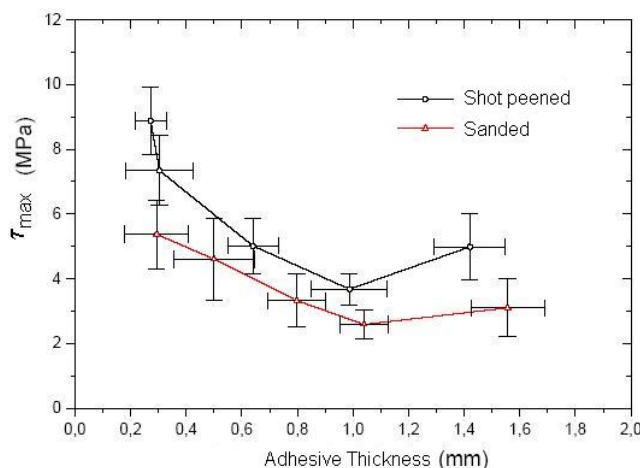
The data obtained in shear tests allowed the construction of graphs tension versus displacement for each of the joints with variable thickness and different surface treatment. In the abscissa of these graphs the displacement was plotted, because the measure supplied by the extensômetro is actually a relative displacement, proportional to the deformation of adhesive. This proportionality can be admitted assuming that the adherends behave as inextensible materials in comparison to the adhesive. Figure 7 shows the shear tests results.

Figure 7 – Shear Tests Results

The maximum shear stress of the adhesive joints is affected by the adhesive thickness layer and the best surface treatment was shot peening, whose joints showed higher shear stress values and cohesive failure mode.

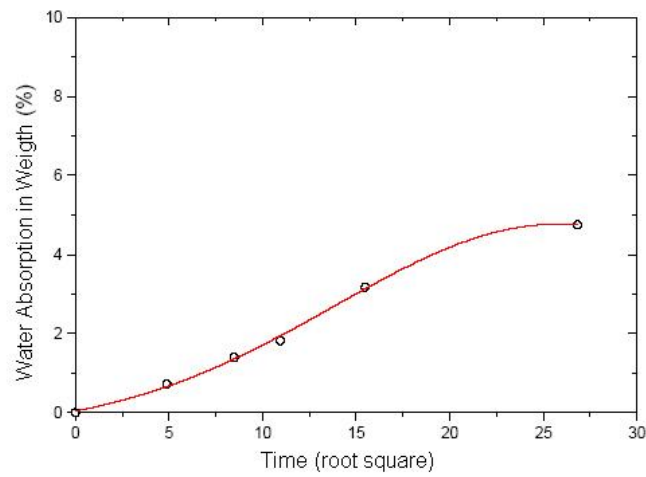
The joints with 0,2 mm adhesive thickness and the metal adherend treated by shot peening process were submitted to hygrothermal ageing at intervals of 24, 72, 120, 240 and 720 hours. Figure 8 shows the adhesives' coupons water absorption. No microstructural change on the adhesives was observed.

It is observed in Fig.7 that the amount of absorbed humidity increases with time of immersion. In this experiment, although the graph can suggest, the saturation point was not reached and the diffusion type was not modeled, as well as the coefficient of diffusion of the adhesive material. To obtain such data it would be necessary to follow the procedure A of the standard ASTM D 5229.

Figure 8 – Water Absorption.
