RESIDUAL STRENGTH OF OFFSHORE STRUCTURES DAMAGED BY COLLISION

***Abstract.** Despite the efforts to reduce accidents involving ship collisions, they continue to happen. The aim of this paper is to compare the ultimate buckling strength of intact and damaged offshore structures after a collision event. Two structures were evaluated, a semi-submersible platform column damaged by a supply vessel collision and a ship bottom hull damaged by a rock. The intact analysis were accomplished with the finite element program ABAQUS. The numerical models were represented by shell elements assuming finite membrane strains and large rotations, considering both geometric and material nonlinearities. Geometric imperfections were represented by a sinusoidal expression based on the recommendations of a classification society. The finite element analysis of a collision accident involves material and geometric high nonlinearities, large rotations and deformations, friction and complexities in the contact and interactions between two structures. Nowadays with the development of advanced computer technology and sophisticated finite element packages it is feasible to accomplish this type of analysis with

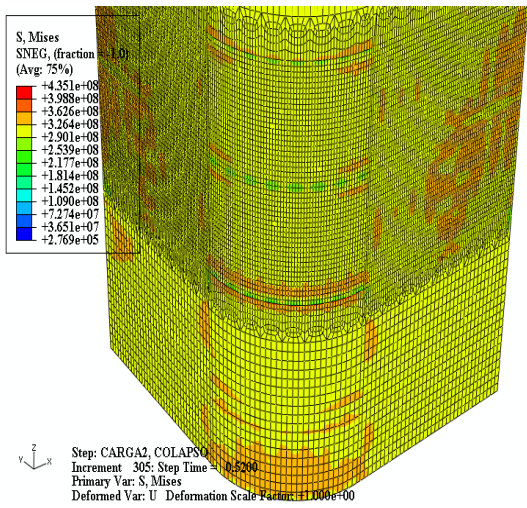
Figure 4. Outer shell von Mises stress (Pa) distribution

Outer shell von Mises stress distribution can be seen in Fig. 4 for the axial displacement associated with the bulkhead buckling load. At the same axial displacement the bulkhead failure associated with elasto-plastic buckling can be observed in Fig. 5. The outer shell buckling regime is established beyond the applied axial displacement 29.8 mm. In Fig. 6 is shown the outer shell initial strength drop. In Fig. 7 is presented an outer view of the column plating post-buckling mode. In all Figures of the column the von Mises stress are presented in Pascal (Pa).

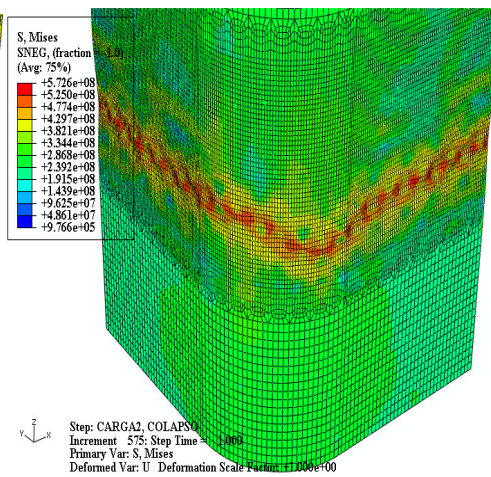
Figure 7. Post-buckling collapse mode
