## **CRITICAL AZIMUTH FOR STABILITY REQUIREMENTS IN DAMAGED CONDITIONS OF RING PONTOON SEMI-SUBMERSIBLE PLATFORMS**

**Abstract.** *The stability standards for intact and damaged conditions contained in international stability codes and regulations generally do not have an explicit indication of which direction they should be applied. For most ships and floating structures this implicit requirement do not become an issue, since their slender hulls clearly indicates the critical direction, usually the transverse one. But in offshore ring pontoon semi-submersible platforms this is not a straightforward perception considering that the hull main dimensions, length and breadth, are both of similar magnitudes. Besides, in damaged conditions, the critical direction, at first glance, seems to be logically well defined by the static resting position. The results gathered and presented in this paper, however, show that the critical stability azimuths in damaged conditions of these structures are quite different from those expected from the respective static equilibrium positions. This is particularly true when the evaluated damaged criteria do not involve areas (energy) under static stabilit

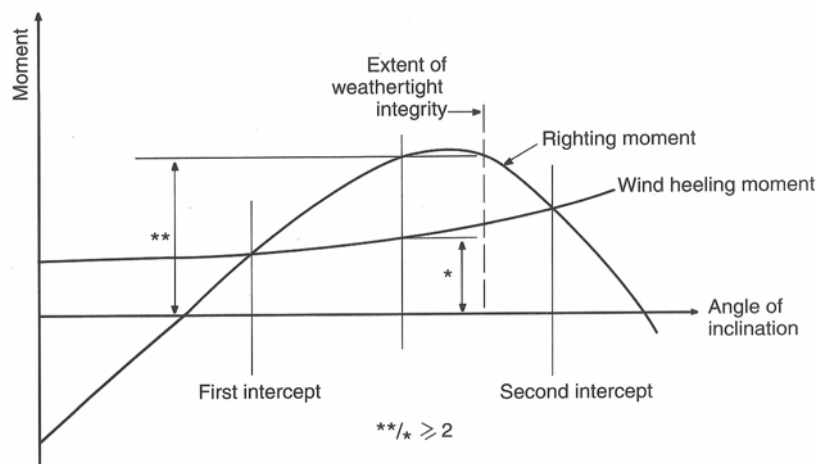
Figure 4 – Righting Moment and Wind Heeling Moment Curves - Damaged Stability (IMO, 1989)

The damaged stability study has been done considering a set of criteria obtained from three different sources: the MODU Code (IMO, 1989), the Norwegian Maritime Directorate Rules (NMD, 1991) and the Det Norske Veritas Offshore Standard C301 (DNV, 2008). The MODU Code establishes two main conditions to be satisfied after the damage: first, the angle of inclination should not be greater than 17 degrees; and, second, the righting moment curve should have, from the first intercept to the lesser of the extent of weathertight integrity required (downflooding point) and the second intercept between the righting and heeling moment curves, a positive stability range of at least 7 degrees. And, within this range, the righting moment curve should reach a value of at least twice the wind heeling moment curve, both being measured at the same angle. The Fig. 4 illustrates these conditions.

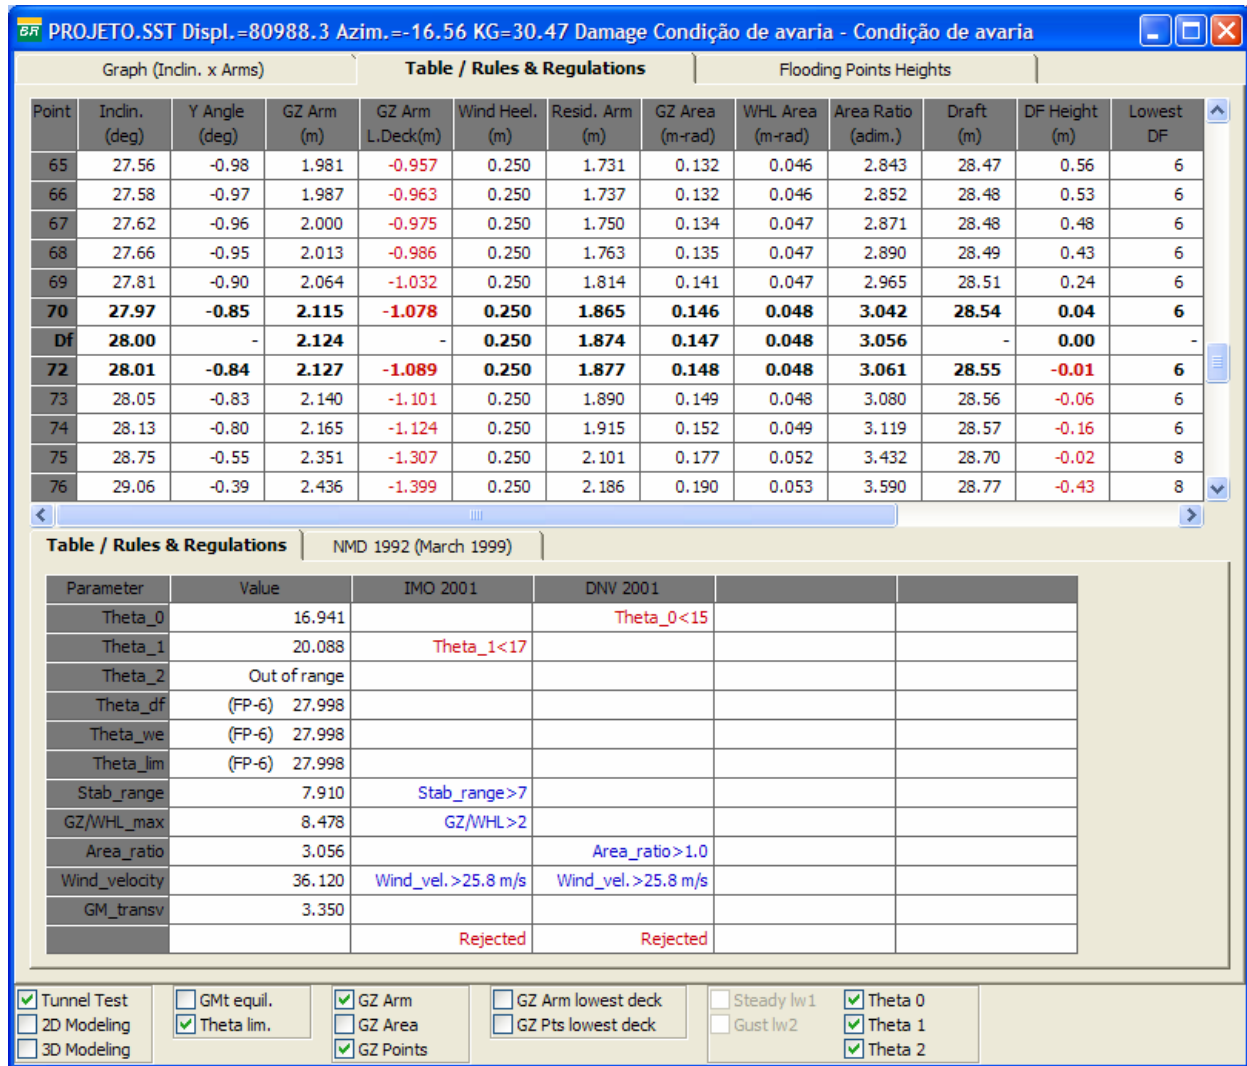
Figure 7 – Damaged Position Results and IMO/DNV Rules Checking for KG = 30.47m

required by the NMD rule. Besides, two more criteria used are being violated: the static resting angle ( $16.94^\circ$ ) is greater than  $15^\circ$  (DNV standard) and the dynamic equilibrium angle ( $20,08^\circ$ ) is also greater than  $17^\circ$  (IMO standard). Those figures are summarized in Fig. 7 tables and rules checking.

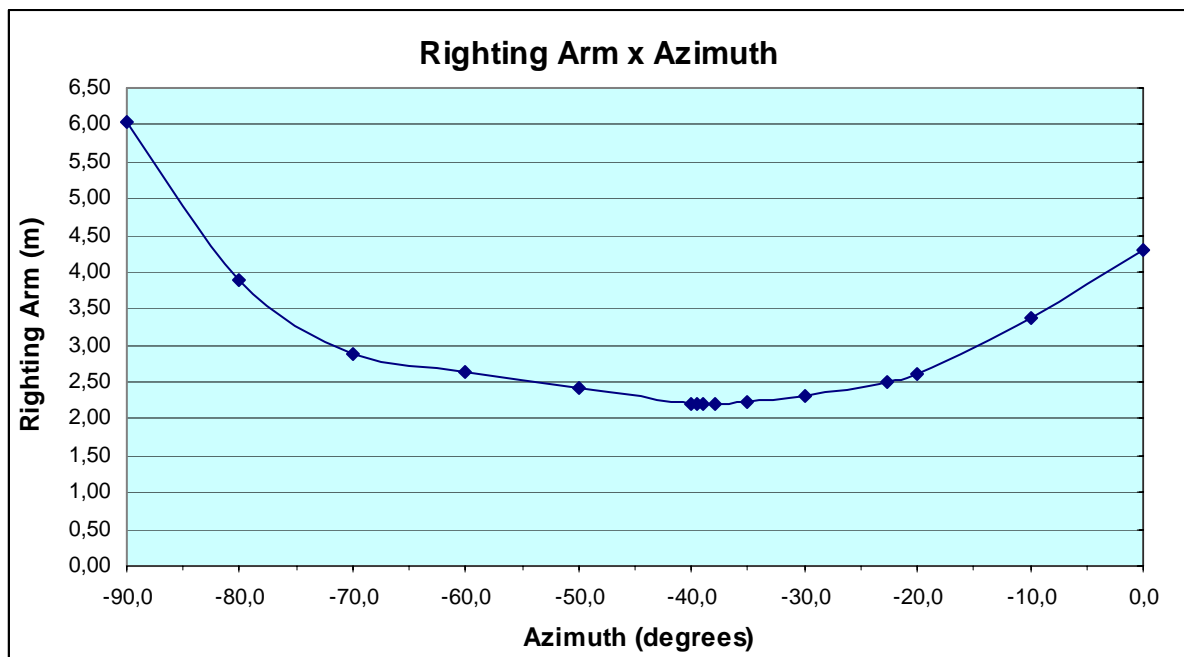
Figure 8 - Maximum Righting Arms versus Azimuth Angles in Damaged Condition for KG = 20.09m

As can be seen from Tab. 6 above and Fig. 8 below, in this case there is a wide range of azimuth values, at least from  $-30^\circ$  to  $-50^\circ$ , in which the minimum GZ requirement of 2.500m is not attained. From the same table and figure it is clear that the probable critical azimuth is located around  $-40^\circ$ . But this is enough to demonstrate that the critical azimuth does not match the resting position azimuth and the search for this critical direction is mandatory to determine the actual maximum permissible KG of the unit when using minimum righting arms criteria. And it is no necessary to search any further to find out the exact critical azimuth value for this damaged condition nor analyze any other damaged condition to validate these conclusions.
