# | Composite tube behavior under low velocity impact

In the present work the results of an experimental test campaign performed with the aim of evaluating the mechanical behavior of tubular structures under impact, with and without torsional pre-load, are presented. In particular, the aspects on which the research was focused are the stacking sequence and the pre-load level, that proved to be a key factor for the impact response of the material. A numerical model based on the Ansys software was developed to describe the material behavior up to the first load drop.

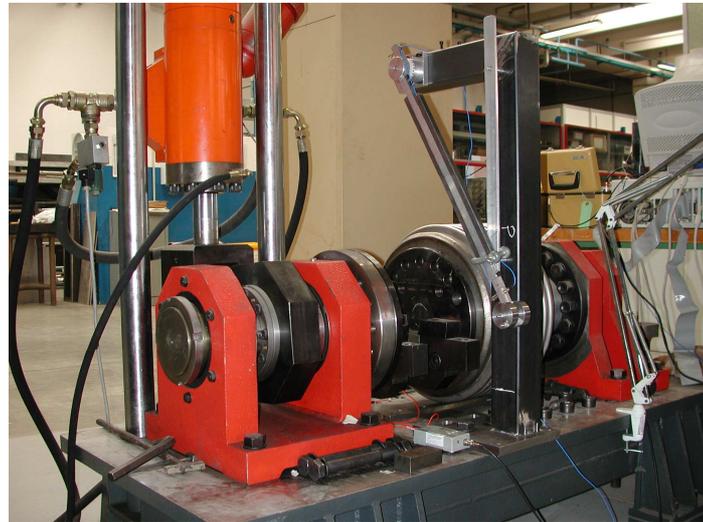
Figure 2 shows the full experimental set-up, including: the Italsigma torsional testing machine, the instrumented pendulum and the signal acquisition system (torque, rotation, deformation of strain gauges, impact force and finally Acoustic Emission, whose details are not discussed in this paper).

Figure 2: Experimental set-up.
